ARCHITECTURAL HERITAGE

The Selkirk and District

Planning Area

David
Butterfield

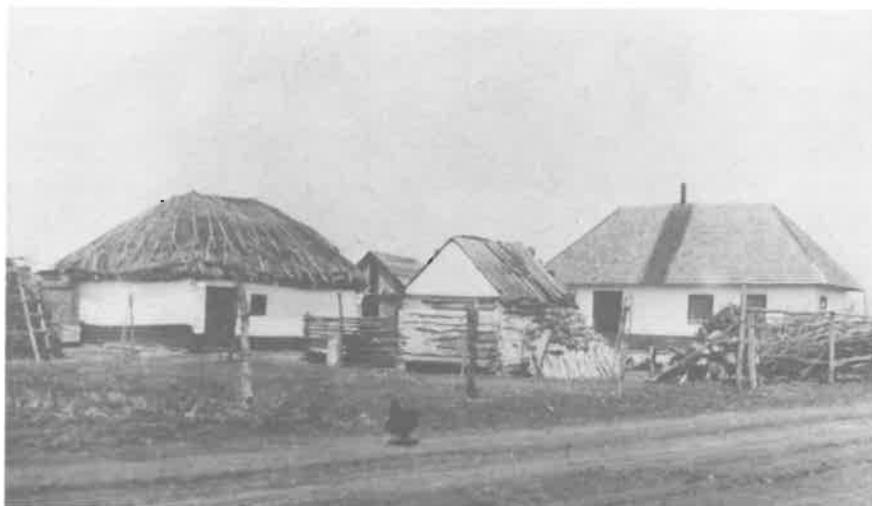
Plate 124. Former Arnsey farmstead. The present building is on the right, its pioneer precursor on the left. Since this photograph was taken the front wall of the later house has been removed and the structure is collapsing.

Peeled logs were connected at its corners with saddlenotch joints, which have weathered better than might have been expected; it is the removal of sections of the front wall that has proved disastrous for the structure's integrity. The plaster cover on the log walls was secured in a novel way: hundreds of small wooden splints cut into thin wedges and driven diagonally into the logs at regularly spaced intervals acted as purchase, holding the first layer of clay and straw in place. This first layer was then covered with layers of plaster and lime. Only at the bottom of the walls has the clay layer been lost, the upper portion being protected by the broad overhang of the roof.

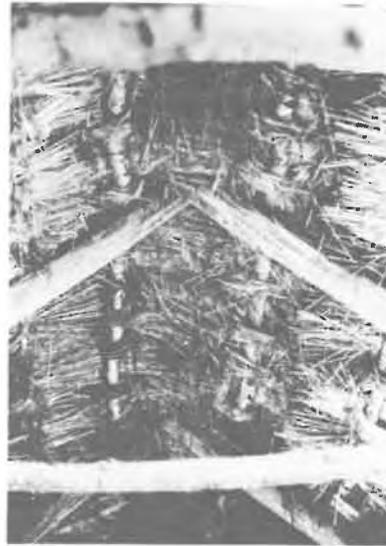
Plate 126. Thatch procedure likely used on the former Arnsey house.

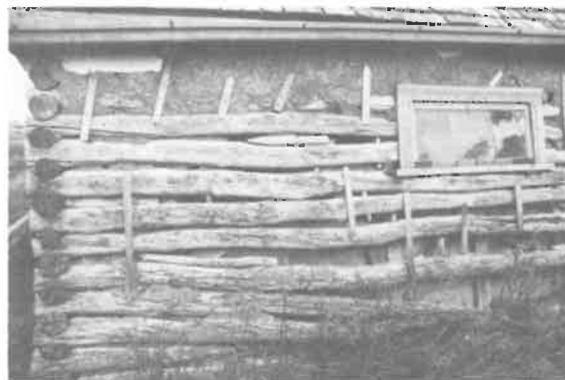
Plate 141. This detail of a granary shows the long pegs used to secure the walls against lateral spread.
