## Schools

## Stores

## Community Residences

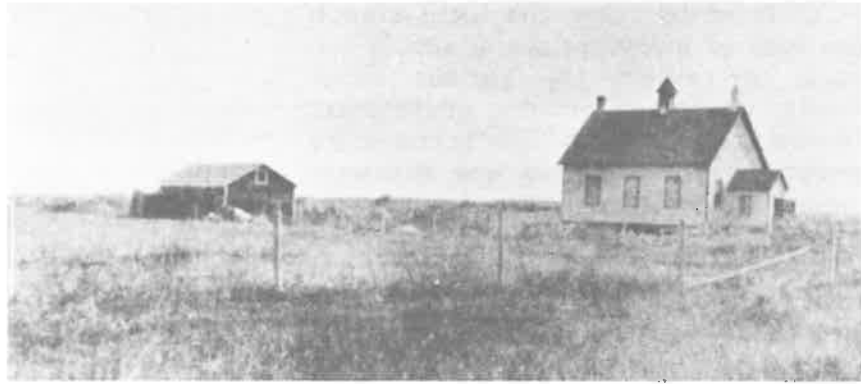
Plate 174. An early wood frame one-room school, at Walkleyburg. (From: East Side of the Red, p. 265.)

The log schools were soon replaced in rural areas by small wood frame buildings (Plate 174). These new structures, though usually gable roofed and rectangularly planned, rarely conformed to any specific requirements for school building construction. They were often drafty, poorly heated and badly lit. Interior appointments -- desks and blackboards -- were mostly jerry-built, a reflection of the pinched economic circumstances of early pioneer life.

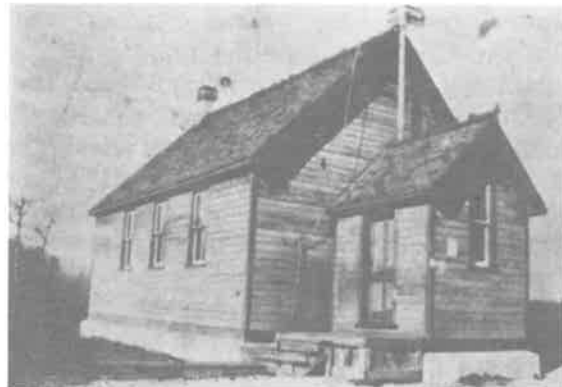
Plate 176. The former Mapleton School had the distinctive offset, detailed tower, square plan and fenestration treatment typical of Hooper's Design No. 3. (From: Beyond the Gates of Lower Fort Garry, p. 78.)

By 1900, however, the intervention of provincial authorities, through regular inspections, had greatly improved school designs and construction. Inspectors had early recognized the limits of ad hoc building ideas but it was not until 1903, when the Department of Education commissioned Samuel Hooper, a notable Winnipeg architect, that a standardized, quality set of plans for school buildings was made available. Hooper's three designs corresponded to three budgetary, or population, conditions. Design No. 1, the simplest, smallest and most popular, was readily adopted as the basis for several school buildings in the planning area (Plate 175). No.'s 2 and 3 were less commonly used, but the old Mapleton School was certainly derived from the latter (Plates 176 and 177).

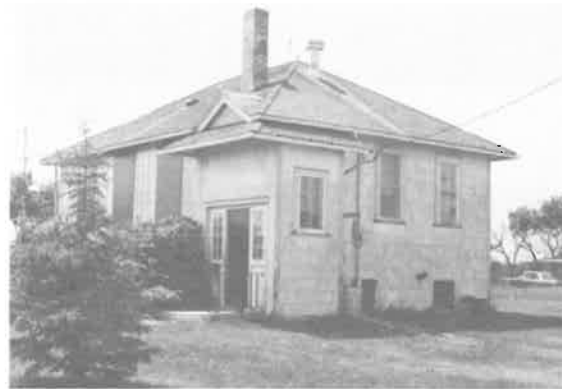
Plate 178. An interesting alternative to Hooper's designs which appeared occasionally in the planning area (here at NE14-15-3E), shifted the entrance to one side and drew it out into a sort of corner tower.

Hooper's designs, in common with other building proposals for rural schools made between 1900 and 1920, relied on a boxy massing with a formal entrance condition (Plate 178). The typical fenestration pattern placed a virtual wall of windows on the west

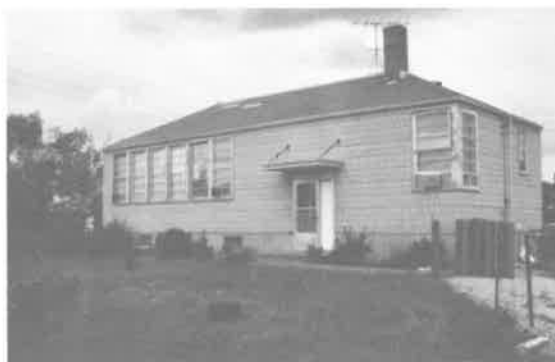
Plate 181. Earl Grey School.

During the 1930s pared-down one-room designs, with low hipped roofs, were promoted by provincial authorities. In the planning area several of these buildings still exist, although often reworked inside to become residences (Plate 181). Some schools were planned so that the classroom opened off one side of the entrance hall, while a cloakroom, office or even teacher's quarters might be accommodated in a smaller space on the other side.

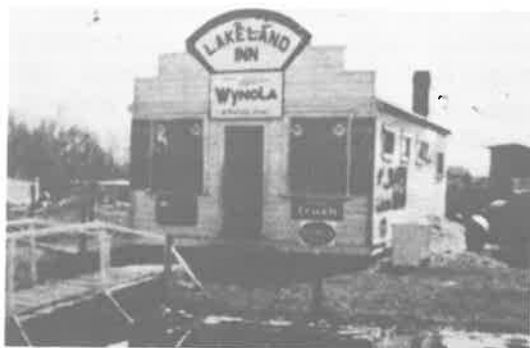
Plate 184. The former Lakeland General Store at Beaconia. (From: East Side of the Red, p. 344.)

have differed markedly from early settlement houses: they were small, unpretentious log structures (Plate 182). Quickly, however, the proximity of lumber milling facilities and the models presented by urban commercial facilities began to bring about the replacement of the first rudimentary buildings. By the turn of the century nearly all commercial establishments throughout the planning area, though still small, were of light wood frame construction and, more significantly, faced with boom town fronts (Plate 183). This architectural feature not only created an impressive entrance condition but also provided space atop for signage or large advertisements. Subtle changes to the outline of such a facade resulted in a distinctive store front (Plate 184).

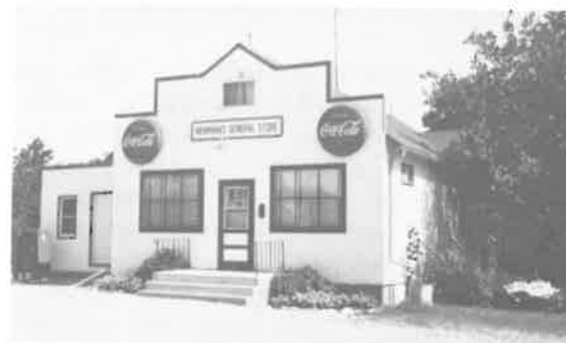
Plate 185. Newman's General Store is cast in stucco, giving it a sleek appearance.

As the need for convenient commercial activity was increasingly met after 1930 by the automobile and the improvement of roads leading to small urban centres, rural business was largely relegated to servicing the automobile. The gas station, while possibly generating some other minor commercial activity, became the predominant rural store. Many of the buildings dating from this period -- several of which exist in the planning area -- present the same boomtown face of the earlier structures although differing slightly in architectural expression. In comparison they, like the automobiles they serviced, are often sleek, influenced by Art Deco styling (Plate 185).

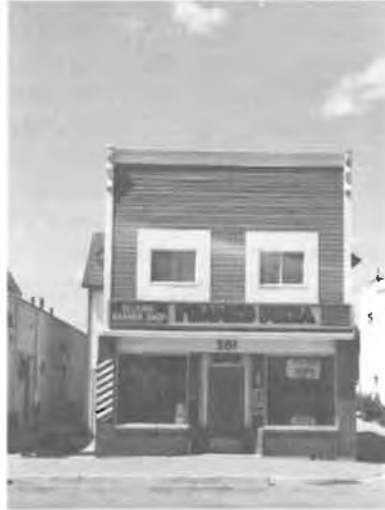
Plate 202. Now Frank's Pizza, this old store features a plain tall boom town front, tipped at the edges of the cornice by decorative little scrolls.

Today the commercial core of Selkirk reveals only hints of its former character and these hints are generally of a humbler nature (Plate 202).

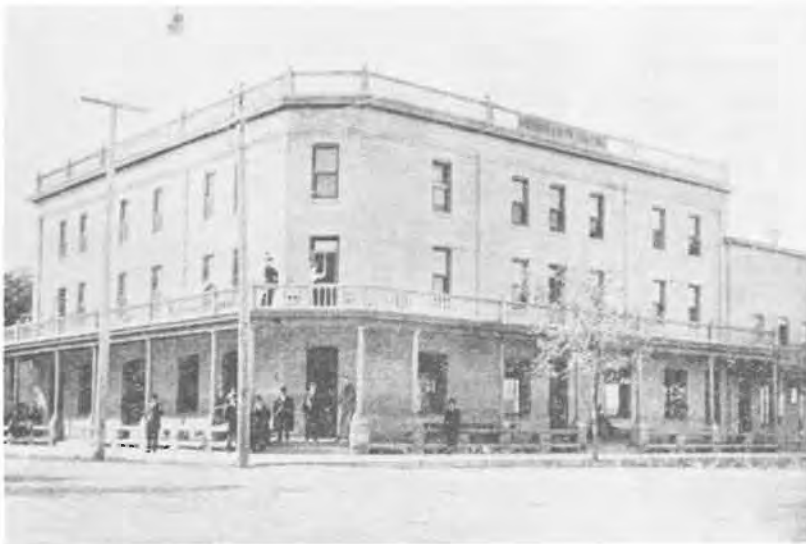
Plate 203. The Merchant's Hotel has been covered with stucco about the main floor, eliminating many of the building's original and interesting features. (PAM)

Exceptions include the old Merchant's Hotel (Plate 203), the former Dominion Bank (Plate 204) and the old Post Office. While buildings like these are of some interest in their own right, they were fairly common in prairie towns and can only assume a greater importance in the particular context of Selkirk, with its current dearth of historic buildings.

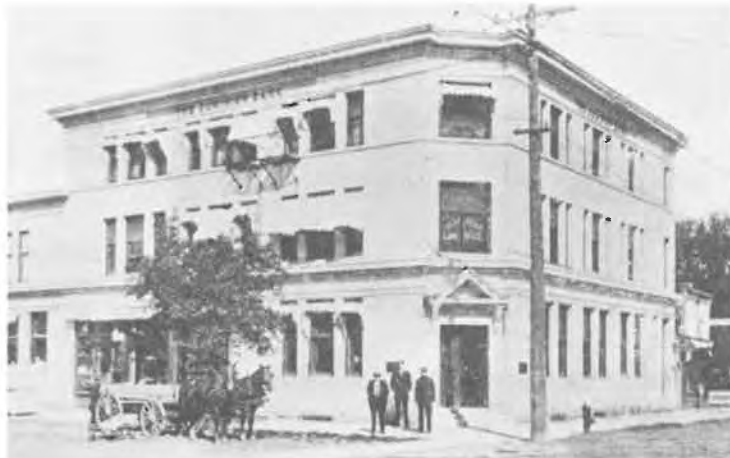
Plate 204. The old Dominion Bank has seen various functions throughout the years, but is remarkably intact, at least on the exterior. Orientation to the corner provides the building with a distinctive entrance bay. This caprice results in interesting details that range across the whole. (PAM)

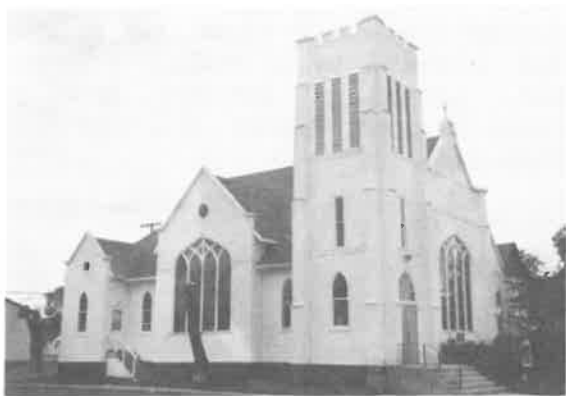
Plate 210. The Evangelical Lutheran Church was built under the direction of an Icelandic carpenter, Mr. Bjarnason.

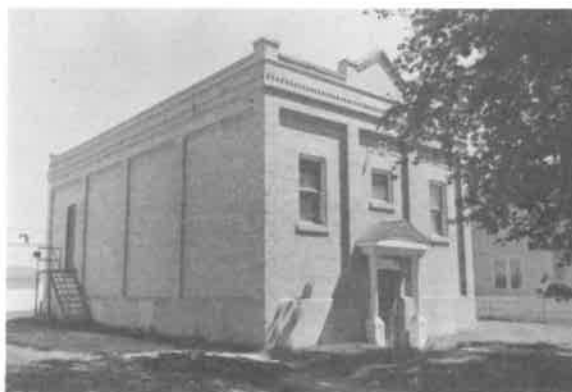
Plate 212. The old Masonic Hall in Selkirk is a fine little brick building with a carefully composed facade of three bays, the central one dominated by a peaked pediment.

The many fraternal organizations that abounded in the West around the turn of the century -- Oddfellows, Orangemen, Masons among the most prominent -- often constructed meeting halls for themselves; in Selkirk one such structure, the old Masonic Hall, remains. Incidentally, masons date their buildings from the reign of King Solomon, the first "master builder", so the datestone on the Selkirk building reading A.L. 5920 should be interpreted to read 1871 (Plate 212).

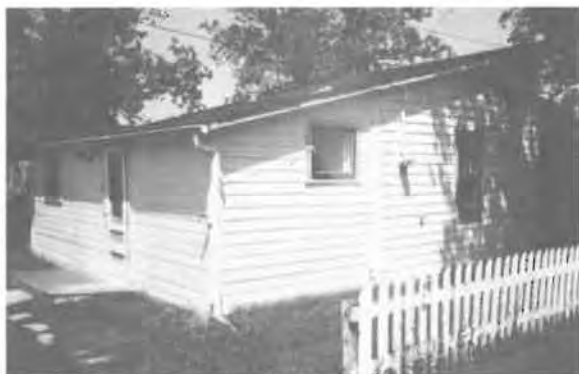
Plate 213. 402 Queen Street, Selkirk.

The housing stock in Selkirk is in many cases unexceptional, but still evocative of the early days in the town. A house at 402 Queen Avenue is a simple little shed-roofed structure, very common for pioneer habitation before the turn of the century (Plate 213). Often the shed was transformed into a kitchen when a larger gable-roofed building was appended to it; in this case the original form remains unaltered. Another house, on Pacific Avenue, once owned by a mayor of Selkirk (F.W. Colcleugh), is a straightforward side hall-planned house (Plate 214). Its carefully restored condition and some simple but effective details, like a bay window at the front, a twinned window on the east face and the pedimented window surrounds lift this building above the numerous run-of-the-mill facsimiles in the countryside.

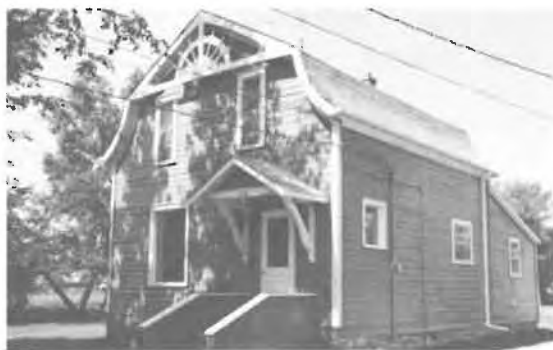
Plate 215. It is perhaps no coincidence that this house, with its maritime themes, lies close to the river on Eveline Street.

There are several other houses of modest size in Selkirk that have a more playful nature. One, on the east side of Main Street, is a side hall plan whose immediate expression is formed more by its gambrel roof shape and the boat wheel detailing in its gable end than its planning (Plate 215). A second house, west of Main on McLean, is likewise a side hall house, but in this case animated by a shallow mansard roof, projecting dormers and a mansard-topped boxed bay window (Plate 216).

- 9) **1 1/2 Storey Side Hall House with Gambrel Roof**  
**Construction Date:** ca. 1900  
**Location:** 475 Eveline Street, Selkirk  
**Present Owner:** Mr. Hawes  
**Present Use:** Occupied  
**Construction:**  
 walls - horizontal siding on milled wooden frame  
 roof - asphalt shingles on milled wooden rafters  
**Integrity:** Largely unaltered  
**Condition:** Good  
**Notes:** This building is also discussed on page 118.

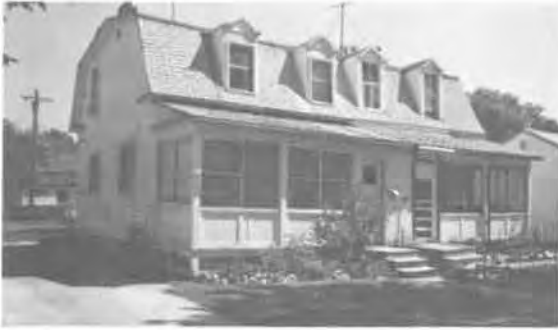
Plate 217. While the old duplex on Rosser Avenue has seen many internal changes, the exterior, including the long verandah, is largely intact.

Selkirk's urban nature required a somewhat increased density of housing. Apartment buildings did not arise in the community until the 1940s but a few duplexes were built here before that date. Constructed ca. 1890, a duplex on Rosser Avenue is a long one-and-a-half storey building, capped by a gambrel roof and gabled dormers (Plate 217).

- 15) 1 1/2 Storey Gambrel-Roofed House  
 Construction Date: ca. 1890  
 Location: 207 & 209 Rosser Avenue, Selkirk  
 Present Owner: Mr. Randy Wilson  
 Present Use: Occupied Duplex  
 Construction:  
   walls - horizontal siding on milled wooden frame  
   roof - asphalt shingles on milled wooden rafters  
 Integrity: The interior has been altered  
 Condition: Fair  
 Notes: This building is also discussed on pages 118-119.

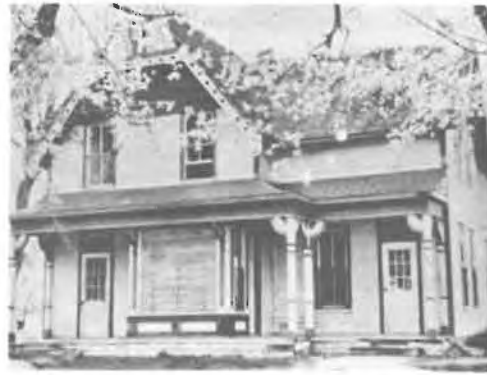
Plate 218. Souter house, Eveline Street. This early photograph shows the original detailing.

All of these modest houses are, not surprisingly, of wood frame construction; wood was cheap and readily available in Selkirk after 1880. Even some of the larger houses in the community are of wood frame. The Souter house, analyzed earlier (see pages 60-61), is a fine structure that displays nicely the possibilities of construction in milled lumber. Carefully carved wooden details abound here: gable end decorations, turned posts on the verandah and shingling on the gable ends (Plate 218). The larger McLeod house is a basic Four Square building, neatly kept and distinguished by three hip-roofed dormer windows (Plate 219).

- 11) **1 1/2 Storey L-Shaped House**  
**Construction Date:** 1893  
**Location:** 323 Eveline Street, Selkirk  
**Present Owner:** Mr. B. Souter  
**Present Use:** Occupied  
**Construction:**  
 walls - horizontal siding on milled wooden frame  
 roof - asphalt shingles on milled wooden rafters  
**Integrity:** The interior has been altered considerably, but still retains its period appearance. The exterior is largely unaltered.  
**Condition:** Good  
**Notes:** This building is also discussed on pages 60-61.

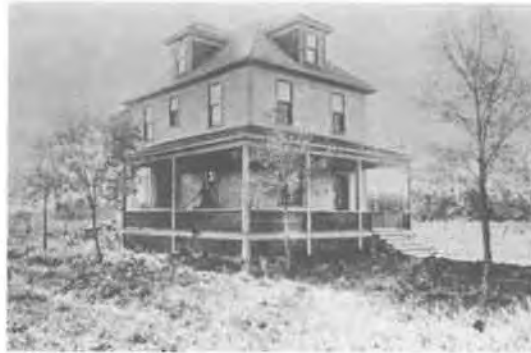
Plate 219. The former Smith house on Eveline Street, built in 1916, has one of the earliest poured concrete basements in Selkirk.

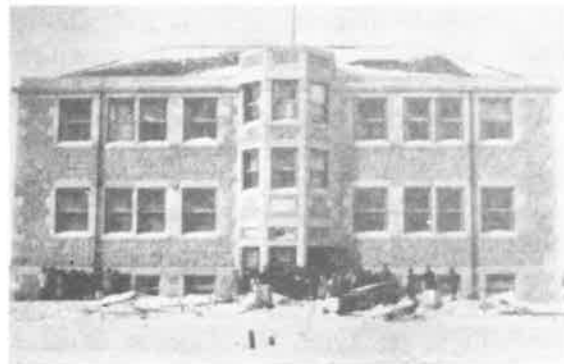
Plate 236. Former stone school, Garson. (From: They Stopped at a Good Place, p. 93.)

The first school, hopefully named "Prosperity", was a two-storey log structure, opened in 1907. By 1909 this building was replaced with a one-room wood frame structure, located one mile south of the village. The growing population in the area required the construction of yet another school, this a one-room structure built in 1914 near the Gillis Quarry. Ultimately, overcrowding in both these buildings was resolved by the war time construction of a large stone school with four classrooms and a basement (Plate 236).

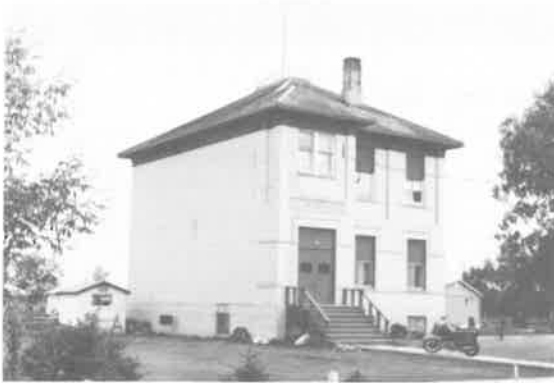
Plate 241. The old brick school in Petersfield.

Like Clandeboye, Petersfield declined after 1930 and most of the services and nearly all of the early buildings are gone. There are a few notable survivors, however. The brick school, now used as a residence, remains (Plate 241). The old CPR station has been moved eastwards, into the summer cottage area, where it too has been renovated for private use (Plate 242). A store dating from the early 1920s is a visible but forlorn reminder of the community's past (Plate 243). The only church now in the village, St. Anne's Roman Catholic Church, was built in 1936, at a time when the village was past its prime (Plate 244).

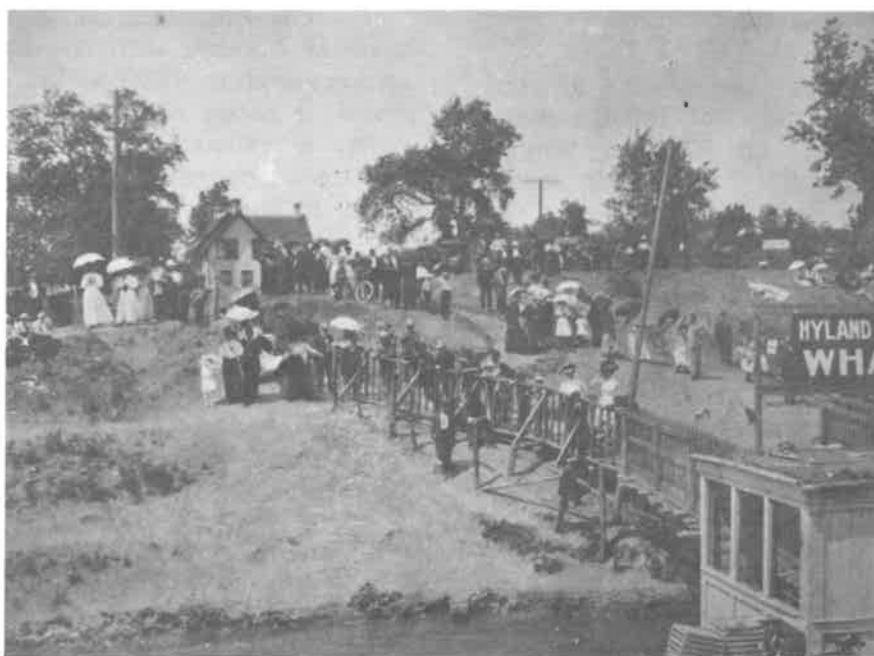
Plate 247. A Lockport scene, before the construction of the lock gate. (PAM)

The area on the west side of the Red River a few kilometres south of Lower Fort Garry was the location of a small concentration of farms and a few businesses before the turn of the century (Plate 247). The name Lockport was not actually used until the Dominion Government completed their lock project in 1911. Great expectations for a subsequent development at Lockport did not materialize, however. The riverboat era was all but over and the locks themselves were infrequently used.

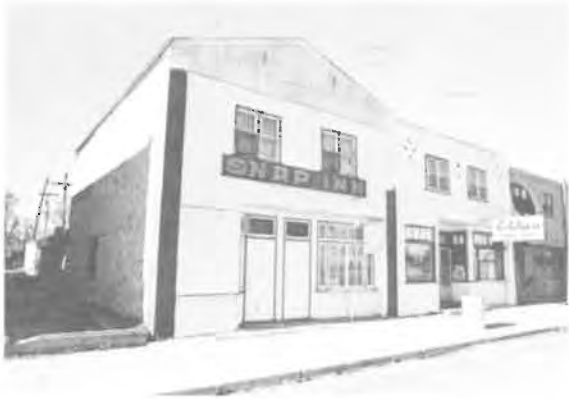
**Plate 256. Commercial structures in Winnipeg Beach.**

Today the first Winnipeg Beach Town Hall is used as a storage facility (Plate 255). A few of the original commercial structures remain along Railway Street but have been drastically altered by the addition of stucco (Plate 256). Two churches, the Anglican and the United, are still standing (Plates 257 and 258) and many of the cottages built by the prolific Mr. Ritchie remain, despite frequent alterations through the years by different owners (Plate 259).

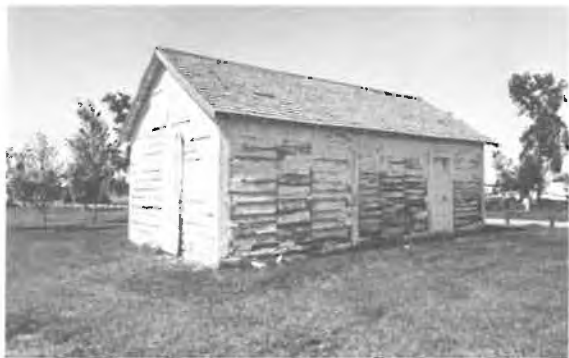
- 1) **Red River Frame House**  
**Construction Date:** ca. 1860  
**Location:** Selkirk Park  
**Present Owner:** Town of Selkirk  
**Present Use:** Storage  
**Construction:**  
 walls - Red River frame logs  
 roof - wooden shingles on milled wooden rafters  
**Integrity:** The house originally stood on Eveline and was altered when it was moved.  
**Condition:** Fair  
**Notes:** This building is also discussed on pages 21-22.

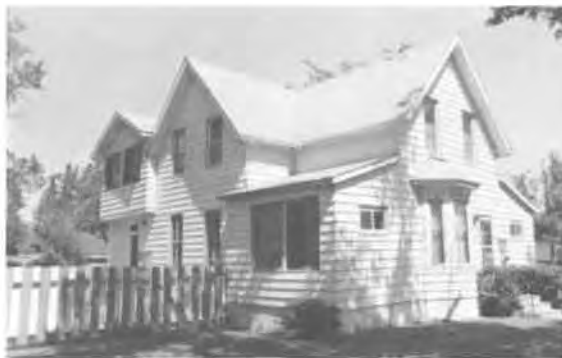
- 2) **1 1/2 Storey House**  
**Construction Date:** ca. 1870-1875  
**Location:** 283 Eveline Street, Selkirk  
**Present Owner:** Mr. Henrikson  
**Present Use:** Occupied  
**Construction:**  
 walls - original section: logs/additions: horizontal siding on milled wooden frame  
 roof - asphalt shingles on milled wooden rafters  
**Integrity:** The original log house has been added to over the years and the same building now bears little semblance of its original humble state.  
**Condition:** Good  
**Notes:** The original log section of this house is one of the oldest remaining buildings in the community.

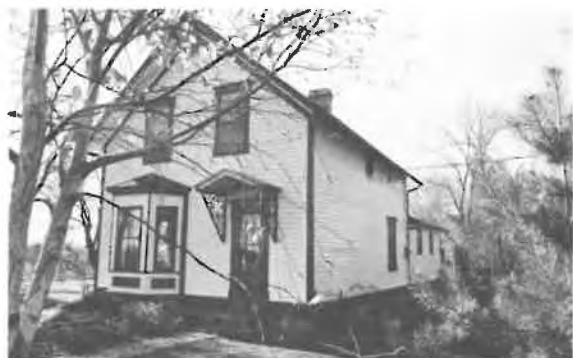
- 3) **1 1/2 Storey Side Hall House**  
**Construction Date:** 1872-74  
**Location:** 102 Pacific Avenue, Selkirk  
**Present Owner:** Mr. H. van der Putten  
**Present Use:** Occupied  
**Construction:**  
 walls - horizontal siding on milled wooden frame  
 roof - asphalt shingles on milled wooden rafters  
**Integrity:** The house is undergoing renovations to bring it very close to its original appearance.  
**Conditions:** Excellent  
**Notes:** This building is also discussed on page 118.

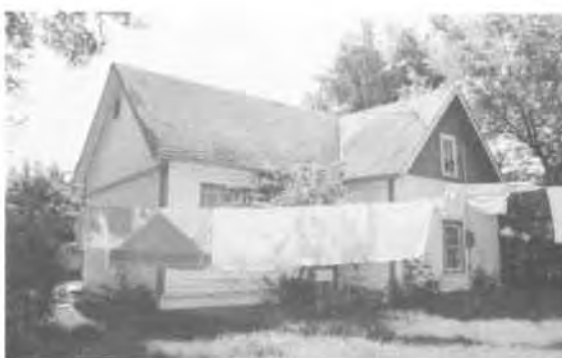
- 4) **L-Shaped Log House**  
**Construction Date:** ca. 1875  
**Location:** 103 Toronto Avenue, Selkirk  
**Present Owner:** A. Bannish  
**Present Use:** Occupied  
**Construction:**  
 walls - squared dovetailed logs with horizontal siding  
 roof - wood shingles on milled wooden rafters  
**Integrity:** The house appears to have had at least one addition and it is likely that the interior has been altered.  
**Condition:** Fair

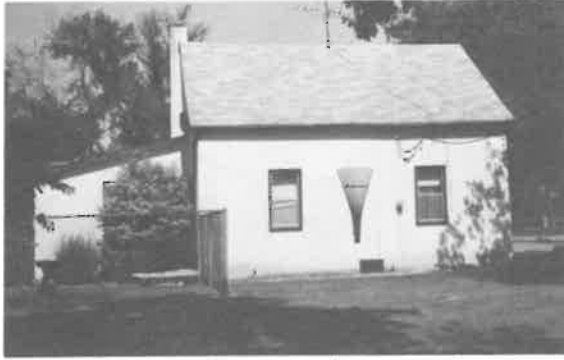
- 5) **Log House**  
**Construction Date:** ca. 1880  
**Location:** 200 Taylor Avenue, Selkirk  
**Present Owner:** Mr. Steve Tell  
**Present Use:** Occupied  
**Construction:**  
 walls - squared dovetailed logs with stucco veneer  
 roof - asphalt shingles on milled wooden rafters  
**Integrity:** Interior has been altered  
**Condition:** Good

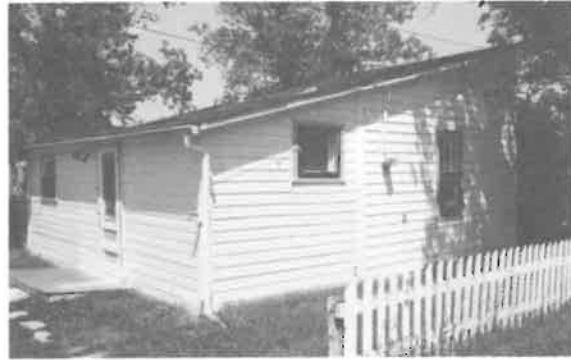
- 6) **Single Storey Shanty**  
**Construction Date:** ca. 1915  
**Location:** 402 Queen Avenue, Selkirk  
**Present Owner:** Mr. Borden McRae  
**Present Use:** Occupied  
**Construction:**  
 walls - horizontal siding on milled wooden frame  
 roof - asphalt shingles on milled wooden rafters  
**Integrity:** Largely unaltered  
**Condition:** Fair  
**Notes:** This building is also discussed on page 118.

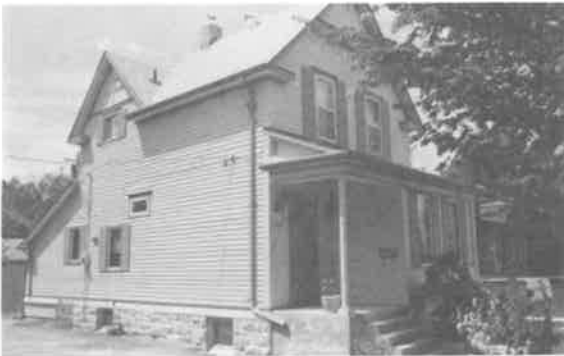
- 7) **1 1/2 Storey Side Hall House**  
**Construction Date:** ca. 1885  
**Location:** 202 Vaughan Avenue, Selkirk  
**Present Owner:** Mr. O. Purdy  
**Present Use:** Occupied  
**Construction:**  
 walls - horizontal siding on milled wooden frame  
 roof - asphalt shingles on milled wooden rafters  
**Integrity:** Interior has been altered, although much is still intact  
**Condition:** Good

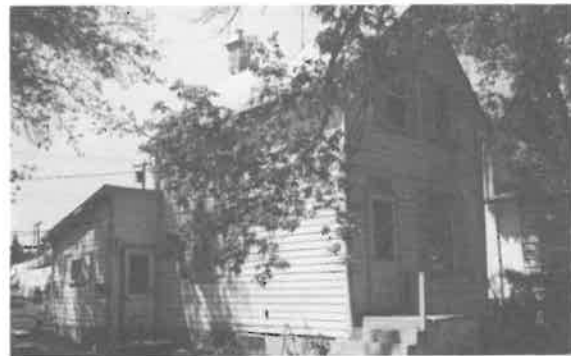
- 8) **1 1/2 Storey Side Hall House**  
**Construction Date:** 1899  
**Location:** 412 Robinson Avenue, Selkirk  
**Present Owner:** Mr. George Bell  
**Present Use:** Occupied  
**Construction:**  
 walls - horizontal siding on milled wooden frame  
 roof - asphalt shingles on milled wooden rafters  
**Integrity:** Largely unaltered  
**Condition:** Fair

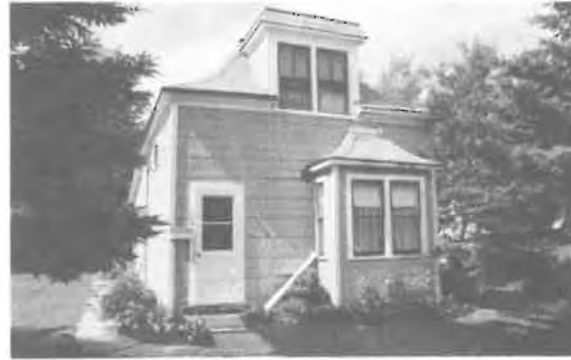
- 10) **1 1/2 Storey Side Hall House with Hipped Bellcast Roof**  
**Construction Date:** ca. 1900  
**Location:** 520 McLean Avenue, Selkirk  
**Present Owner:** Mr. Russell Hendry  
**Present Use:** Occupied  
**Construction:**  
 walls - wooden shingles on milled wooden frame  
 roof - asphalt shingles on milled wooden rafters  
**Integrity:** Largely unaltered  
**Condition:** Fair  
**Notes:** This building is also discussed on page 118.

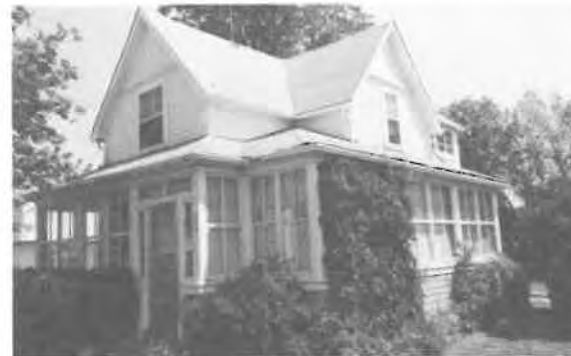
- 12) **1 1/2 Storey T-Shaped House**  
**Construction Date:** ca. 1900  
**Location:** 470 Main Street, Selkirk  
**Present Owner:** Mr. H. Little  
**Present Use:** Occupied  
**Construction:**  
 walls - horizontal siding on milled wooden frame  
 roof - asphalt shingles on milled wooden rafters  
**Integrity:** Largely unaltered  
**Condition:** Good

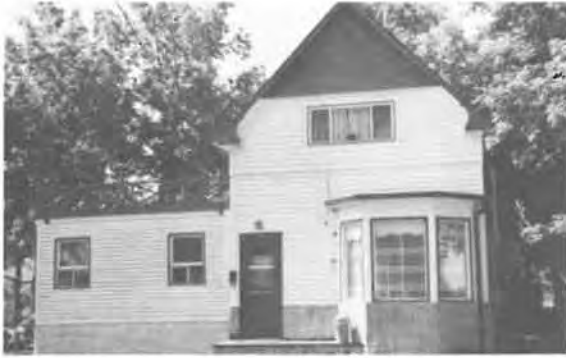
- 13) 1 1/2 Storey Side Hall House  
 Construction Date: ca. 1900  
 Location: 206 Taylor Avenue, Selkirk  
 Present Owner: Mr. R.A. Luining  
 Present Use: Occupied  
 Construction:  
   walls - horizontal siding on milled wooden frame  
   roof - asphalt shingles on milled wooden rafters  
 Integrity: The main portion of the house is unaltered, but additions have been made to increase the floor size.  
 Condition: Good

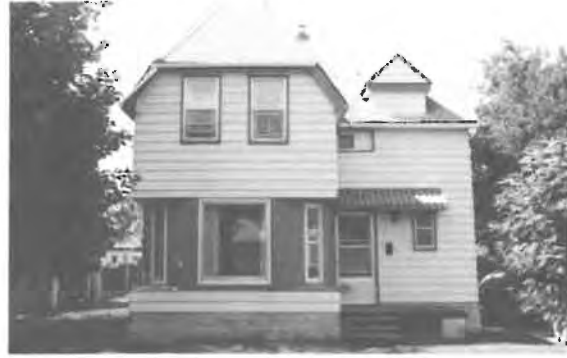
- 14) 1 1/2 Store L-Shaped House  
 Construction Date: ca. 1895  
 Location: 204 Taylor Avenue, Selkirk  
 Present Owner: G. E. Still  
 Present Use: Occupied  
 Construction:  
   walls - aluminum siding on milled wooden frame  
   roof - asphalt shingles on milled wooden rafters  
 Integrity: Both interior and exterior have been significantly altered.  
 Condition: Good

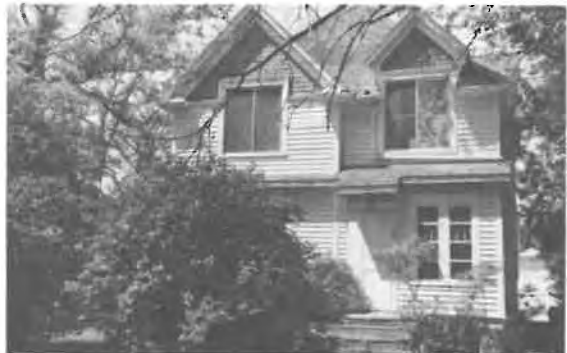
- 16) 1 1/2 Storey L-Shaped House  
 Construction Date: 1900  
 Location: 149 Eveline Street, Selkirk  
 Present Owner: Mrs. Lulashuyk  
 Present Use: Occupied  
 Construction:  
   walls - horizontal siding on milled wooden frame  
   roof - wood shingles on milled wooden rafters  
 Integrity: The interior is currently being renovated. The exterior is in good unaltered condition.  
 Condition: Fair

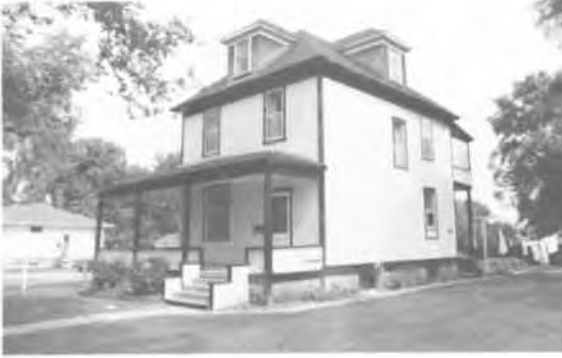
- 17) 2 1/2 Storey Square Plan House  
 Construction Date: 1916  
 Location: 260 Eveline Street, Selkirk  
 Present Owner: Mrs. E. Smith  
 Present Use: Occupied  
 Construction:  
   walls - horizontal siding on milled wooden frame  
   roof - asphalt shingles on milled wooden rafters  
 Integrity: Largely unaltered  
 Condition: Good  
 Notes: This building is also discussed on page 119.

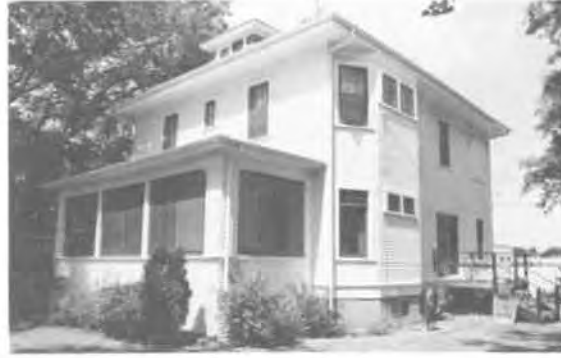
- 18) 2 Storey Square Plan House  
 Construction Date: ca. 1900  
 Location: 213 Dorchester Avenue, Selkirk  
 Present Owner: Mr. Hurley  
 Present Use: Occupied  
 Construction:  
   walls - horizontal siding on milled wooden frame  
   roof - asphalt shingles on milled wooden rafters  
 Integrity: The interior has been altered.  
 Condition: Good

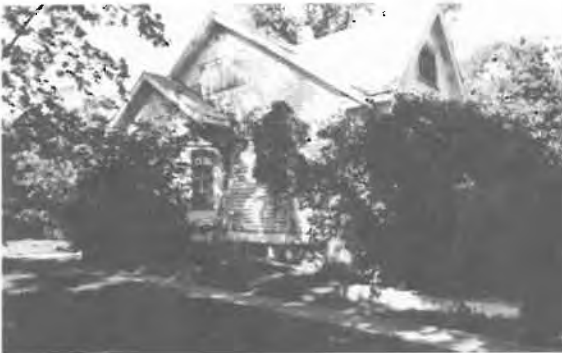
- 19) 1/2 Storey "T" Plan House  
 Construction Date: 1896  
 Location: 419 Eveline Street, Selkirk  
 Present Owner: Mr. R. Hooker  
 Present Use: Occupied  
 Construction:  
   walls - horizontal siding on milled wooden frame  
   roof - asphalt shingles on milled wooden rafters  
 Integrity: The house was originally 3 1/2 storeys in height. In 1936/37 the middle two storeys were removed.  
 Condition: Good

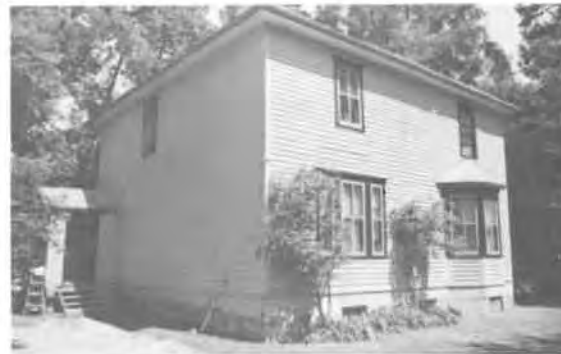
- 20) 2 Storey Square Plan House  
 Construction Date: 1903  
 Location: 239 Eveline Street, Selkirk  
 Present Owner: Mr. Don Lugtig  
 Present Use: Occupied  
 Construction:  
   walls - horizontal siding on milled wooden frame  
   roof - asphalt shingles on milled wooden rafters  
 Integrity: Largely unaltered  
 Condition: Good  
 Notes: This building was previously an Anglican manse.

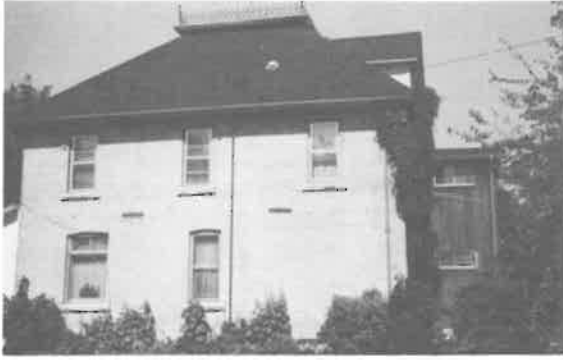
- 21) **2 1/2 Storey Square Plan House**  
**Construction Date:** 1904-05  
**Location:** 210 Taylor Avenue, Selkirk  
**Present Owner:** Mr. Roy Purvis  
**Present Use:** Occupied  
**Construction:**  
 walls - buff brick on milled wood frame  
 roof - asphalt shingles on milled wooden rafters  
**Integrity:** Largely unaltered  
**Condition:** Good  
**Notes:** This building is also discussed on page 120.

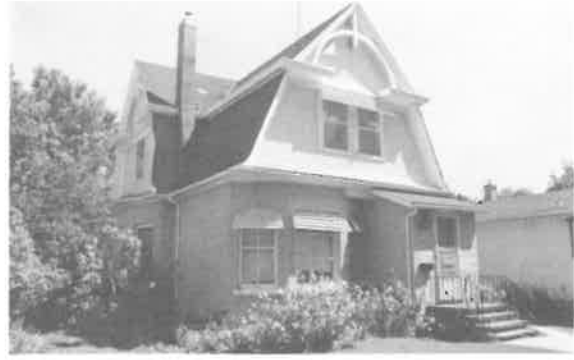
- 22) **1 1/2 Storey Side Hall House with Gambrel Roof**  
**Construction Date:** 1905  
**Location:** 215 Rosser Avenue, Selkirk  
**Present Owner:** Mrs. Ellen Howard  
**Present Use:** Occupied  
**Construction:**  
 walls - horizontal siding on milled wooden frame  
 roof - wood shingles on milled wooden rafters  
**Integrity:** Largely unaltered  
**Condition:** Good

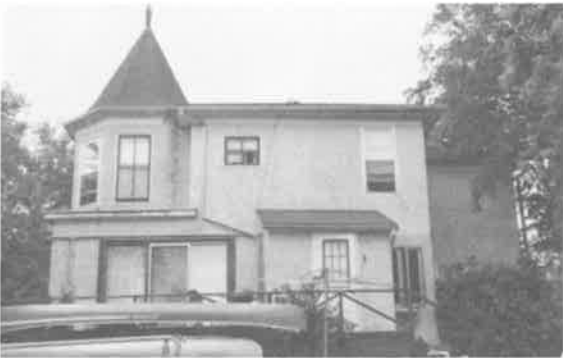
- 23) **2 Storey T-Shaped House**  
**Construction Date:** 1905  
**Location:** 326 Eveline Street, Selkirk  
**Present Owner:** Mr. Williams  
**Present Use:** Occupied  
**Construction:**  
 walls - stucco veneer on milled wooden frame  
 roof - asphalt shingles on milled wooden rafters  
**Integrity:** Largely unaltered  
**Condition:** Good  
**Notes:** This house was previously owned by two local physicians, Drs. Grain and Atkinson.

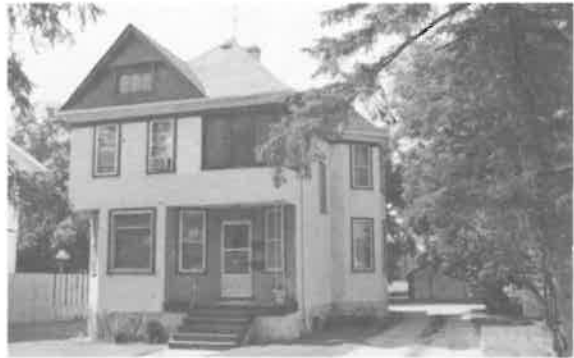
- 24) **2 1/2 Storey T-Shaped House**  
**Construction Date:** ca. 1905  
**Location:** 243 Eveline Street, Selkirk  
**Present Owner:** Mrs. Helena Pollock  
**Present Use:** Occupied  
**Construction:**  
 walls - stucco veneer on milled wooden frame  
 roof - asphalt shingles on milled wooden rafters  
**Integrity:** The interior and exterior have both been altered.  
**Condition:** Good

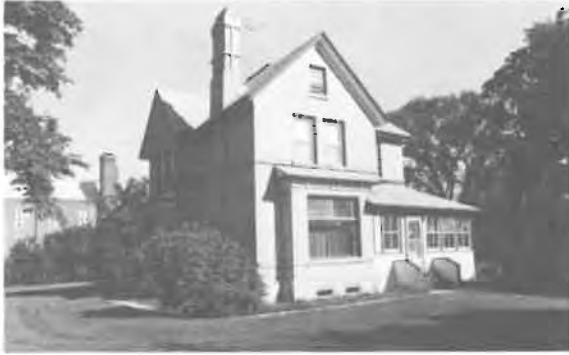
25) 1 1/2 Storey Square Plan House  
 Construction Date: ca. 1890  
 Location: Selkirk Mental Health Centre Grounds  
 Present Owner: Selkirk Mental Health Centre  
 Present Use: Occupied  
 Construction:  
   walls - buff brick on milled wooden frame  
   roof - asphalt shingles on milled wooden rafters  
 Integrity: Largely unaltered  
 Condition: Good

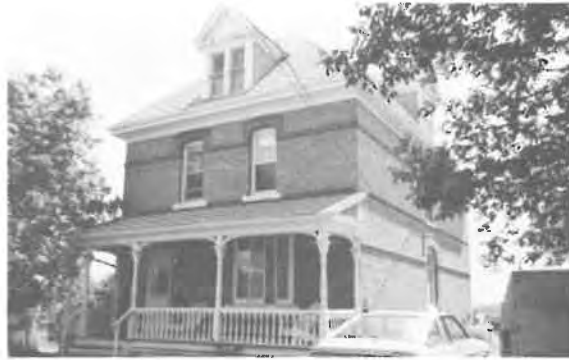
26) 2 1/2 Storey Square Plan House  
 Construction Date: 1911  
 Location: 478 Eveline Street, Selkirk  
 Present Owner: Mr. G. McLeod  
 Present Use: Occupied  
 Construction:  
   walls - red brick on milled wooden frame  
   roof - asphalt shingles on milled wooden rafters  
 Integrity: Largely unaltered  
 Condition: Good  
 Notes: This building is also discussed on page 120.

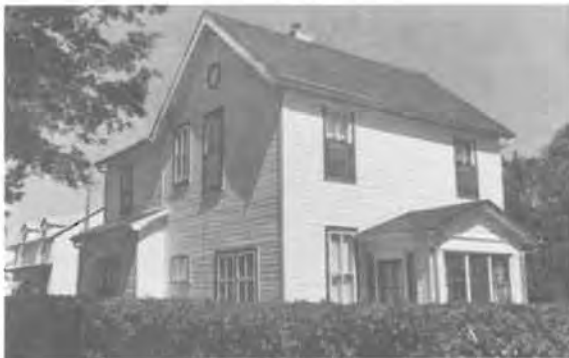
27) 1 1/2 Storey L-Shaped House  
 Construction Date: ca. 1910  
 Location: 285 Eveline Street, Selkirk  
 Present Owner: Mr. Edward Lennon  
 Present Use: Occupied  
 Construction:  
   walls - horizontal siding on milled wooden frame  
   roof - asphalt shingles on milled wooden rafters  
 Integrity: Largely unaltered  
 Condition: Good

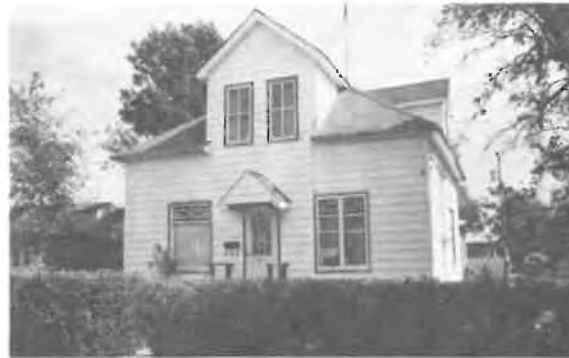
28) 1 1/2 Storey Square Plan House  
 Construction Date: ca. 1900  
 Location: 517 McLean Avenue, Selkirk  
 Present Owner: Mrs. Kushliak  
 Present Use: Occupied  
 Construction:  
   walls - horizontal siding on milled wooden frame  
   roof - asphalt shingles on milled wooden rafters  
 Integrity: Largely unaltered  
 Condition: Good

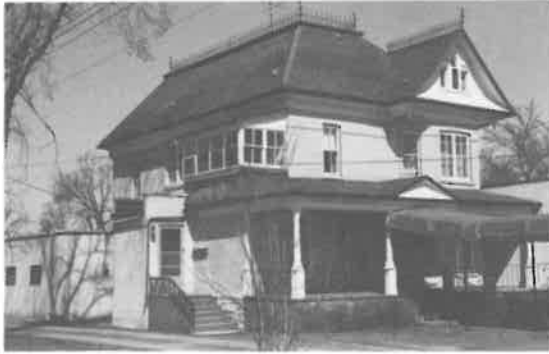
- 29) **2 1/2 Storey Square Plan House**  
**Construction Date:** 1913  
**Location:** 307 Eveline Street, Selkirk  
**Present Owner:** Mr. Roy Gilbert  
**Present Use:** Funeral Parlour  
**Construction:**  
 walls - buff brick on milled wood frame  
 roof - wood shingles on milled wooden rafters  
**Integrity:** The interior has been altered considerably.  
 The exterior retains most of its original features.  
**Condition:** Good  
**Notes:** This building is also discussed on page 120.

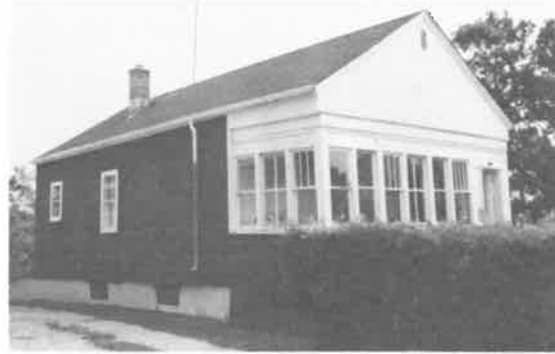
- 30) **Single Storey House**  
**Construction Date:** ca. 1880  
**Location:** 515 Clandeboye Avenue, Selkirk  
**Present Owner:** Mr. K. Davidson  
**Present Use:** Occupied  
**Construction:**  
 walls - insulbrick siding on milled wooden frame  
 roof - asphalt shingles on milled wooden rafters  
**Integrity:** Unaltered floorplan  
**Condition:** Fair

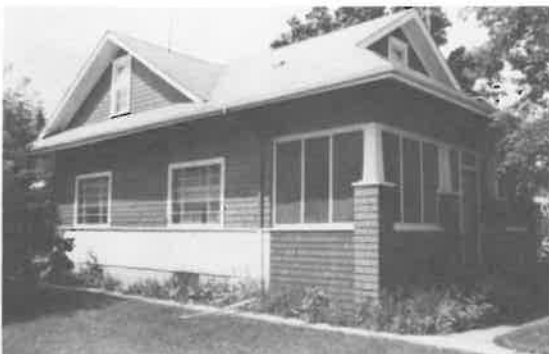
- 31) **1 1/2 Storey House**  
**Construction Date:** ca. 1910  
**Location:** 218 McLean Avenue, Selkirk  
**Present Owner:** Mr. C. Reid  
**Present Use:** Occupied  
**Construction:**  
 walls - wood shingles and horizontal siding on milled wooden frame  
 roof - asphalt shingles on milled wooden rafters  
**Integrity:** Largely unaltered  
**Condition:** Good  
**Notes:** This unpretentious house was designed by the architect George Teeter, who designed the Winnipeg Shriner's Hospital.

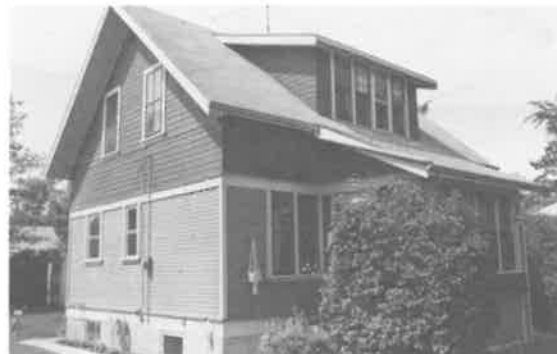
- 32) **1 1/2 Storey House**  
**Construction Date:** 1922  
**Location:** 212 McLean Avenue, Selkirk  
**Present Owner:** Mr. Hadfield  
**Present Use:** Occupied  
**Construction:**  
 walls - horizontal siding on milled wooden frame  
 roof - asphalt shingles on milled wooden rafters  
**Integrity:** Largely unaltered  
**Condition:** Good  
**Notes:** This house was constructed by Roy Hooker, once owner of Hooker's Lumber in Selkirk.

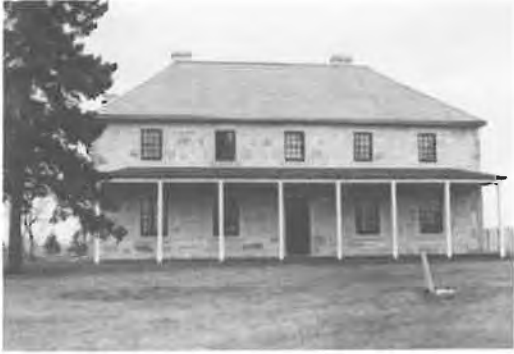
- 33) **St. Andrew's Anglican Church Rectory**  
**Construction Date:** 1854  
**Location:** River Lot #62  
**Present Owner:** Parks Canada  
**Present Use:** Museum/Residence  
**Construction:**  
 walls - fieldstone  
 roof - wood shingles on square cut timbers  
**Integrity:** The building was recently restored by Parks Canada to its original state.  
**Condition:** Excellent  
**Notes:** This building is also discussed on page 39.

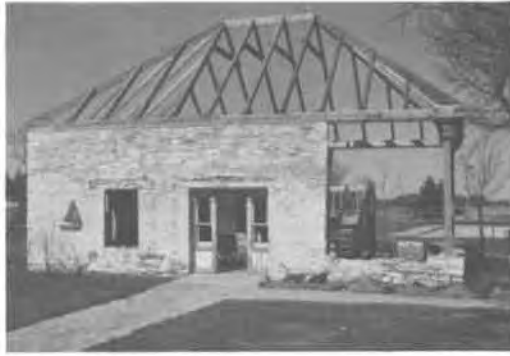
- 34) **Scott House**  
**Construction Date:** ca. 1855  
**Location:** River Lot #47  
**Present Owner:** Manitoba Parks Branch  
**Present Use:** Tourist attraction  
**Construction:**  
 walls - fieldstone  
 roof - wood shingles on cut timbers  
**Integrity:** The building has been altered considerably for its current function.  
**Condition:** Fair  
**Notes:** This building is also discussed on page 34.

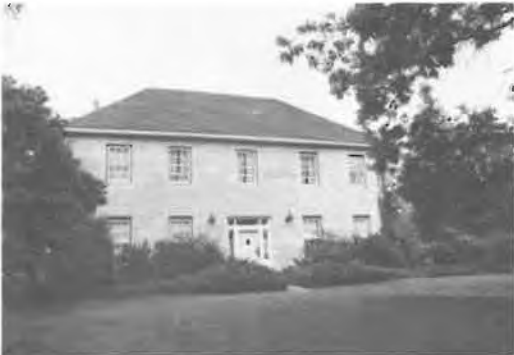
- 35) **Twin Oaks, formerly Miss Davis' School**  
**Construction Date:** 1858  
**Location:** River Lot #51  
**Present Owner:** Mr. T. Denton  
**Present Use:** Occupied  
**Construction:**  
 walls - limestone  
 roof - asphalt shingles on cut timbers  
**Integrity:** The interior has been altered.  
**Condition:** Good  
**Notes:** This building is also discussed on page 38.

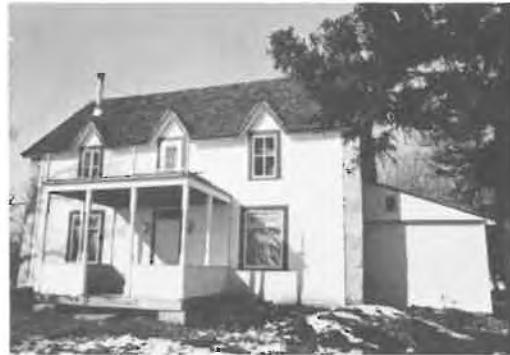
- 36) **Hay House**  
**Construction Date:** ca. 1861  
**Location:** River Lot #86  
**Present Owner:** Mr. Rudi Isbach  
**Present Use:** Vacant  
**Construction:**  
 walls - fieldstone and horizontal wood siding on milled wooden frame  
 roof - asphalt shingles on cut timbers  
**Integrity:** The interior has been altered.  
**Condition:** This building is being greatly upgraded.  
**Notes:** This building is also discussed on pages 34-36.

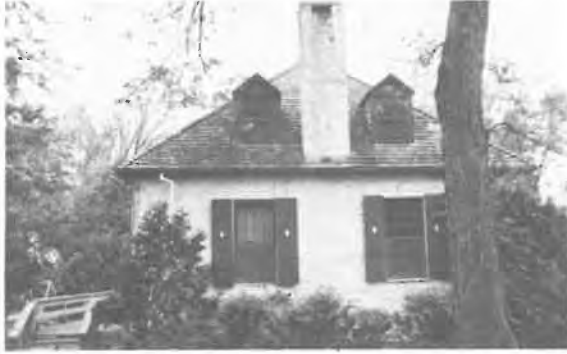
37) **Bunn House**  
**Construction Date:** 1861-64  
**Location:** River Lot #97  
**Present Owner:** The Stewart Brothers  
**Present Use:** Summer residence  
**Construction:**  
 walls - fieldstone  
 roof - wood shingles on cut timbers  
**Integrity:** Unaltered  
**Condition:** Good  
**Notes:** This building is also discussed on pages 36-38.

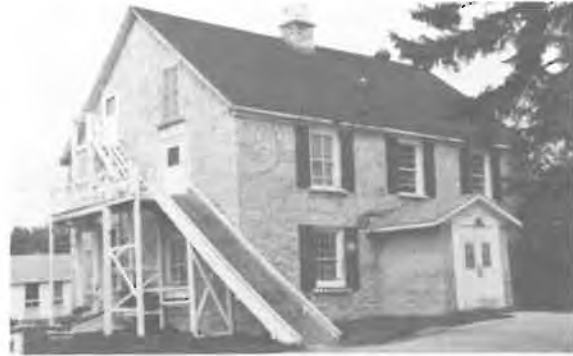
38) **St. Peter's Dynevor Indian Hospital**  
**Construction Date:** 1862-65  
**Location:** River Lot #40  
**Present Owner:** St. John's Cathedral Boy's School  
**Present Use:** Administrative Offices  
**Construction:**  
 walls - fieldstone  
 roof - asphalt shingles on cut timbers  
**Integrity:** The interior has been altered  
**Condition:** Fair  
**Notes:** This building is also discussed on pages 40-42.

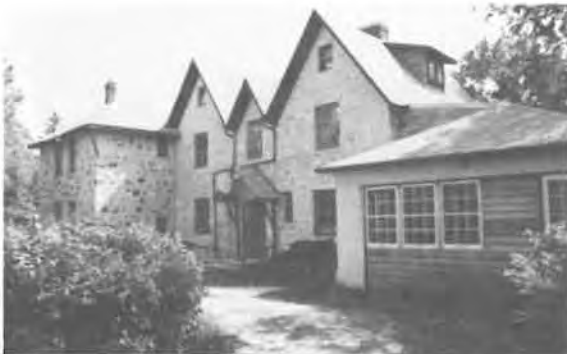
39) **Kennedy House**  
**Construction Date:** 1866-70  
**Location:** River Lot #70  
**Present Owner:** Manitoba Parks Branch  
**Present Use:** Tourist Attraction/Tea Room  
**Construction:**  
 walls - fieldstone  
 roof - wood shingles on cut timbers  
**Integrity:** The interior has been greatly altered and the exterior has been modified.  
**Condition:** Good  
**Notes:** This building is also discussed on pages 42-43.

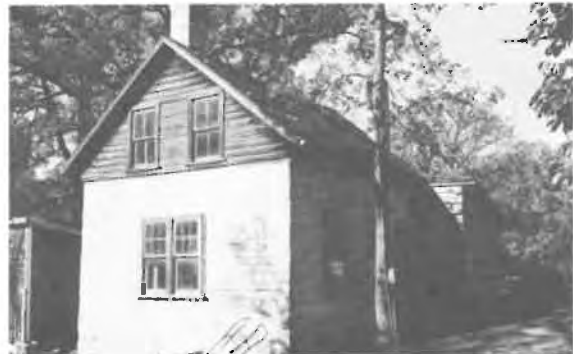
40) **Log House**  
**Construction Date:** ca. 1895  
**Location:**  
**Present Owner:** Mrs. West  
**Present Use:** Cottage  
**Construction:**  
 walls - squared dovetailed logs  
 roof - shingles on milled wooden rafters  
**Integrity:** Largely unaltered  
**Condition:** Good

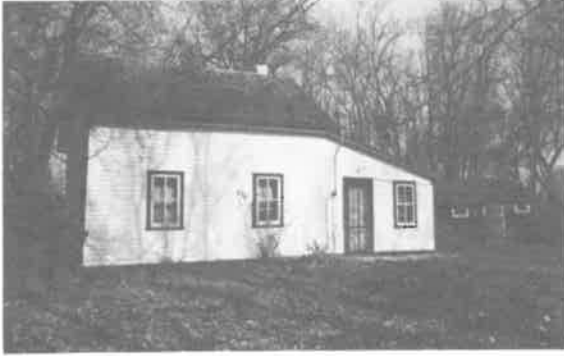
- 41) **Log House**  
**Construction Date:** ca. 1875  
**Location:** St. Peter's Anglican Church Grounds  
**Present Owner:** Mr. S. Hawchuk  
**Present Use:** Vacant  
**Construction:**  
 walls - horizontal siding on dovetailed square logs  
 roof - wooden shingles on square timber rafters  
**Integrity:** The building has been moved to its present site.  
**Condition:** Good  
**Notes:** This building may be an Indian home from St. Peter's Reserve.

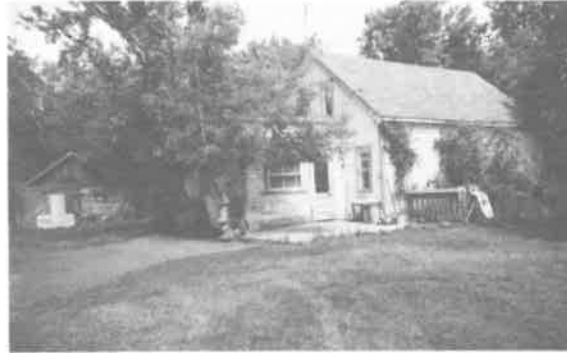
- 42) **Log House**  
**Construction Date:** ca. 1900  
**Location:** River Lot #129  
**Present Owner:** Mr. P. Kuhn  
**Present Use:** Occupied  
**Construction:**  
 walls - horizontal siding on squared dovetailed logs  
 roof - asphalt shingles on milled wooden rafters  
**Integrity:** Largely unaltered  
**Condition:** Fair

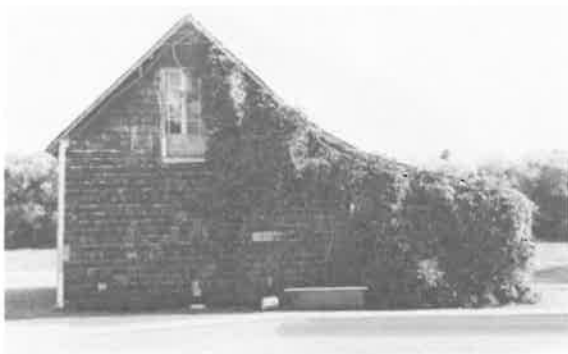
- 43) **Log House**  
**Construction Date:** ca. 1900  
**Location:** SW 2-17-3E  
**Present Owner:** Mr. Hawkins  
**Present Use:** Children's Playhouse  
**Construction:**  
 walls - horizontal siding on squared dovetailed logs  
 roof - wood shingles on milled wooden rafters  
**Integrity:** The interior has been completely gutted.  
**Condition:** Fair  
**Notes:** This building is also discussed on pages 55-56.

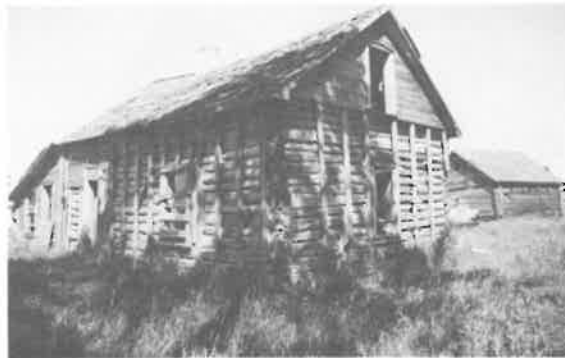
- 44) **Log House**  
**Construction Date:** 1906  
**Location:** NE 32-16-7E  
**Present Owner:** Mr. Otto  
**Present Use:** Vacant  
**Construction:**  
 walls - horizontal siding on saddlenotched logs  
 roof - wood shingles on milled wooden rafters  
**Integrity:** Largely unaltered  
**Condition:** Poor  
**Notes:** This building served as a post office from 1907-1920.

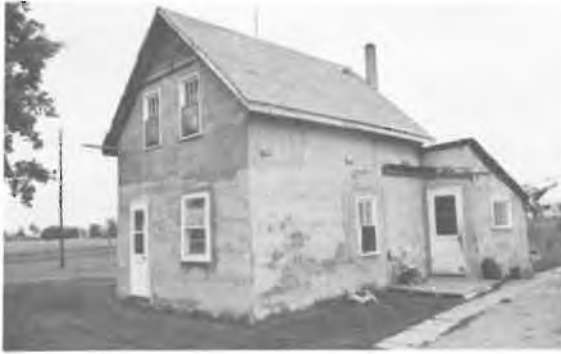
- 45) Log House  
 Construction Date: 1910  
 Location: River Lot #81  
 Present Owner: Mrs. Lillie  
 Present Use: Occupied  
 Construction:  
   walls - stucco veneer on squared dovetailed logs  
   roof - asphalt shingles on milled wooden rafters  
 Integrity: The interior has been altered.  
 Condition: Fair

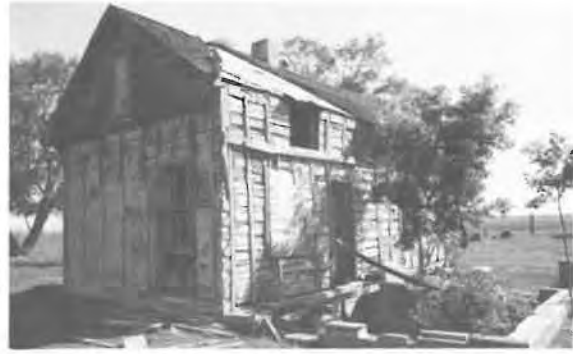
- 46) Log House  
 Construction Date: ca. 1910  
 Location: SE 12-16-7E  
 Present Owner: Mr. V. Parke  
 Present Use: Abandoned  
 Construction:  
   walls - horizontal siding on squared dovetailed logs  
   roof - wood shingles on milled wooden rafters  
 Integrity: Largely unaltered  
 Condition: Poor  
 Notes: Henry Parks, who homesteaded this land in 1908, was among the second group of settlers who crossed the Brokenhead River. He was the first school teacher in the area.

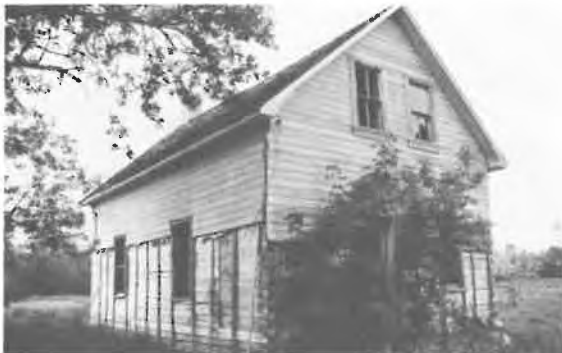
- 47) Log House  
 Construction Date: ca. 1910  
 Location: NW 3-15-6E  
 Present Owner:  
 Present Use: Vacant  
 Construction:  
   walls - horizontal siding on squared dovetailed logs  
   roof - wood shingles on milled wooden rafters  
 Integrity: Largely unaltered  
 Condition: Poor
