## Schools

## Stores

## Community Residences

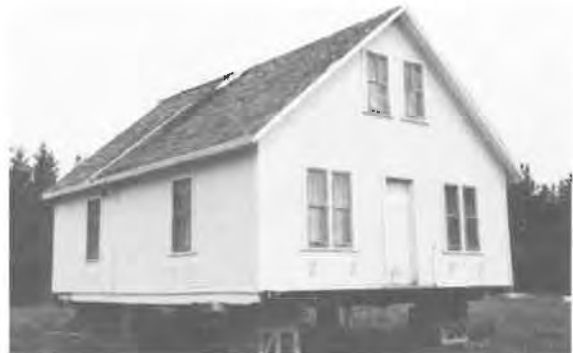
- 48) Log House  
 Construction Date: ca. 1910  
 Location: SE 32-14-6E  
 Present Owner: Mrs. Bowden  
 Present Use: Vacant  
 Construction:  
   walls - horizontal siding on squared dovetailed logs  
   roof - wood shingles on milled wooden rafters  
 Integrity: Largely unaltered  
 Condition: Fair

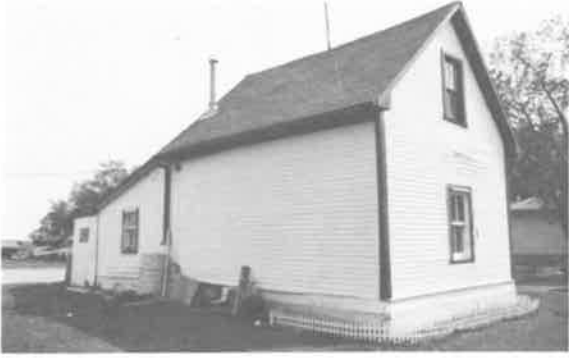
49) Log House  
 Construction Date: 1911  
 Location: River Lot #219  
 Present Owner: Mrs. R. Honnie  
 Present Use: Occupied  
 Construction:  
   walls - horizontal siding on squared dovetailed logs  
   roof - asphalt shingles on milled wooden rafters  
 Integrity: Largely unaltered  
 Condition: Fair

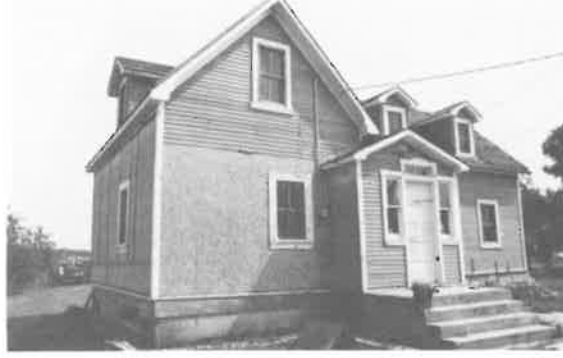
50) Log House  
 Construction date: ca. 1915  
 Location: River Lot #242  
 Present Owner: Mr. W. Meger  
 Present Use: Occupied  
 Construction:  
   walls - horizontal siding on dovetailed square logs  
   roof - wood shingles on milled wooden rafters  
 Integrity: Unaltered floorplan  
 Condition: Fair  
 Notes: The rather complex plan of this house suggests wood frame construction; it is actually of log.

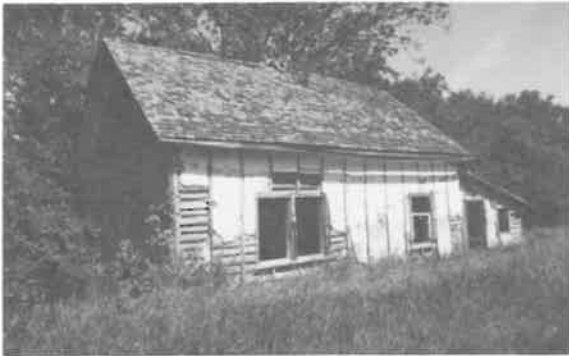
51) Log House  
 Construction Date: ca. 1920  
 Location: River Lot #151  
 Present Owner:  
 Present Use: Vacant  
 Construction:  
   walls - plaster veneer on squared dovetailed logs  
   roof - wood shingles on cut timbers  
 Integrity: Largely unaltered  
 Condition: Poor  
 Notes: This building is also discussed on page 85.

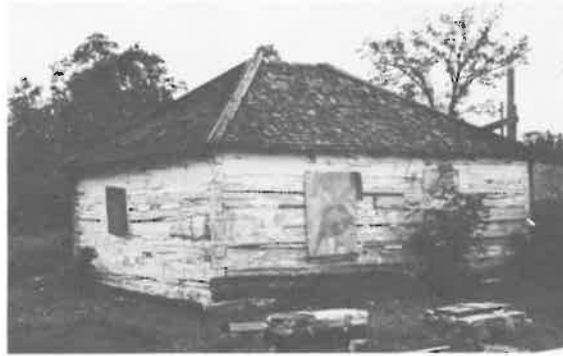
52) Log House  
 Construction Date: 1931  
 Location: SE 6-17-7E  
 Present Owner: Mr. W. Viznagh  
 Present Use: Storage  
 Construction:  
   walls - squared dovetailed logs  
   roof - wood shingles on milled wooden rafters  
 Integrity: Largely unaltered  
 Condition: Fair

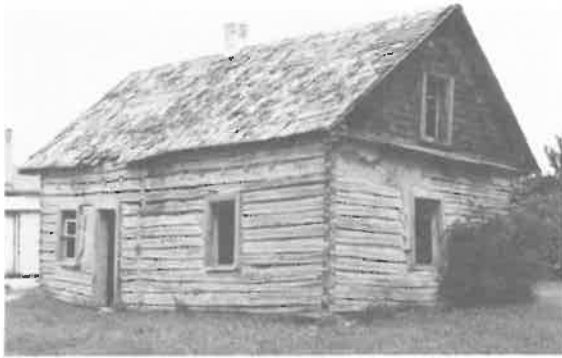
- 53) **Galician Log House**  
**Construction Date:** ca. 1890  
**Location:** SW 30-17-4E  
**Present Owner:** V. Srutwa  
**Present Use:** Vacant  
**Construction:**  
    walls - squared dovetailed logs  
    roof - wooden shingles on cut timbers  
**Integrity:** Largely unaltered  
**Condition:** Poor  
**Notes:** This building is also space discussed on page 83.

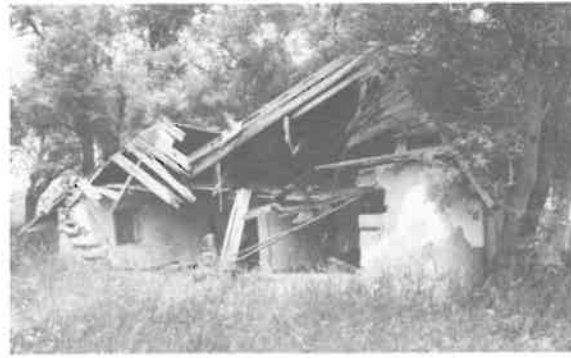
- 54) **Galician Log House**  
**Construction Date:** ca. 1895  
**Location:** River Lot #193  
**Present Owner:** R.M. of St. Clements  
**Present Use:** Abandoned  
**Construction:**  
    walls - Plaster veneer on square dovetailed logs  
    roof - wood shingles on uncut logs  
**Integrity:** Largely unaltered  
**Condition:** Poor  
**Notes:** This building is also discussed on pages 81-83.

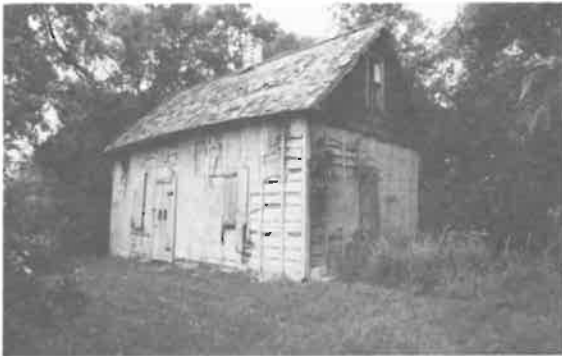
- 55) **Galician-Style Log House**  
**Construction Date:**  
**Location:** SW 6-17-4E  
**Present Owner:** Mr. W. Bilan  
**Present Use:** Vacant  
**Construction:**  
    walls - squared dovetailed logs  
    roof - wood shingles on cut timbers  
**Integrity:** Largely unaltered  
**Condition:** Poor  
**Notes:** This building is also discussed on page 85.

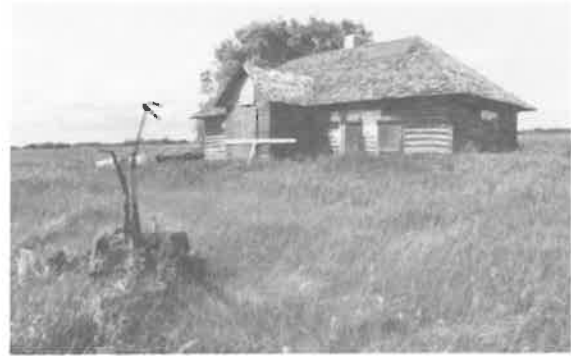
- 56) **Bukovynian Log House**  
**Construction Date:** 1913  
**Location:** River Lot #178  
**Present Owner:** Mr. Depaulo  
**Present Use:** Vacant  
**Construction:**  
    walls - horizontal siding on square dovetailed logs  
    roof - wood shingles on milled wooden rafters  
**Integrity:** The interior has been altered  
**Condition:** Fair  
**Notes:** This building is also discussed on page 84. The structure was demolished in 1987.

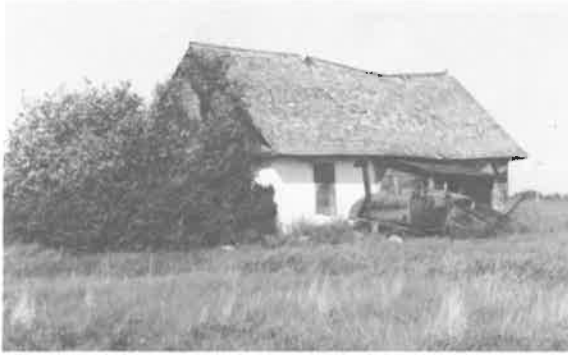
57) Galician Log House  
 Construction Date: ca. 1920  
 Location:  
 Present Owner: Mr. Sawchuk  
 Present Use: Abandoned  
 Construction:  
   walls - plaster veneer on square dovetailed logs  
   roof - wood shingles on squared logs  
 Integrity: Largely unaltered  
 Condition: Poor

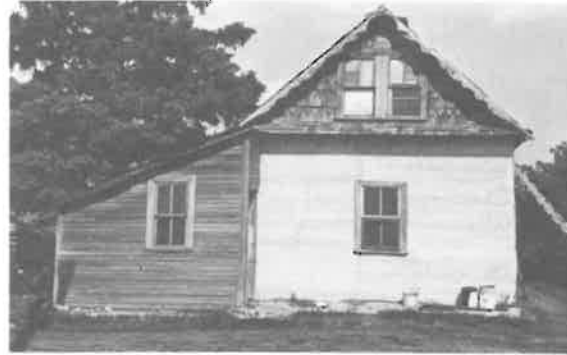
58) Galician Log House  
 Construction Date: ca. 1920  
 Location: NW 12-17-3E  
 Present Owner: Mr. Yakobowski  
 Present Use: Occupied  
 Construction:  
   walls - plaster veneer on squared dovetailed logs  
   roof - wood shingles on cut timbers  
 Integrity: Largely unaltered  
 Condition: Fair  
 Notes: This building is also discussed on page 2 83-84.

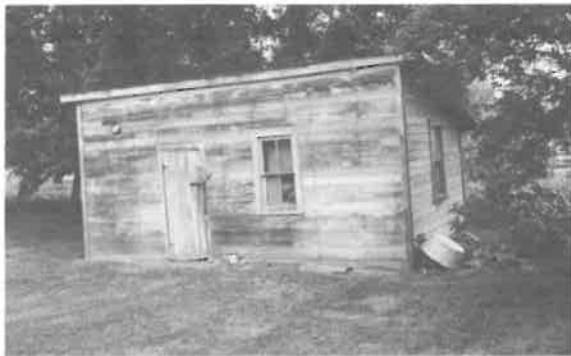
59) Single Storey Shanty  
 Construction Date: ca. 1890  
 Location: River Lot #199  
 Present Owner: Mrs. M. Ritchie  
 Present Use: Storage  
 Construction:  
   walls - horizontal siding on milled wooden frame  
   roof - wood shingles on milled wooden rafters  
 Integrity: Largely unaltered  
 Condition: Fair  
 Notes: This building is also discussed on page 58.

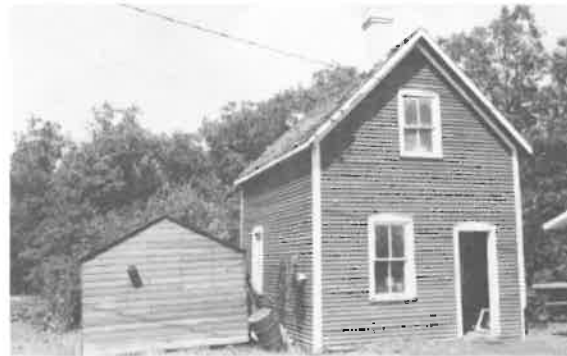
60) 1 1/2 Storey Side Hall House  
 Construction Date: ca. 1890  
 Location: SW 12-14-3E  
 Present Owner: Mr. Dewar  
 Present Use: Storage  
 Construction:  
   walls - horizontal siding on milled wooden frame  
   roof - wood shingles on milled wooden rafters  
 Integrity: The interior has been altered  
 Condition: Fair

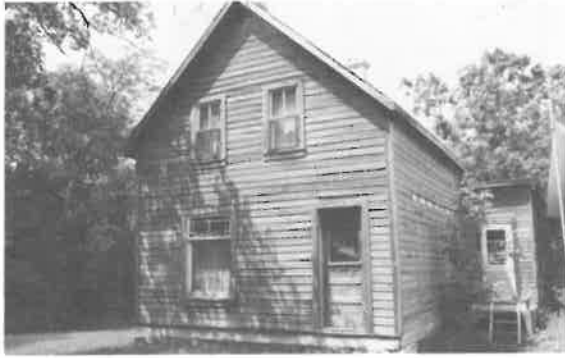
61) 1 1/2 Storey Side Hall House  
 Construction Date: ca. 1905  
 Location: River Lot #255  
 Present Owner: S. Michaelson  
 Present Use: Vacant  
 Construction:  
   walls - horizontal siding on milled wooden frame  
   roof - asphalt shingles on milled wooden rafters  
 Integrity: Largely unaltered  
 Condition: Fair

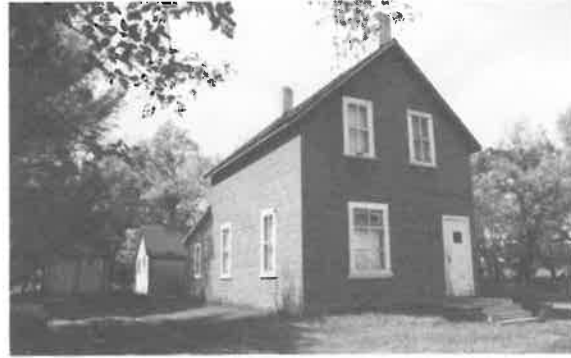
62) 1 1/2 Storey Side Hall House  
 Construction Date: ca. 1905  
 Location: River Lot #97  
 Present Owner: M. Clark  
 Present Use: Occupied  
 Construction:  
   walls - insulbrick siding on milled wooden frame  
   roof - wood shingles on milled wooden rafters  
 Integrity: Largely unaltered  
 Condition: Fair

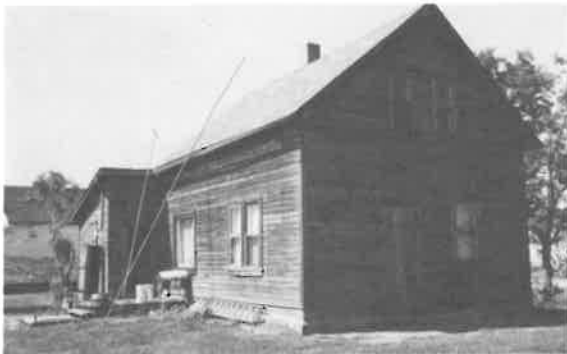
63) 1 1/2 Storey Side Hall House  
 Construction Date: ca. 1910  
 Location: NE 32-16-8E  
 Present Owner: L. Turner & R. Dick  
 Present Use: Occupied  
 Construction:  
   walls - horizontal siding on milled wooden frame  
   roof - asphalt shingles on milled wooden rafters  
 Integrity: Largely unaltered  
 Condition: Fair

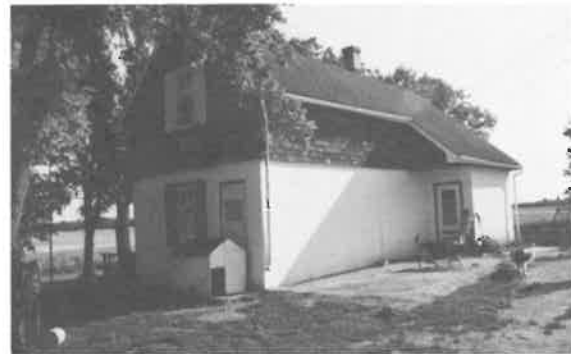
64) 1 1/2 Storey Side Hall House  
 Construction Date: ca. 1910  
 Location: NW 24-15-6E  
 Present Owner: Mr. C. Horbady  
 Present Use: Occupied  
 Construction:  
   walls - stucco and shingle veneer on milled  
   wooden frame  
   roof - asphalt shingles on milled wooden rafters  
 Integrity: Largely unaltered  
 Condition: Good

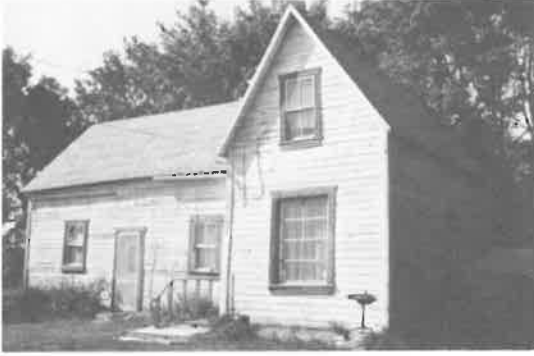
- 69) 1 1/2 Storey L-Shaped House  
 Construction Date: ca. 1890  
 Location: SW 27-15-6E  
 Present Owner: R. Krahn  
 Present Use: Vacant  
 Construction:  
   walls - horizontal siding on squared dovetailed logs  
   roof - asphalt shingles on milled wooden rafters  
 Integrity: The original log house has been enlarged  
 with an addition.  
 Condition: Fair

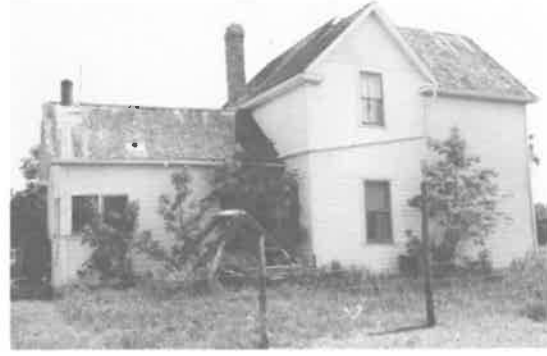
- 70) 1 1/2 Storey L-Shaped House  
 Construction Date: 1900  
 Location: SW 9-14-4E  
 Present Owner: T. Jenkins  
 Present Use: Storage  
 Construction:  
   walls - horizontal siding on milled wooden frame  
   roof - wood shingles on milled wooden rafters  
 Integrity: Largely unaltered  
 Condition: Good

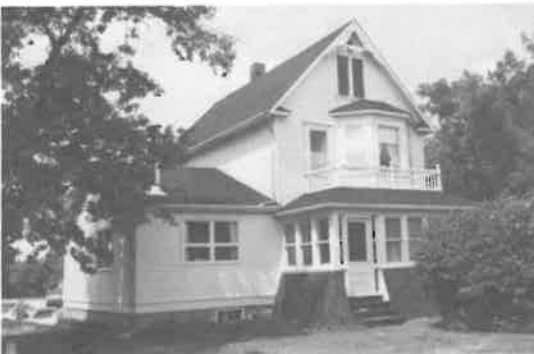
- 71) 1 1/2 Storey L-Shaped House  
 Construction Date: ca. 1900  
 Location: River Lot #124  
 Present Owner: Mr. K.W. Noreus  
 Present Use: Occupied  
 Construction:  
   walls - horizontal siding on milled wooden frame  
   roof - asphalt shingles on milled wooden rafters  
 Integrity: The interior has been altered.  
 Condition: Good  
 Notes: This building is also discussed on page 58.

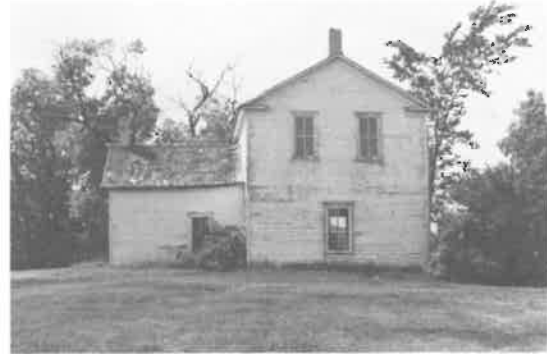
- 72) 1 1/2 Storey L-Shaped House  
 Construction Date: ca. 1900  
 Location: SE 3-15-4E  
 Present Owner: H. Zelyk  
 Present Use: Vacant  
 Construction:  
   walls - horizontal siding on milled wooden frame  
   roof - wood shingles on milled wooden rafters  
 Integrity: Largely unaltered  
 Condition: Poor

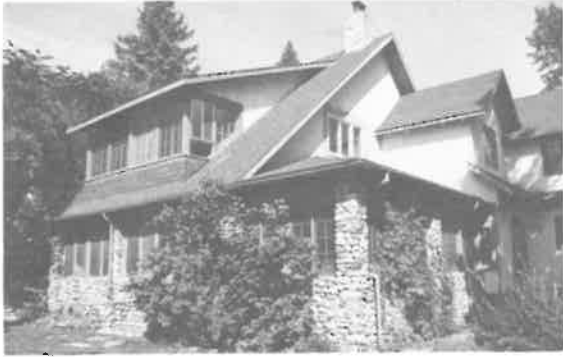
- 73) 1 1/2 Storey House  
 Construction Date: 1908-1910  
 Location: River Lot #13  
 Present Owner: Mrs. Tallin  
 Construction:  
   walls - fieldstone  
   roof - asphalt shingles on milled wooden rafters  
 Integrity: The floorplan has been expanded with several additions  
 Condition: Good

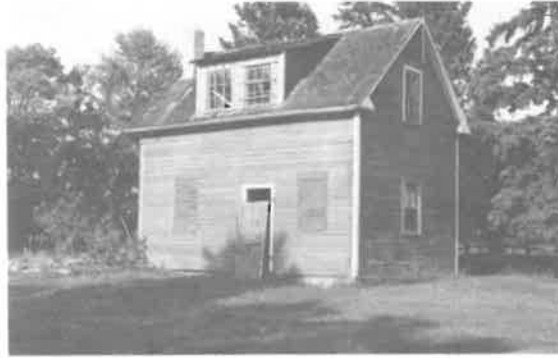
- 74) 1 1/2 Storey House  
 Construction Date: ca. 1910  
 Location: SW 2-17-3E  
 Present Owner: Mr. Hawkins  
 Present Use: Vacant  
 Construction:  
   walls - horizontal siding on saddlenotched logs  
   roof - wood shingles on milled wooden rafters  
 Integrity: The interior was altered at one time for use as a chicken coop.  
 Condition: Poor  
 Notes: The building has been destroyed since the survey was done.

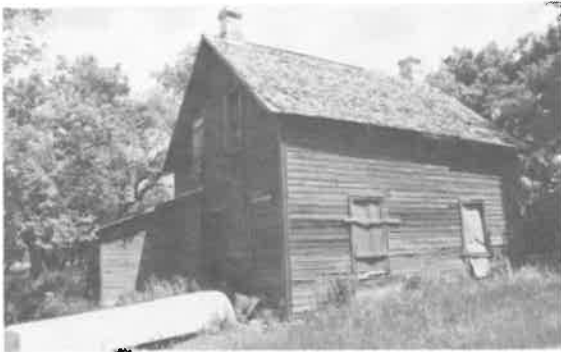
- 75) 1 1/2 Storey House  
 Construction Date: ca. 1910  
 Location: River Lot #138  
 Present Owner: The Klos Brothers  
 Present Use: Vacant  
 Construction:  
   walls - horizontal siding on milled wooden frame  
   roof - wood shingles on milled wooden rafters  
 Integrity: Largely unaltered  
 Condition: Fair

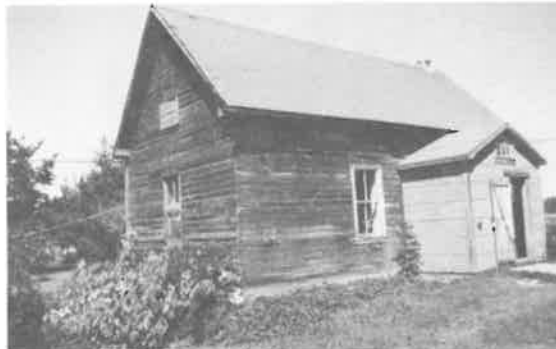
- 76) 1 1/2 Storey House  
 Construction Date: 1912  
 Location: NW 24-16-7E  
 Present Owner: Mr. Monsan  
 Present Use: Occupied  
 Construction:  
   walls - horizontal siding on milled wooden frame  
   roof - asphalt shingles on milled wooden rafters  
 Integrity: Largely unaltered  
 Condition: Fair

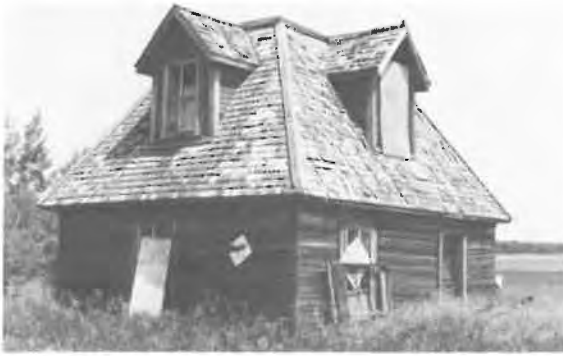
77) 1 1/2 Storey Cottage  
 Construction Date: ca. 1915  
 Location: NW 19-15-4E  
 Present Owner: J. Hacking  
 Present Use: Vacant  
 Construction:  
   walls - horizontal siding on milled wooden frame  
   roof - wood shingles on milled wooden rafters  
 Integrity: Largely unaltered  
 Condition: Poor

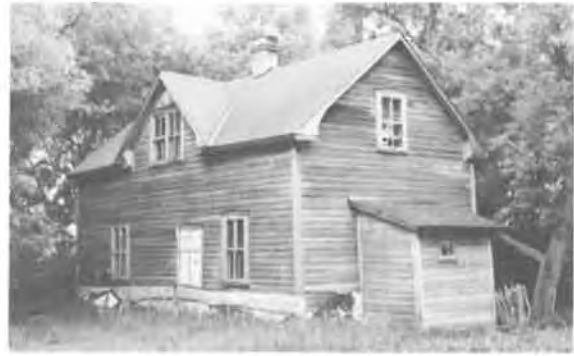
78) 1 1/2 Storey Central Gable House  
 Construction Date: ca. 1890  
 Location: NW 36-17-3E  
 Present Owner: Mr. N. Swirski  
 Present Use: Occupied  
 Construction:  
   walls - horizontal siding on milled wooden frame  
   roof - asphalt shingles on milled wooden rafters  
 Integrity: Largely unaltered  
 Condition: Fair

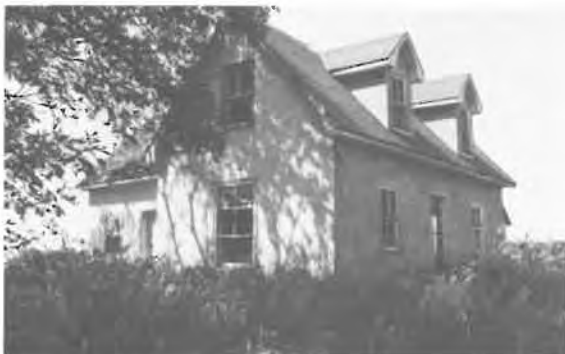
79) 1 1/2 Storey Central Plan House  
 Construction Date: ca. 1920  
 Location: SE 33-15-6E  
 Present Owner: S. Myslawchuk  
 Present Use: Vacant  
 Construction:  
   walls - stucco veneer on milled wooden frame  
   roof - wood shingles on milled wooden rafters  
 Integrity: Largely unaltered  
 Condition: Poor

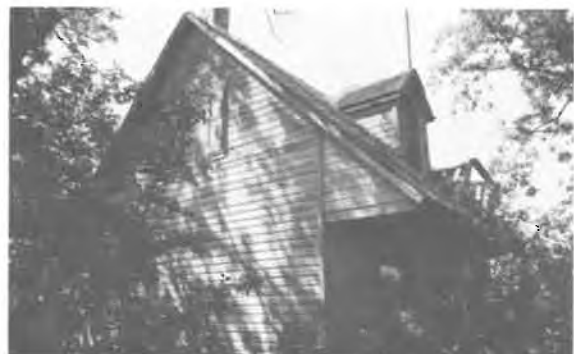
80) 1 1/2 Storey House  
 Construction Date: ca. 1925  
 Location: NE 9-14-4E  
 Present Owner: J. Clouston  
 Present Use: Vacant  
 Construction:  
   walls - horizontal siding on milled wooden frame  
   roof - wood shingles on milled wooden rafters  
 Integrity: Largely unaltered  
 Condition: Poor

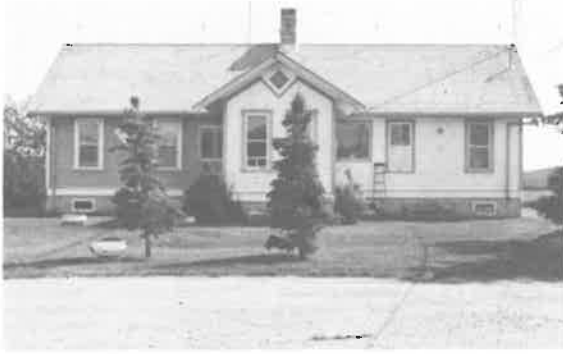
85) **Single Storey House**  
**Construction Date:** 1928  
**Location:** NE 2-16-3E  
**Present Owner:** Mr. C.P. Kollar  
**Present Use:** Occupied  
**Construction:**  
 walls - horizontal siding on milled wooden frame  
 roof - asphalt shingles on milled wooden rafters  
**Integrity:** Largely unaltered  
**Condition:** Good

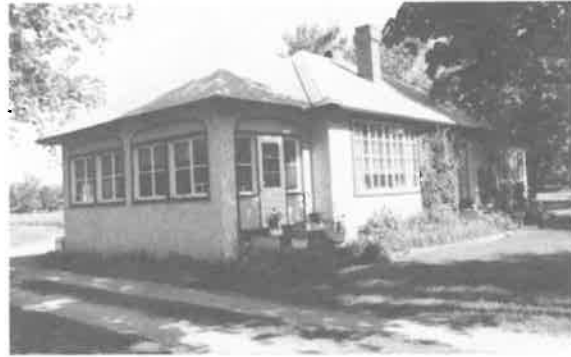
86) **Single Storey House**  
**Construction Date:** ca. 1920  
**Location:** River Lot #10  
**Present Owner:** Mr. John Grochowich  
**Present Use:** Occupied  
**Construction:**  
 walls - stucco veneer on milled wooden frame  
 roof - asphalt shingles on milled wooden rafters  
**Integrity:** Largely unaltered  
**Condition:** Good  
**Notes:** This building was constructed as a summer cottage by a former manager of Eaton's Department Store in Winnipeg. A garage and chauffeur's quarters are at the back of the site.

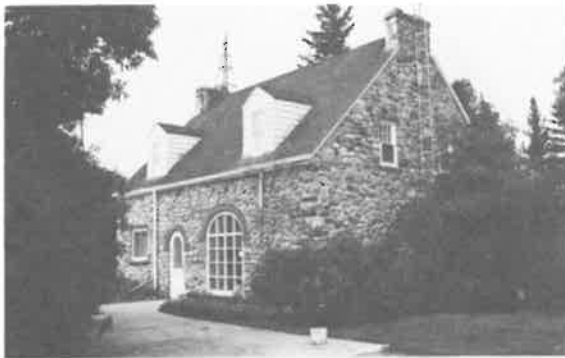
87) **1 1/2 Storey Stone House**  
**Construction Date:** 1939-41  
**Location:** NW 1-14-5E  
**Present Owner:** Mr. W. Buchanan  
**Present Use:** Occupied  
**Construction:**  
 walls -  
 roof - wood shingles on milled wooden rafters  
**Integrity:** Largely unaltered  
**Condition:** Good

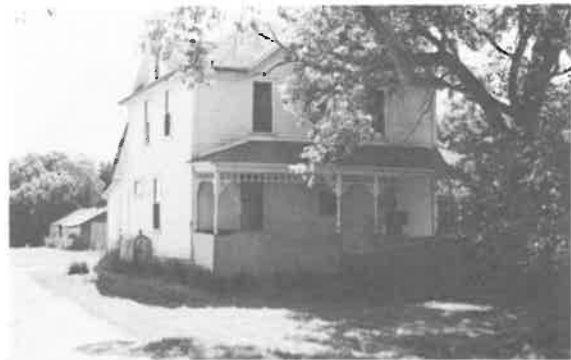
88) **2 1/2 Storey Square Plan House**  
**Construction Date:** ca. 1910  
**Location:** SW 35-14-4E  
**Present Owner:** E. Bracken  
**Present Use:** Vacant  
**Construction:**  
 walls - horizontal siding on milled wooden frame  
 roof - asphalt shingles on milled wooden rafters  
**Integrity:** Largely unaltered  
**Condition:** Good  
**Notes:** This building is also discussed on page 61.

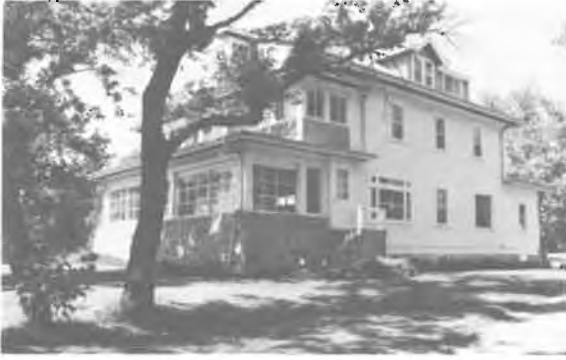
89) **2 1/2 Storey Square Plan House**  
**Construction Date:** 1912  
**Location:** River Lot #17  
**Present Owner:** Mrs. Fox  
**Present Use:** Occupied  
**Construction:**  
 walls - horizontal siding on milled wooden frame  
 roof - asphalt shingles on milled wooden rafters  
**Integrity:** Largely unaltered  
**Condition:** Good  
**Notes:** This building is also discussed on pages 61-63.

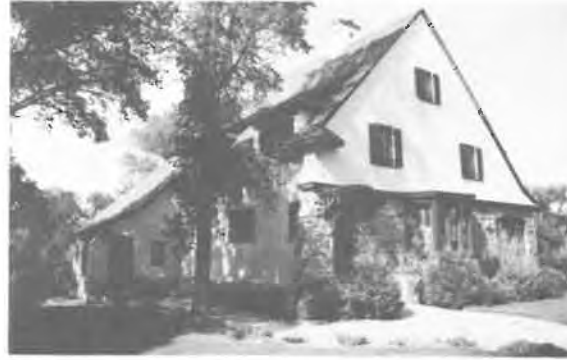
90) **2 1/2 Storey House**  
**Construction Date:** 1918  
**Location:** River Lots #117-119  
**Present Owner:** Dr. Olafson  
**Present Use:** Occupied  
**Construction:**  
 walls - stone and stucco veneer on milled wooden frame  
 roof - asphalt shingles on milled wooden rafters  
**Integrity:** Unaltered floorplan  
**Condition:** Good  
**Notes:** This building stands on the site of the original Hawthorne Lodge, discussed on page 29.

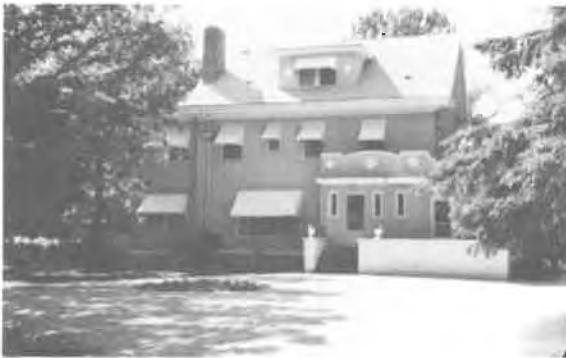
91) **2 1/2 Storey House**  
**Construction Date:** 1915  
**Location:** River Lot #114  
**Present Owner:** Dr. Robertson  
**Present Use:** Occupied  
**Construction:**  
 walls - stucco veneer on milled wooden frame  
 roof - asphalt shingles on milled wooden rafters  
**Integrity:** Largely unaltered  
**Condition:** Good

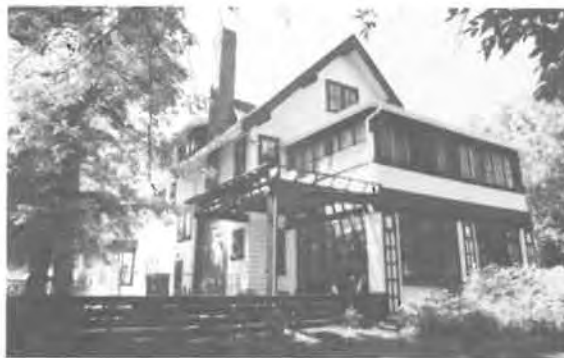
92) **2 1/2 Storey House**  
**Construction Date:** 1919  
**Location:** River Lot #114  
**Present Owner:** Ms. Schadek  
**Present Use:** Occupied  
**Construction:**  
 walls - horizontal siding on milled wooden frame  
 roof - asphalt shingles on milled wooden rafters  
**Integrity:** Largely unaltered  
**Condition:** Good

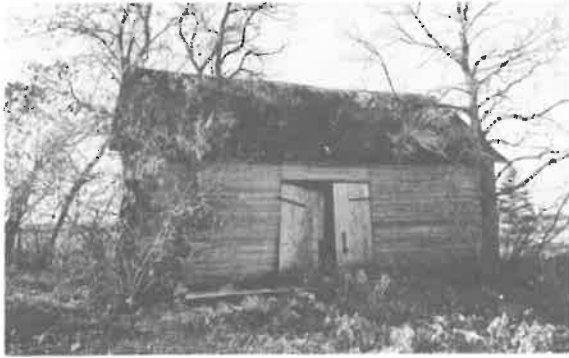
- 93) **Red River Frame Barn**  
**Construction Date:** ca. 1870  
**Location:** SW 10-14-4E  
**Present Owner:**  
**Present Use:** Vacant  
**Construction:**  
     walls - Red River frame logs  
     roof - wood shingles on hewn log rafters  
**Integrity:** Largely unaltered  
**Condition:** Poor  
**Notes:** This building is one of only three remaining structures in the planning area that used Red River frame construction procedures.

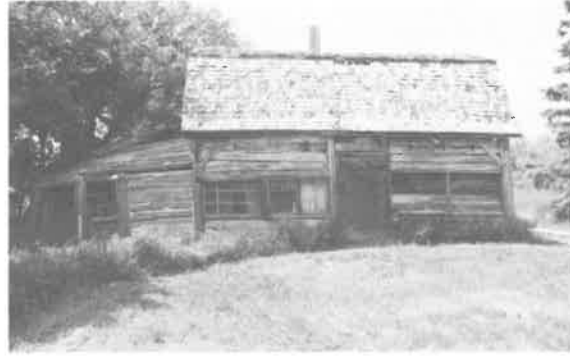
- 94) **Log Barn**  
**Construction Date:** 1860 (reconstructed 1922)  
**Location:** River Lot #129  
**Present Owner:** Mr. P. Kuhn  
**Present Use:** Storage  
**Construction:**  
     walls - Red River Frame log construction  
     roof - wood shingles on milled wooden rafters  
**Integrity:** The barn was once much larger and oriented differently. Materials from the 1860 barn were used in this barn.  
**Condition:** Poor  
**Notes:** This building is also discussed on pages 23-24.

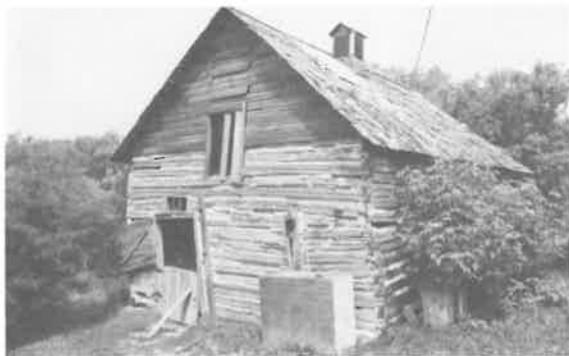
- 95) **Log Barn**  
**Construction Date:** ca. 1880  
**Location:** River Lot #255  
**Present Owner:** Mr. A. Ducharme  
**Present Use:** Storage  
**Construction:**  
     walls - dovetailed logs  
     roof - wood shingles on squared logs  
**Integrity:** The interior has been gutted  
**Condition:** Poor

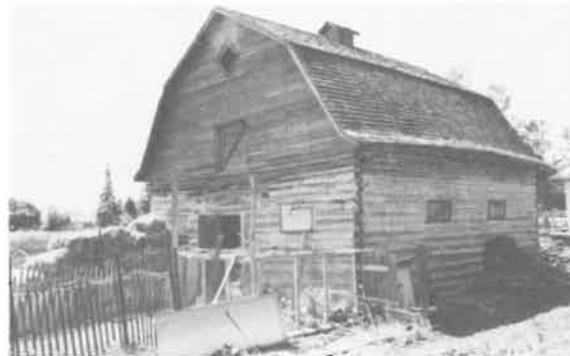
- 96) **Log Barn**  
**Construction Date:** ca. 1880  
**Location:** River Lot #188  
**Present Owner:** Mr. S. Miller  
**Present Use:** Storage  
**Construction:**  
     walls - squared dovetailed logs  
     roof - wood shingles on milled wooden rafters  
**Integrity:** The former gable roof was replaced.  
**Condition:** Fair

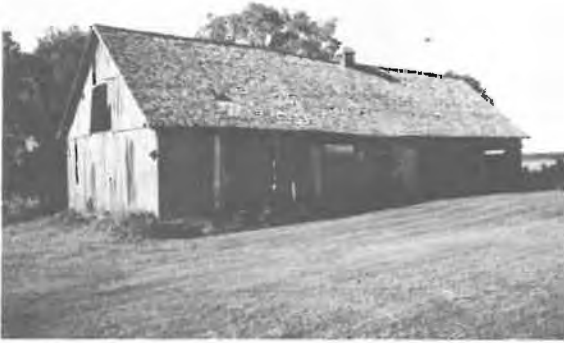
97) **Heavy Wood Frame Barn**  
**Construction Date:** ca. 1910  
**Location:** NW 24-15-6E  
**Present Owner:** Mr. C. Horbady  
**Present Use:** Storage  
**Construction:**  
 walls - horizontal and vertical siding on heavy wood frame  
 roof - wood shingles on milled wooden rafters  
**Integrity:** Unaltered  
**Condition:** Fair

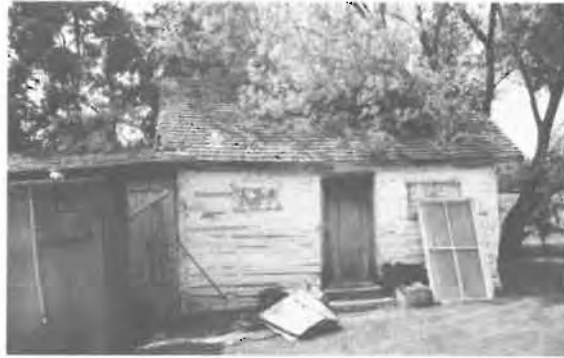
98) **Log Barn**  
**Construction Date:** ca. 1910  
**Location:** River Lot #264  
**Present Owner:** Henry Semenchuk  
**Present Use:** Storage  
**Construction:**  
 walls - dovetailed squared logs  
 roof - wood shingles on hewn wooden rafters  
**Integrity:** Largely unaltered  
**Condition:** Fair  
**Notes:** This building is also discussed on page 64.

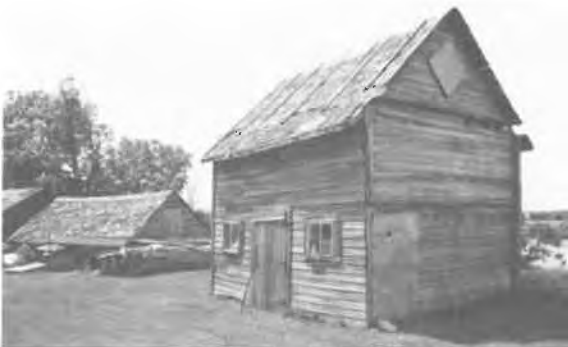
99) **Light Wood Frame Stable**  
**Construction Date:** ca. 1910  
**Location:** River Lot #255  
**Present Owner:** Mr. M. Nebozonko  
**Present Use:** Storage  
**Construction:**  
 walls - horizontal siding on milled wooden frame  
 roof - wood shingles on milled wooden rafters  
**Integrity:** Unaltered  
**Condition:** Good

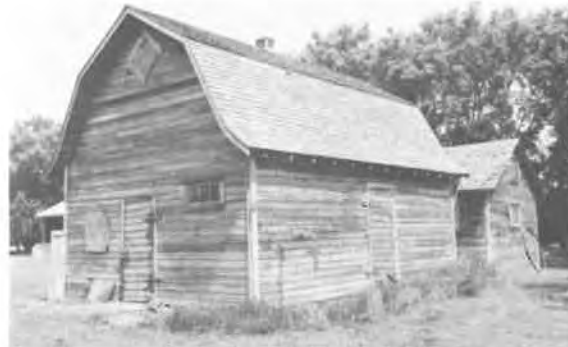
100) **Light Wood Frame Barn**  
**Construction Date:** 1912  
**Location:** River Lot #261  
**Present Owner:** Mr. Henry Semenchuk  
**Present Use:** Storage  
**Construction:**  
 walls - horizontal siding on milled wooden frame  
 roof - wood shingles on milled wooden rafters  
**Integrity:** Unaltered  
**Condition:** Good

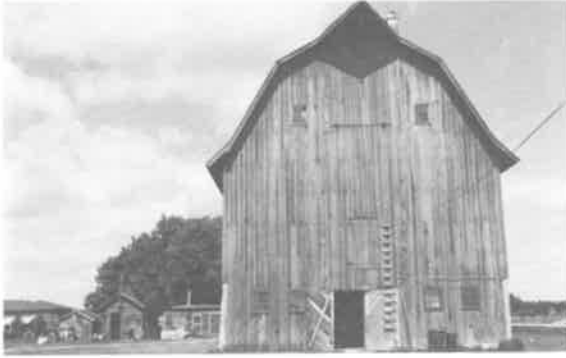
101) Large Light Wood Frame Barn  
 Construction Date: 1912  
 Location: River Lot #20  
 Present Owner: Mr. Overwater  
 Present Use: Storage  
 Construction:  
   walls - concrete stable and light frame loft  
   roof - wood shingles on built-up wooden rafters  
 Integrity: Unaltered  
 Condition: Good  
 Notes: This building is also discussed on pages 65-66.

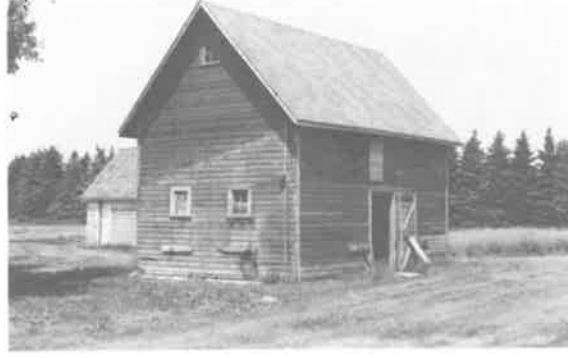
102) Light Wood Frame Stable  
 Construction Date: 1913  
 Location: NE 15-15-3E  
 Present Owner: Mrs. C.S. Pruden  
 Present Use: Storage  
 Construction:  
   walls - horizontal siding on milled wooden frame  
   roof - wood shingles on milled wooden rafters  
 Integrity: Unaltered  
 Condition: Good  
 Notes: This building is also discussed on pages 65 and 67.

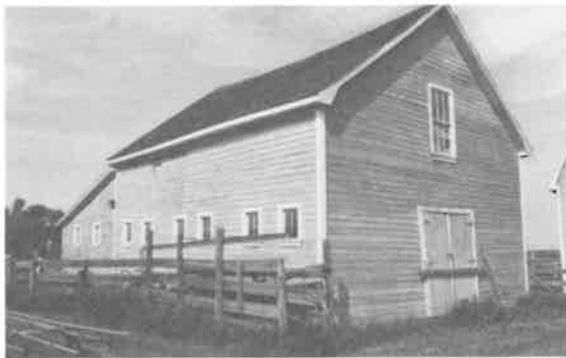
103) Large Light Wood Frame Barn  
 Construction Date: 1915  
 Location: SE 1-15-4E  
 Present Owner: Mr. Macklin  
 Present Use: Functioning Barn  
 Construction:  
   walls - horizontal siding on milled wooden frame  
   roof - wood shingles on milled wooden rafters  
 Integrity: Unaltered  
 Condition: Good

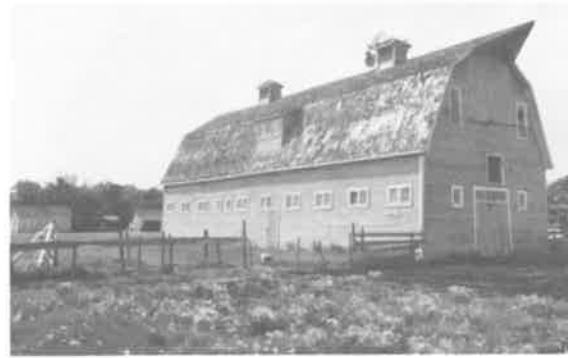
104) Large Light Wood Frame Barn  
 Construction Date: 1915  
 Location: SE 1-15-4E  
 Present Owner: Mr. Macklin  
 Present Use: Functioning Barn  
 Construction:  
   walls - horizontal siding on milled wooden frame  
   roof - wood shingles on built-up wooden rafters  
 Integrity: Unaltered  
 Condition: Good

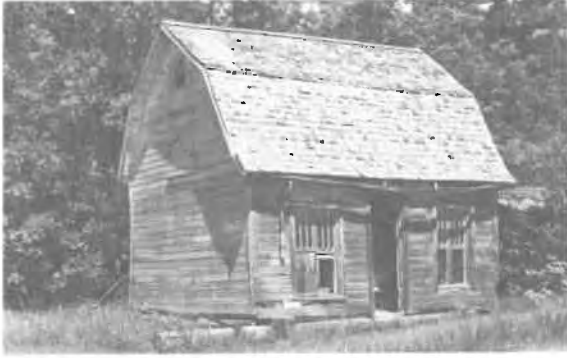
105) **Small Light Wood Frame Barn**  
**Construction Date:** ca. 1915  
**Location:** River Lots 89 and 90  
**Present Owner:** Mr. Kartzmark  
**Present Use:** Storage  
**Construction:**  
 walls - horizontal siding on milled wooden frame  
 roof - wood shingles on milled wooden rafters  
**Integrity:** The interior has been altered for its later function as a residence  
**Condition:** Fair

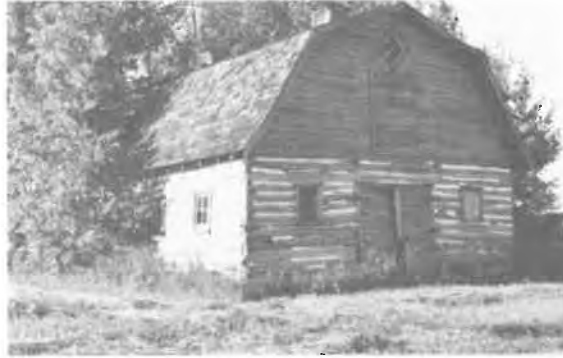
106) **Log Barn**  
**Construction Date:** ca. 1920  
**Location:** SW 34-17-3E  
**Present Owner:** Mr. Huminicki  
**Present Use:** Storage  
**Construction:**  
 walls - dovetailed logs  
 roof - wood shingles on milled wooden rafters  
**Integrity:** Unaltered  
**Condition:** Fair

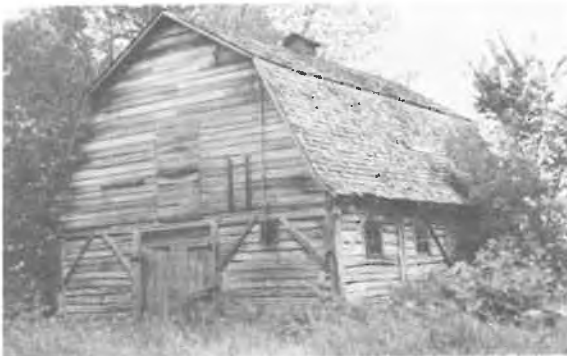
107) **Log Barn**  
**Construction Date:** ca. 1920  
**Location:** NW 35-17-3E  
**Present Owner:** Mr. C. Stutsky  
**Present Use:** Vacant  
**Construction:**  
 walls - Post-and-Sill Logs  
 roof - wood shingles on milled wooden rafters  
**Integrity:** Unaltered  
**Condition:** Good  
**Notes:** Like earlier Ukrainian barns in other areas of the province, this log structure was supported at its corners with diagonal braces.

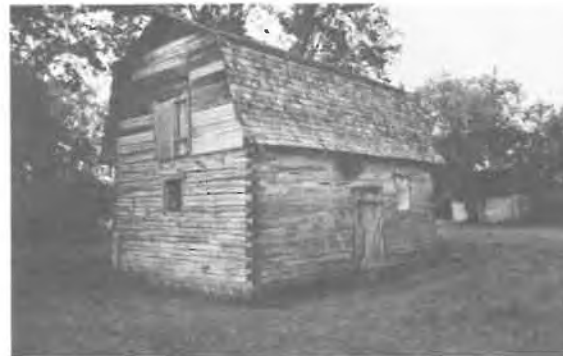
108) **Log Barn**  
**Construction Date:** ca. 1920  
**Location:** Libau  
**Present Owner:**  
**Present Use:** Storage  
**Construction:**  
 walls - squared dovetailed logs  
 roof - wood shingles on milled wooden rafters  
**Integrity:** Unaltered  
**Condition:** Fair

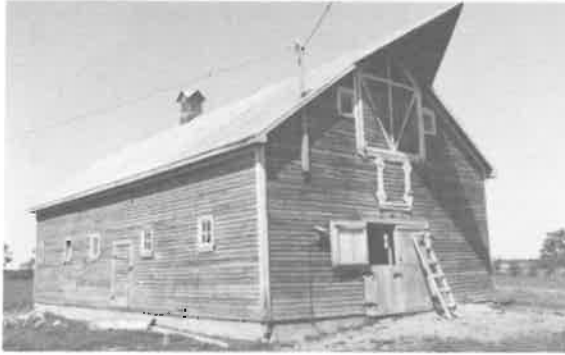
109) **Large Light Wood Frame Barn**  
**Construction Date:** ca. 1920  
**Location:** NE 18-16-8E  
**Present Owner:** G. Lloyd  
**Present Use:** Functioning Barn  
**Construction:**  
 walls - horizontal siding on milled wooden frame  
 roof - metal sheeting on milled wooden rafters  
**Integrity:** Unaltered  
**Condition:** Good

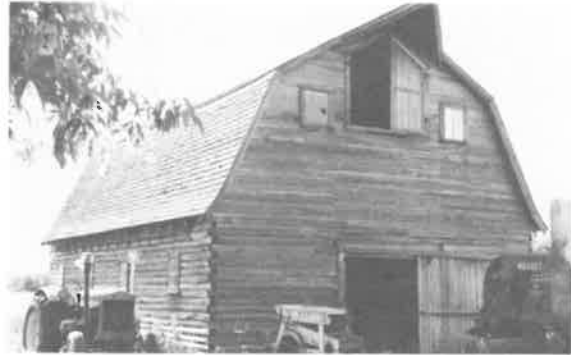
110) **Log Barn**  
**Construction Date:** ca. 1925  
**Location:** SE 12-17-3E  
**Present Owner:** Mr. A. Husluk  
**Present Use:** Storage  
**Construction:**  
 walls - pre-cut squared logs  
 roof - wood shingles on milled wooden rafters  
**Integrity:** Unaltered  
**Condition:** Good

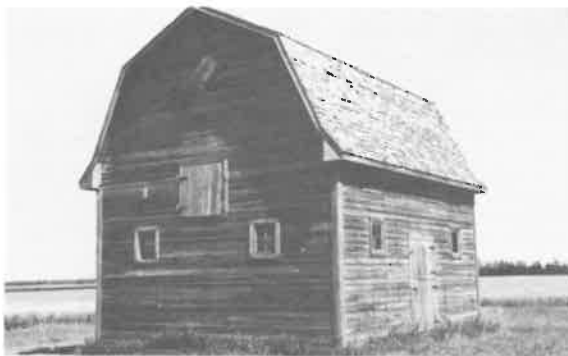
111) **Small Light Wood Frame Barn**  
**Construction Date:** ca. 1925  
**Location:** SW 21-15-6E  
**Present Owner:**  
**Present Use:** Storage  
**Construction:**  
 walls - horizontal siding on milled wooden frame  
 roof - wood shingles on milled wooden rafters  
**Integrity:** Unaltered  
**Condition:** Good

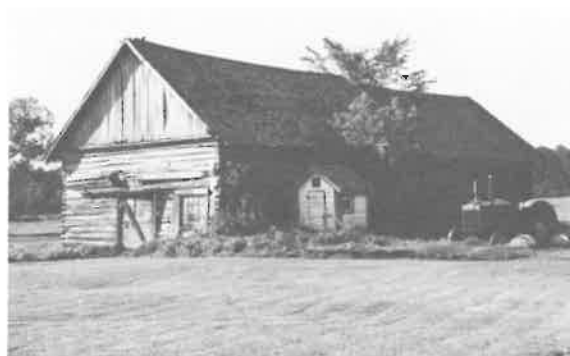
112) **Log Barn**  
**Construction Date:** ca. 1925  
**Location:** SW 13-15-6E  
**Present Owner:** Mr. R. Ozol  
**Present Use:** Storage  
**Construction:**  
 walls - squared dovetailed logs  
 roof - wood shingles on squared logs  
**Integrity:** Unaltered  
**Condition:** Fair

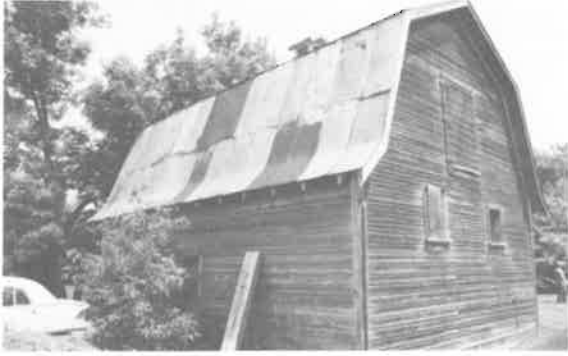
113) **Small Light Wood Frame Barn**  
**Construction Date:** ca. 1930  
**Location:** River Lot #236  
**Present Owner:** Mr. A. Wachel  
**Present Use:** Storage

**Construction:**  
 walls - horizontal siding on milled wooden frame  
 roof - metal sheeting on milled wooden rafters  
**Integrity:** Unaltered  
**Condition:** Good

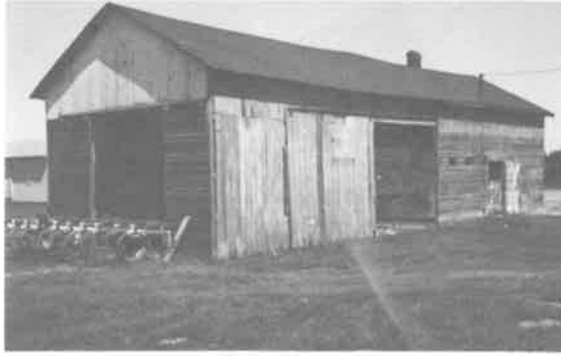
114) **Light Wood Frame Barn**  
**Construction Date:** ca. 1930  
**Location:** NE 30-16-8E  
**Present Owner:** Mr. F. Klann  
**Present Use:** Storage/Granary

**Construction:**  
 walls - horizontal siding on milled wooden frame  
 roof - asphalt shingles on milled wooden rafters  
**Integrity:** Unaltered  
**Condition:** Fair  
**Notes:** This building is also discussed on page 74.

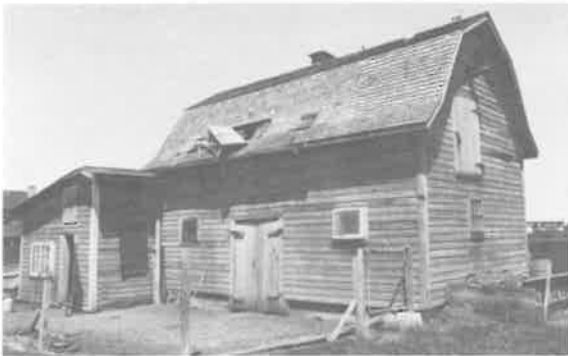
115) **Small Light Wood Frame Barn**  
**Construction Date:** 1936  
**Location:** River Lots #21 and 22  
**Present Owner:** Mr. Art Neltner  
**Present Use:** Pigeon Coop

**Construction:**  
 walls - horizontal siding on milled wooden frame  
 roof - wood shingles on milled wooden rafters  
**Integrity:** The interior has been altered for its present function  
**Condition:** Fair

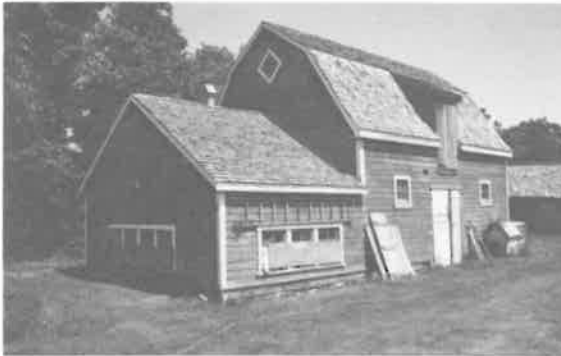
116) **Market Barn**  
**Construction Date:** ca. 1930  
**Location:** River Lot #69  
**Present Owner:** P. Charaton  
**Present Use:** Storage

**Construction:**  
 walls - horizontal siding on milled wooden frame  
 roof - asphalt shingles on built-up wooden rafters  
**Integrity:** The interior has been altered with the extension of the building to incorporate a chicken coop.  
**Condition:** Good  
**Notes:** This building is also discussed on pages 68-69.

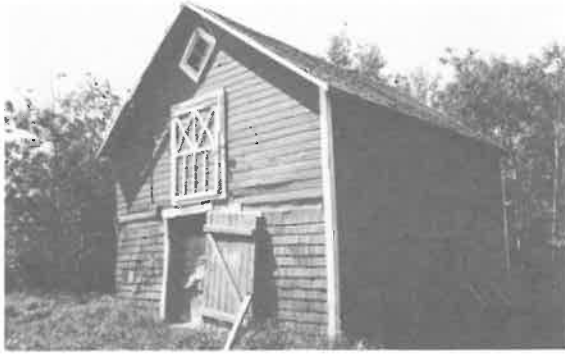
- 117) **Small Light Wood Frame Barn**  
**Construction Date:** 1938  
**Location:** SE 7-14-6E  
**Present Owner:** Mr. M. Chorney  
**Present Use:** Storage  
**Construction:**  
 walls - horizontal siding on milled wooden frame  
 roof - wood shingles on milled wooden rafters  
**Integrity:** Stable has been altered  
**Condition:** Fair

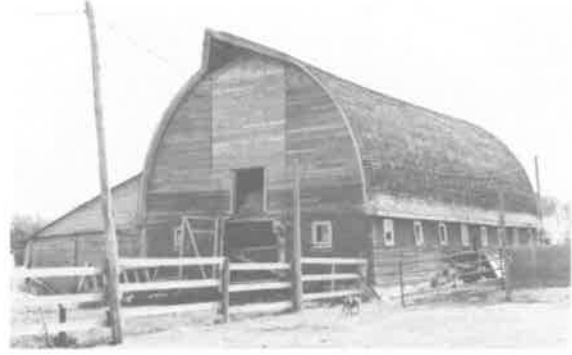
- 118) **Large Light Wood Frame Barn with Vaulted Roof**  
**Construction Date:** ca. 1940  
**Location:** SW 9-14-4E  
**Present Owner:** Mr. T. Jenkins  
**Present Use:** Functioning Barn  
**Construction:**  
 walls - horizontal siding on milled wooden frame  
 roof - wood shingles on built up rafters  
**Integrity:** The stable has been altered to produce a more open space  
**Condition:** Fair  
**Notes:** This building is also discussed on pages 69-70.

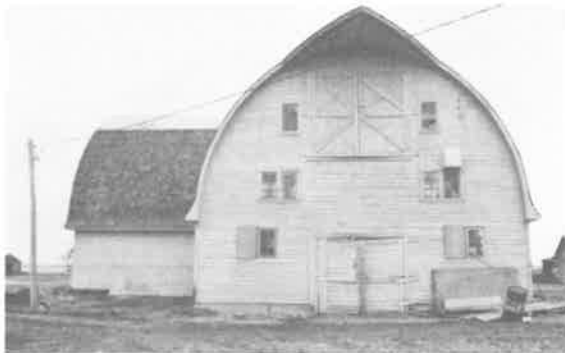
- 119) **Large Light Wood Frame Barn with Vaulted Roof**  
**Construction Date:** ca. 1940  
**Location:** SE 20-15-8E  
**Present Owner:** Mr. K. Goritz  
**Present Use:** Functioning Barn  
**Construction:**  
 walls - horizontal siding on milled wooden frame  
 roof - wood shingles on built-up rafters  
**Integrity:** Unaltered  
**Condition:** Good

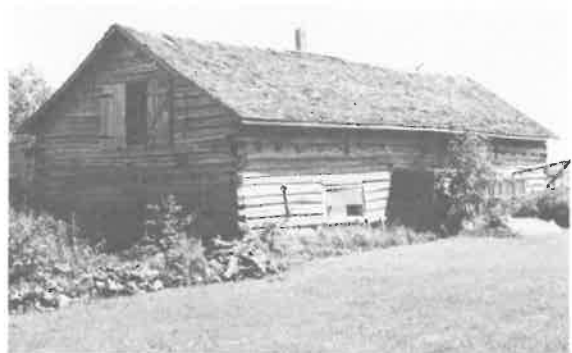
- 120) **Log Barn**  
**Construction Date:** 1943  
**Location:** NW 10-17-7E  
**Present Owner:** Mr. K. Klatt  
**Present Use:** Vacant  
**Construction:**  
 walls - squared dovetailed logs  
 roof - wood shingles on milled wooden rafters  
**Integrity:** Unaltered  
**Condition:** Fair

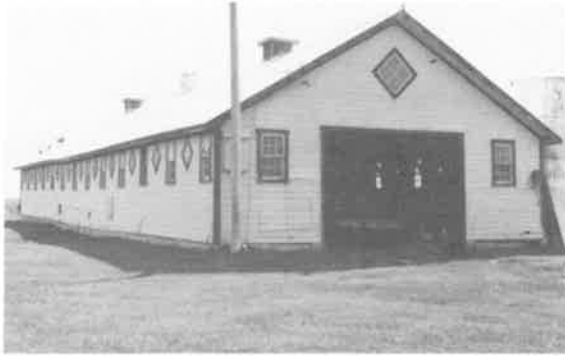
- 121) Light Wood Frame Cattle Feeder  
 Construction Date: ca. 1925  
 Location: NE 2-16-3E  
 Present Owner: Mr. C.P. Kollar  
 Present Use: Machine Storage  
 Construction:  
   walls - horizontal siding on milled wooden frame  
   roof - metal sheeting on milled wooden rafters  
 Integrity: The interior has been altered to accommodate machinery  
 Condition: Good

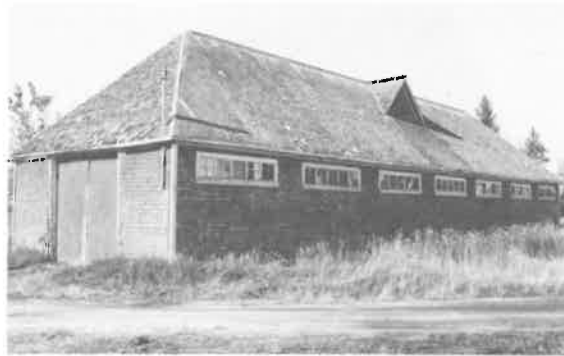
- 122) Horse Barn  
 Construction Date: ca. 1910  
 Location:  
 Present Owner: Mr. Buus  
 Present Use: Summer Theatre for Interlake Theatre Troupe  
 Construction:  
   walls - wood shingles on milled wooden frame  
   roof - wood shingles on milled wooden rafters  
 Integrity: Unaltered  
 Condition: Good

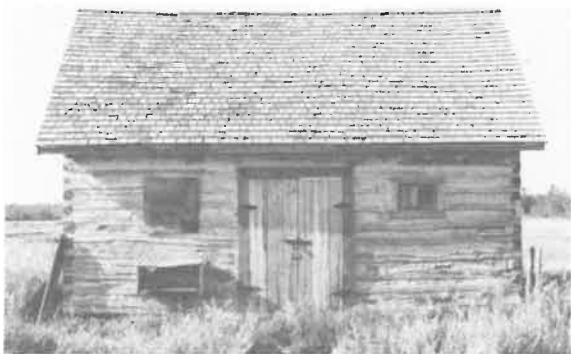
- 123) Log Granary  
 Construction Date: ca. 1930  
 Location:  
 Present Owner: Arnold Husluk  
 Present Use: Storage  
 Construction:  
   walls - dovetailed squared logs  
   roof - wood shingles on hewn log rafters  
 Integrity: Unaltered  
 Condition: Good  
 Notes: This building is also discussed on page 71.

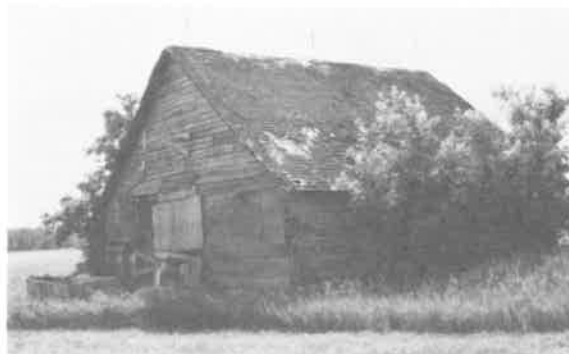
- 124) Granary  
 Construction Date: ca. 1880  
 Location: NE 12-17-3E  
 Present Owner: Mrs. M. Allison  
 Present Use: Storage  
 Construction:  
   walls - horizontal siding on milled wooden frame  
   roof - wood shingles on milled wooden rafters  
 Integrity: The interior posts and beams have gradually been replaced so that none of the originals exist today  
 Condition: Fair  
 Notes: This building is also discussed on pages 71-72.

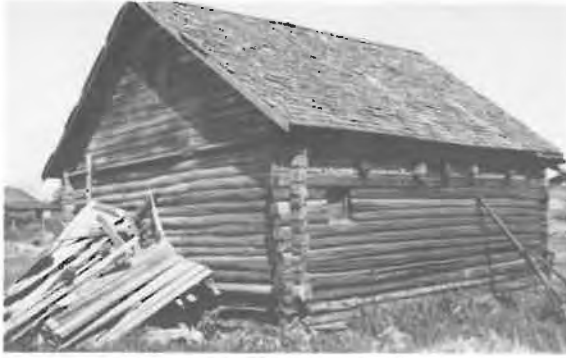
125) Log Granary  
 Construction Date: 1906  
 Location: SW 18-16-8E  
 Present Owner: Mr. Otto  
 Present Use: Storage  
 Construction:  
   walls - round lap-notched logs  
   roof - wood shingles on milled wood rafters  
 Integrity: Unaltered  
 Condition: Fair

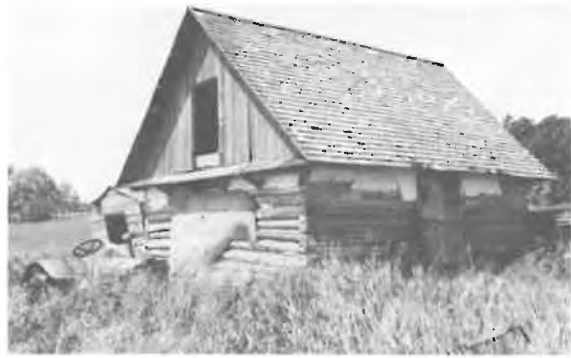
126) Log Granary  
 Construction Date: ca. 1910  
 Location:  
 Present Owner:  
 Present Use: Vacant  
 Construction:  
   walls - dovetailed logs with plaster cover  
   roof - wood shingles on milled wood rafters  
 Integrity: Unaltered, but plaster is disintegrating  
 Condition: Fair

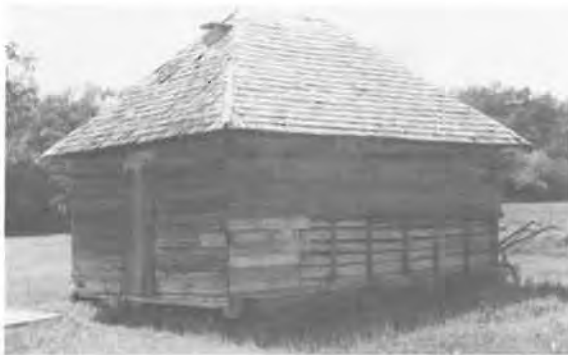
127) Log Granary  
 Construction Date: ca. 1915  
 Location: River Lot #156  
 Present Owner: N. Schafer  
 Present Use: Storage  
 Construction:  
   walls - horizontal siding on dovetailed logs  
   roof - wood shingles on milled wooden rafters  
 Integrity: Unaltered  
 Condition: Good  
 Notes: The hipped roof on this structure is unusual in the local context, where farmers preferred the simple gable roof.

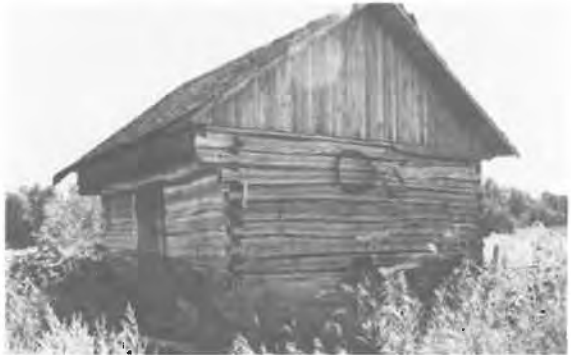
128) Log Granary  
 Construction Date: ca. 1915  
 Location: SE 19-14-6E  
 Present Owner: Mr. A. Caravan  
 Present Use: Storage  
 Construction:  
   walls - dovetailed logs  
   roof - wooden shingles on milled wooden rafters  
 Integrity: Unaltered  
 Condition: Good

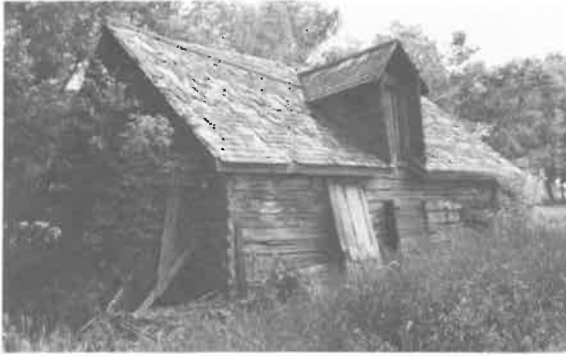
129) Log Granary  
 Construction Date: ca. 1920  
 Location: River Lot #277  
 Present Owner: Nick Switski  
 Present Use: Abandoned  
 Construction:  
   walls - dovetailed logs  
   roof - wood shingles on milled wooden rafters  
 Integrity: the gabled dormer was added to accept grain from an auger  
 Condition: Fair

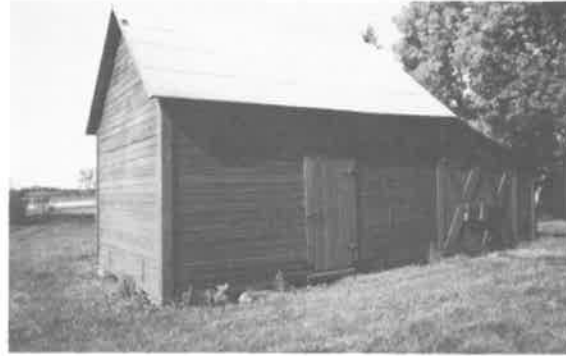
130) Granary  
 Construction Date: ca. 1930  
 Location: SW 27-15-6E  
 Present Owner:  
 Present Use: Storage  
 Construction:  
   walls - horizontal siding on milled wooden frame  
   roof - wood shingles on milled wooden rafters  
 Integrity: Unaltered  
 Condition: Good
