## Schools

## Stores

## Community Residences

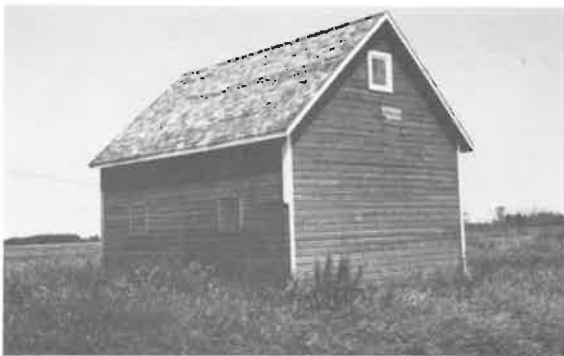
131) Granary  
 Construction Date: ca. 1915  
 Location: NE 11-15-6E  
 Present Owner: M. Makarachuk  
 Present Use: Vacant  
 Construction:  
   walls - horizontal siding on milled wooden frame  
   roof - wood shingles on milled wood rafters  
 Integrity: Unaltered  
 Condition: Good

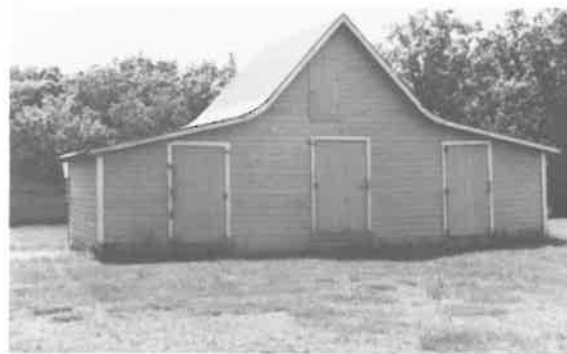
132) Granary  
 Construction Date: ca. 1920  
 Location: River Lot #71  
 Present Owner:  
 Present Use:  
   walls - horizontal siding on milled wooden frame  
   roof - wood shingles on milled wooden rafters  
 Integrity: Unaltered  
 Condition: Good  
 Notes: The central section of the building is for grain storage; the projecting wings house crushing equipment and related machinery

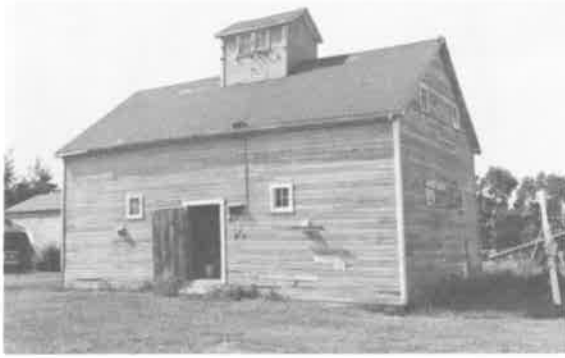
133) Elevator  
 Construction Date: 1915  
 Location: SE 1-15-4E  
 Present Owner: Mr. Macklin  
 Present Use: Functioning Elevator  
 Construction:  
   walls - horizontal siding on milled wooden frame  
   roof - asphalt shingles on milled wooden rafters  
 Integrity: Unaltered  
 Condition: Good  
 Notes: this building is also discussed on pages 72-73.

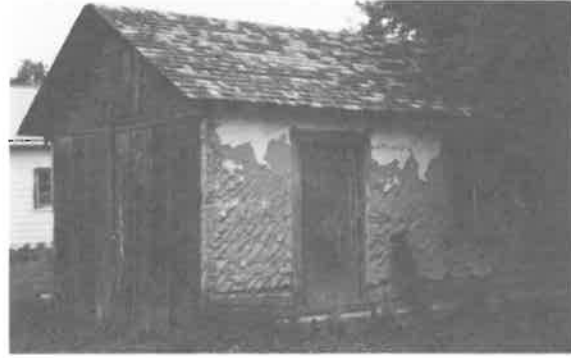
134) Machine Shed  
 Construction Date: ca. 1930  
 Location:  
 Present Owner: Peter Romanic  
 Present Use: Storage  
 Construction:  
   walls - plaster and willow lath on dovetailed logs  
   roof - wood shingles on milled wooden rafters  
 Integrity: Largely unaltered  
 Condition: Fair  
 Notes: This building is also discussed on page 74.

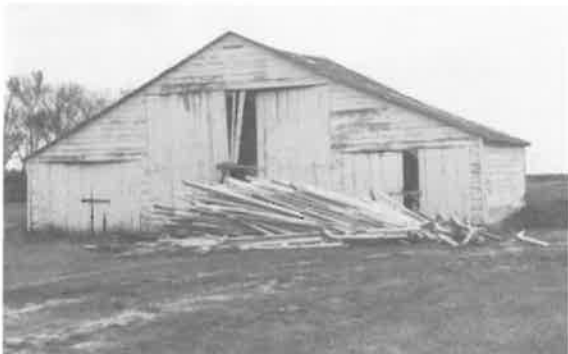
135) Machine Shed  
 Construction Date: ca. 1910  
 Location: River Lot #120  
 Present Owner: Province of Manitoba  
 Present Use: Vacant  
 Construction:  
   walls - horizontal siding with milled wooden frame  
   roof - wood shingles on milled wooden rafters  
 Integrity: Unaltered  
 Condition: Poor  
 Notes: The large central doors accommodated a threshing machine

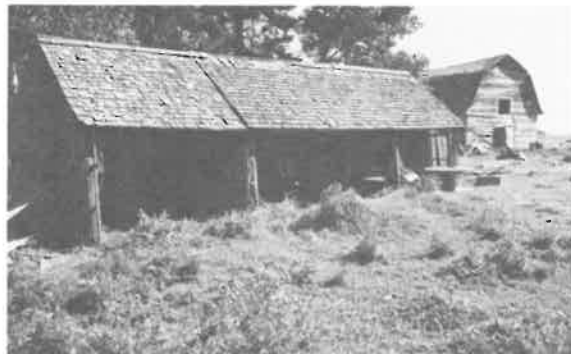
136) Machine Shed  
 Construction Date: ca. 1920  
 Location: SE 12-16-7E  
 Present Owner: V. Parke  
 Present Use: Abandoned  
 Construction:  
   walls - vertical logs  
   roof - wood shingles on hewn wooden rafters  
 Integrity: Unaltered  
 Condition: Poor

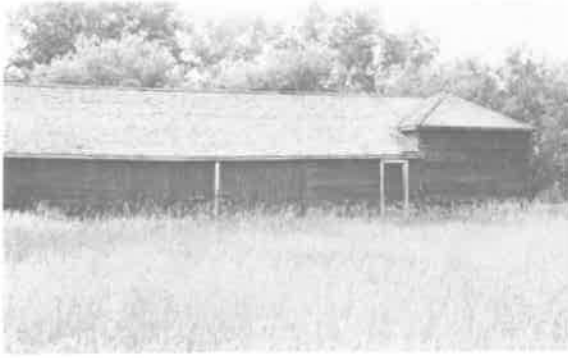
137) Machine Shed  
 Construction Date: ca. 1910  
 Location: SE 22-16-3E  
 Present Owner: A. Dalman  
 Present Use: Abandoned  
 Construction:  
   walls - horizontal siding on milled wooden frame  
   roof - wood shingles on milled wooden rafters  
 Integrity: Unaltered  
 Condition: Poor

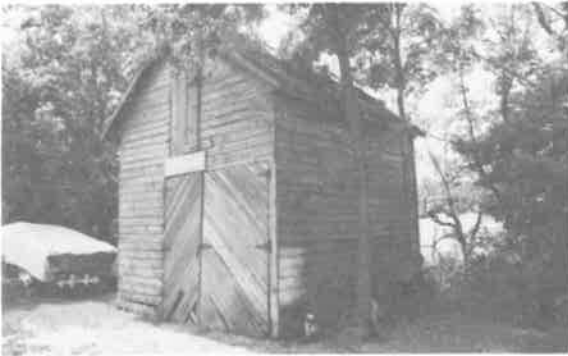
139) Garage  
 Construction Date: ca. 1910  
 Location: River Lot #255  
 Present Owner: M. Nebozenko  
 Present Use: Storage  
 Construction:  
   walls - horizontal siding on milled wooden frame  
   roof - wood shingles on milled wooden rafters  
 Integrity: Unaltered  
 Condition: Good  
 Notes: The upper level was used for miscellaneous storage.

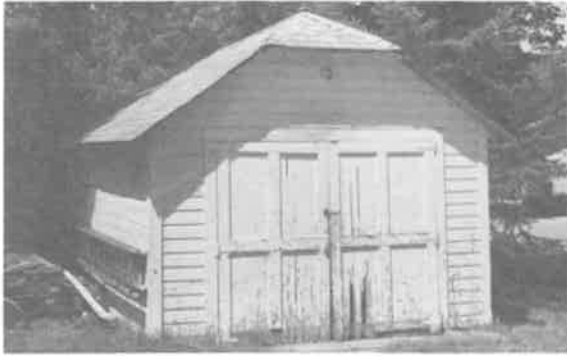
140) Garage  
 Construction Date: 1900  
 Location: 149 Eveline Street, Selkirk  
 Present Owner: Mrs. Lulashyk  
 Present Use: Functioning garage  
 Construction:  
   walls - horizontal siding on milled wooden frame  
   roof - asphalt shingles on milled wooden rafters  
 Integrity: Unaltered  
 Condition: Fair

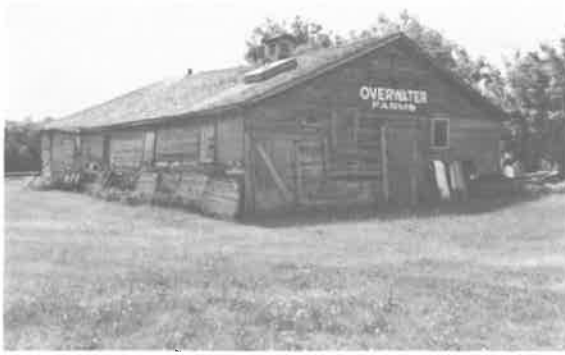
- 141) Shed  
 Construction Date: 1912  
 Location: River Lot #20  
 Present Owner: Mr. Overwater  
 Present Use: Storage  
 Construction:  
   walls - horizontal siding on milled wooden frame  
   roof - wood shingles on milled wooden rafters  
 Integrity: Parts of the building are now used for grain storage.  
 Condition: Poor - The roof has a swayback and the walls have buckled in places.

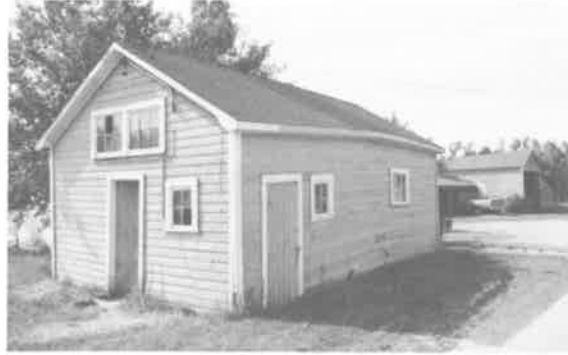
- 142) Shed  
 Construction Date: 1915  
 Location: SE 1-15-4E  
 Present Owner: Mr. Macklin  
 Present Use: Storage  
 Construction:  
   walls - horizontal siding on milled wooden frame  
   roof - asphalt shingles on milled wooden rafters  
 Integrity: Unaltered  
 Condition: Good

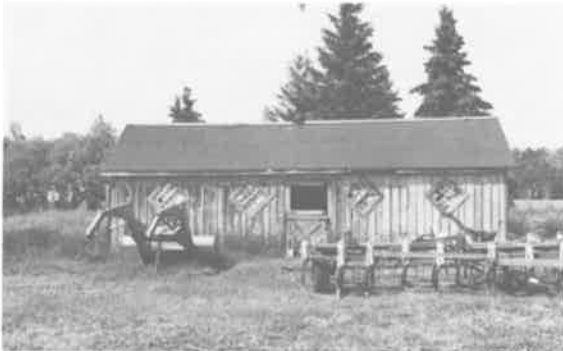
- 143) Shed  
 Construction Date: ca. 1925  
 Location: NE 2-16-3E  
 Present Owner: C.P. Kollar  
 Present Use: Storage  
 Construction:  
   walls - vertical board-and-batten on milled wooden frame  
   roof - asphalt shingles on milled wooden rafters  
 Integrity: Unaltered  
 Condition: Good

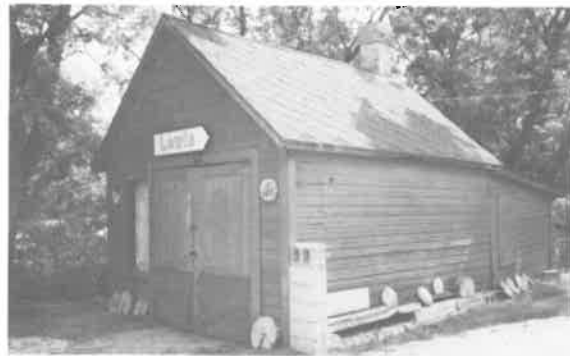
- 144) Blacksmith Shop  
 Construction Date: ca. 1910  
 Location: River Lot #120  
 Present Owner: Mr. Lewis  
 Present Use: Storage  
 Construction:  
   walls - horizontal siding on milled wooden frame  
   roof - wood shingles on milled wooden rafters  
 Integrity: Unaltered  
 Condition: Good  
 Notes: The chimney, large front doors and single window belie this building's function.

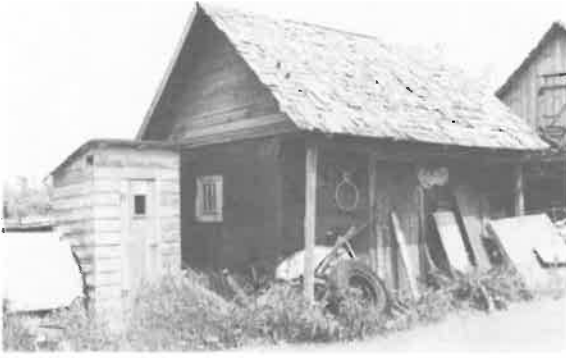
145) Workshop  
 Construction Date: 1932  
 Location: River Lot #226  
 Present Owner: W.R. Kozak  
 Present Use: Storage  
 Construction:  
   walls - dovetailed logs  
   roof - wood shingles on milled wooden rafters  
 Integrity: Unaltered  
 Condition: Fair

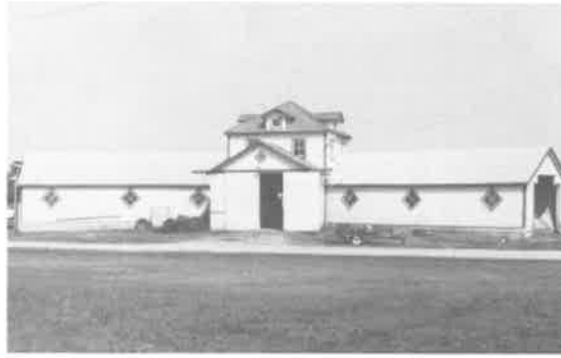
146) Bunkhouse/Machine Shed  
 Construction Date: ca. 1925  
 Location: NE 2-16-3E  
 Present Owner: C.P. Kollar  
 Present Use: Storage  
 Construction:  
   walls - horizontal siding on milled wooden frame  
   roof - wood shingles on milled wooden rafters  
 Integrity: The attached wings have been altered to accommodate larger machinery  
 Condition: Good  
 Notes: This building is also discussed on page 74.

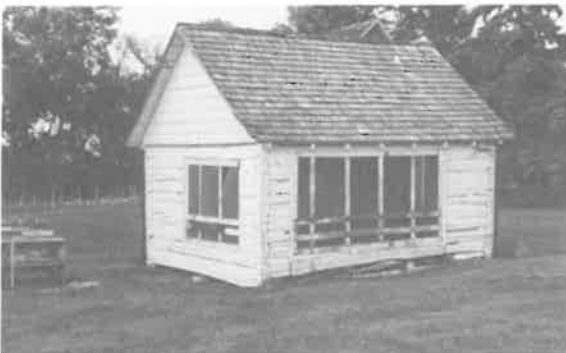
147) Chicken Coop  
 Construction Date: ca. 1920  
 Location: SW 2-17-3E  
 Present Owner: Mr. Hawkins  
 Present Use: Storage  
 Construction:  
   walls - dovetailed logs  
   roof - wood shingles on milled wooden rafters  
 Integrity: Interior has been gutted  
 Condition: Fair

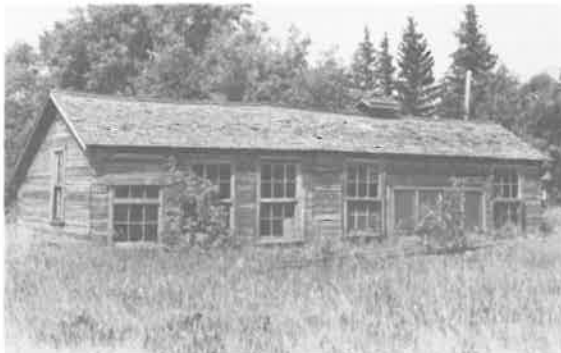
148) Chicken Coop  
 Construction Date: ca. 1920  
 Location: SE 22-16-3E  
 Present Owner: A. Dalman  
 Present Use: Abandoned  
 Construction:  
   walls - horizontal siding on milled wooden frame  
   roof - wood shingles on milled wooden rafters  
 Integrity: Unaltered  
 Condition: Poor  
 Notes: This building is also discussed on page 75.

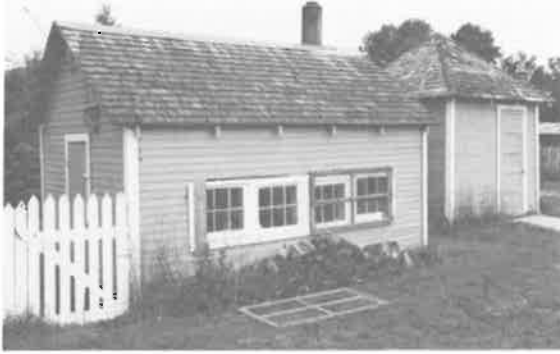
- 149) Chicken Coop  
 Construction Date: ca. 1915  
 Location: River Lot #82  
 Present Owner: Mr. Goltz  
 Present Use: Storage  
 Construction:  
   walls - horizontal siding on milled wooden frame  
   roof - wood shingles on milled wooden rafters  
 Integrity: Unaltered  
 Condition: Good

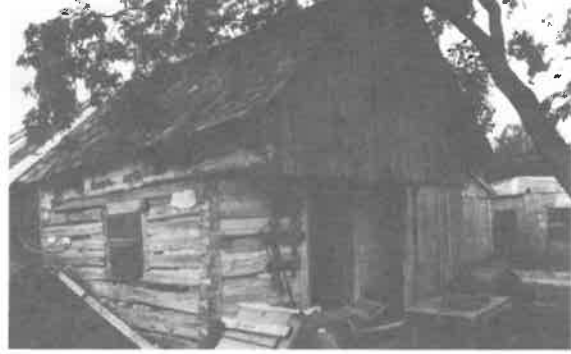
- 150) Komora  
 Construction Date: ca. 1925  
 Location:  
 Present Owner: Joan Polanski  
 Present Use: Vacant  
 Construction:  
   walls - squared dovetailed logs  
   roof - wood shingles on hewn timber rafters  
 Integrity: Largely unaltered  
 Condition: Poor  
 Notes: This building is also discussed on page 88.

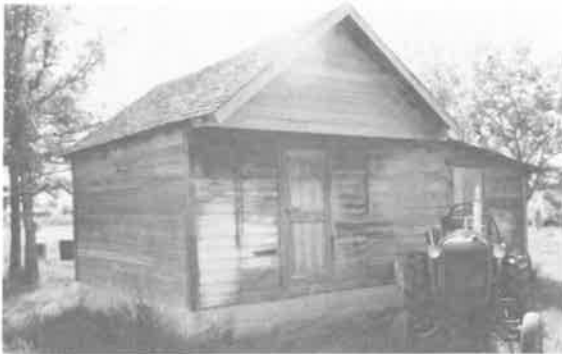
- 151) Komora  
 Construction Date: ca. 1915  
 Location: River Lot #109  
 Present owner: Joseph Pronyk  
 Present Use: Storage  
 Construction:  
   walls - squared dovetailed logs  
   roof - wood shingles on hewn timber rafters  
 Integrity: Largely unaltered  
 Condition: Fair  
 Notes: This building is also discussed on pages 88-89.

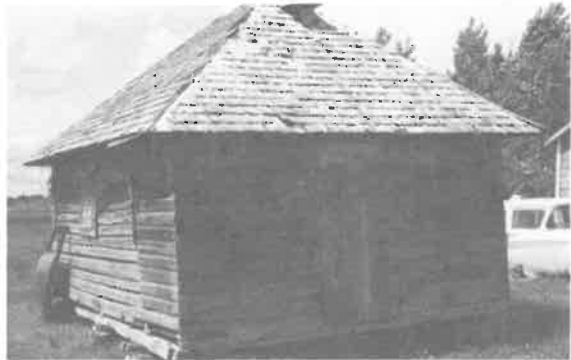
- 152) Komora  
 Construction Date: ca. 1920  
 Location:  
 Present Owner: Nick Shafer  
 Present Use: Storage  
 Construction:  
   walls - squared dovetailed logs  
   roof - wood shingles on hewn timber rafters  
 Integrity: Largely unaltered  
 Condition: Fair

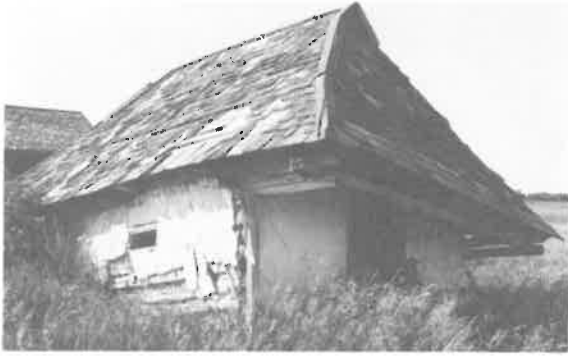
153) Summer Kitchen  
 Construction Date: ca.1900  
 Location: River Lot #90  
 Present Owner:  
 Present Use: Abandoned  
 Construction:  
   walls - Plaster cover on dovetailed logs  
   roof - wood shingles on milled wooden rafters  
 Integrity: Unaltered  
 Condition: Poor - the structure is collapsing on the north side

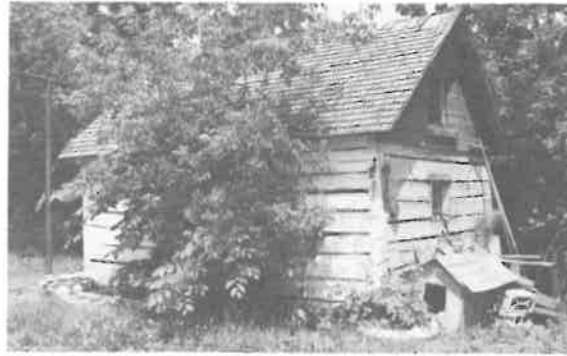
154) Summer Kitchen  
 Construction Date: 1926  
 Location: River Lot #240  
 Present Owner: E. Huzarski  
 Present Use: Storage  
 Construction:  
   walls - dovetailed logs  
   roof - wood shingles on milled wooden rafters  
 Integrity: Interior has been gutted  
 Condition: Fair

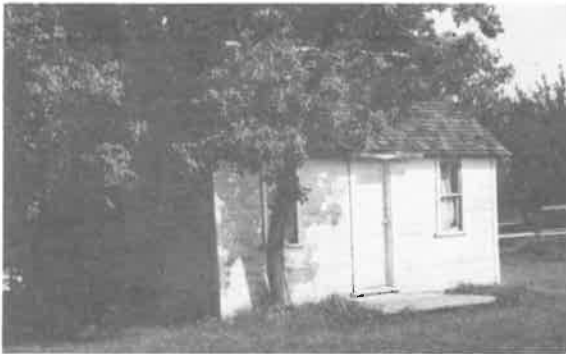
155) Summer Kitchen  
 Construction Date: ca. 1910  
 Location: SE 27-15-6E  
 Present Owner: R. Krahn  
 Present Use: Storage  
 Construction:  
   walls - horizontal siding on milled wooden frame  
   roof - wood shingles on milled wooden rafters  
 Integrity: Unaltered  
 Condition: Good

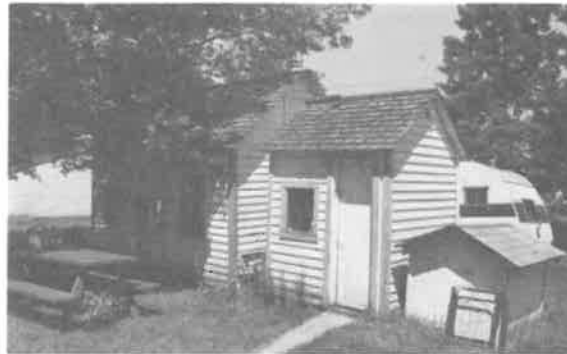
156) Summer Kitchen  
 Construction Date: ca.1915  
 Location: 423 Sinclair Avenue, Selkirk  
 Present Owner: Mrs. L. Morriseau  
 Present Use: Storage  
 Construction:  
   walls - horizontal siding on milled wooden frame  
   roof - wood shingles on milled wooden rafters  
 Integrity: Unaltered  
 Condition: Good

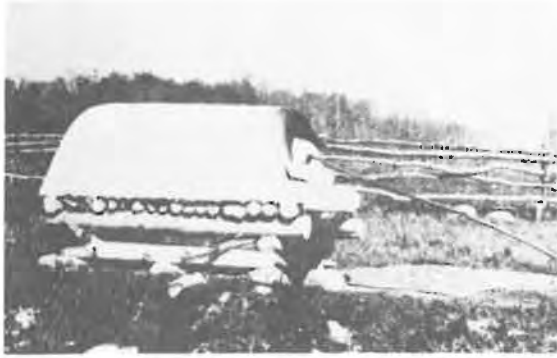
157) Bake Oven  
 Construction Date: c.a. 1920  
 Location: Winnipeg Beach Ukrainian Heritage Museum  
 Present Owner: Winnipeg Beach Ukrainian Heritage Museum  
 Present Use: Display  
 Construction: Clay and rubble formed into a small vault  
 Integrity: Unaltered  
 Condition: Good  
 Notes: This structure is also discussed on page 89.

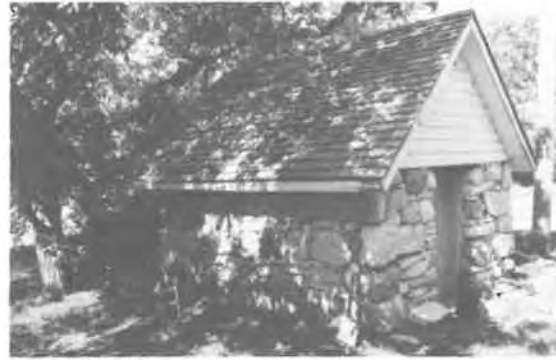
158) Milk House  
 Construction Date: Ca. 1880  
 Location: River Lot #10  
 Present Owner: Mrs. Larter  
 Present Use: Storage  
 Construction:  
     walls - solid fieldstone  
     roof - wood shingles on milled wooden rafters  
 Integrity: Unaltered  
 Condition: Good  
 Notes: This building is also discussed on page 76.

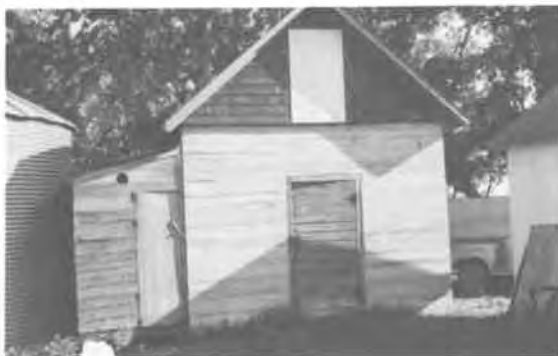
159) Ice House  
 Construction Date: ca. 1910  
 Location: NW 24-15-6E  
 Present Owner: C. Horbady  
 Present Use: Storage  
 Construction:  
     walls - solid poured concrete  
     roof - asphalt shingles on milled wooden rafters  
 Integrity: Unaltered  
 Condition: Good

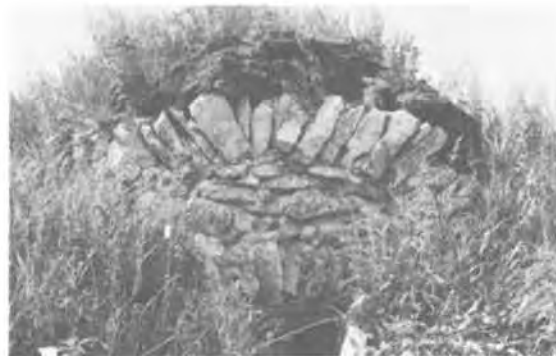
160) Root Cellar  
 Construction Date: ca. 1920  
 Location: SE 2-13-5E  
 Present Owner:  
 Present Use: Abandoned  
 Construction:  
     walls - fieldstone barrel vault  
     roof - fieldstone, covered with sod  
 Integrity: Unaltered  
 Condition: Poor

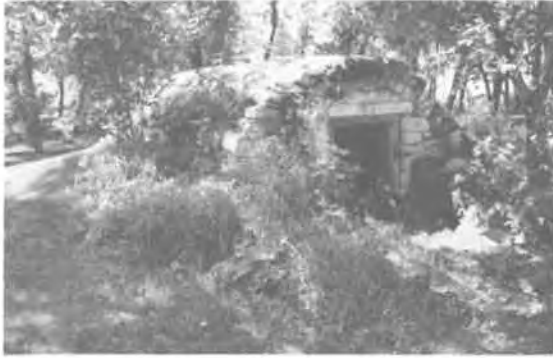
161) **Root Cellar**  
**Construction Date:** ca. 1920  
**Location:** SE 2-13-5E  
**Present Owner:** J. Letecki  
**Present Use:** Storage  
**Construction:**  
 walls - fieldstone barrel vault  
 roof - fieldstone, covered with sod  
**Integrity:** Unaltered  
**Condition:** Good  
**Notes:** This building is also discussed on page 75.

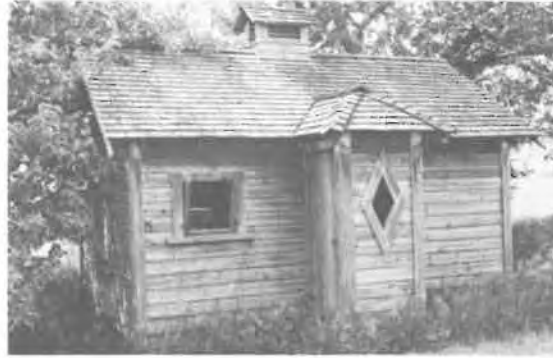
162) **Outhouse**  
**Construction Date:** ca. 1920  
**Location:**  
**Present Owner:**  
**Present Use:** Vacant  
**Construction:**  
 walls - horizontal siding on milled wooden frame  
 roof - wood shingles on milled wooden rafters  
**Integrity:** Unaltered  
**Condition:** Good

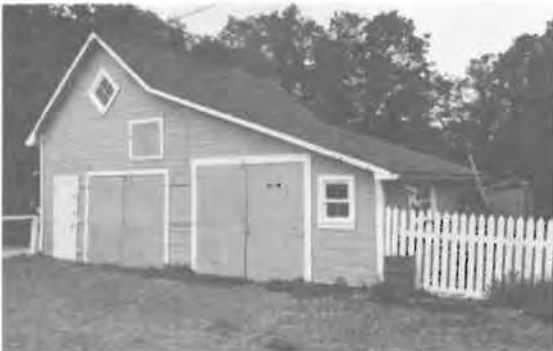
163) **Pump House**  
**Construction Date:** ca. 1915  
**Location:** River Lot #82  
**Present Owner:**  
**Present Use:** Storage  
**Construction:**  
 walls - horizontal siding on milled wooden frame  
 roof - wood shingles on milled wooden rafters  
**Integrity:** Unaltered  
**Condition:** Fair

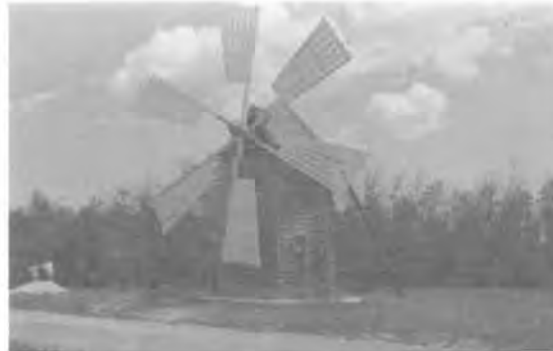
164) **Windmill**  
**Construction Date:** ca. 1910  
**Location:** Winnipeg Beach Ukrainian Heritage Museum  
**Present Owner:** Winnipeg Beach Ukrainian Heritage Museum  
**Present Use:** Display  
**Construction:** Wood shingles on wooden frame on roughly hewn logs  
**Integrity:** The building has been moved to its present site and numerous changes have been made to the interior. The sails are of recent construction.  
**Condition:** Good  
**Notes:** This building is also discussed on pages 90-91.

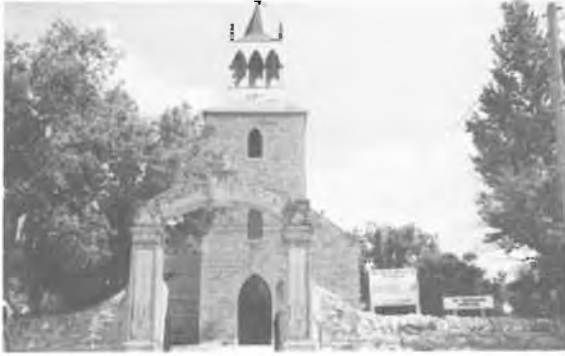
- 165) **St. Andrew's Anglican Church**  
**Construction Date:** 1844-49  
**Location:** River Lot #63  
**Present Owner:** Anglican Church of Canada  
**Present Use:** Active Congregation  
**Construction:**  
     walls - fieldstone  
     roof - wood shingles on milled wooden rafters  
**Integrity:** Unaltered  
**Condition:** Good  
**Notes:** This building is also discussed on pages 44-45.

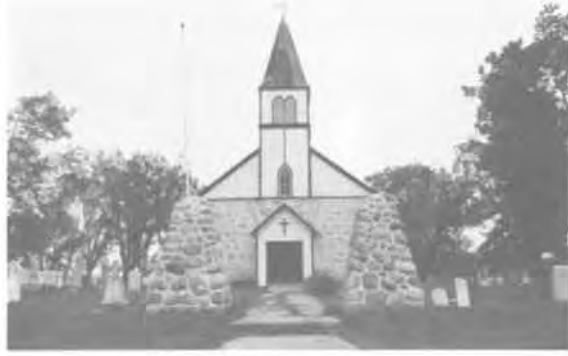
- 166) **St. Peter's Dynevor Anglican Church**  
**Construction Date:** 1853  
**Location:** River Lot #212  
**Present Owner:** Anglican Church of Canada  
**Present Use:**  
**Construction:**  
     walls - fieldstone  
     roof - wood shingles on milled wooden rafters  
**Integrity:** Unaltered  
**Condition:** Fair  
**Notes:** This building is also discussed on pages 45-46.

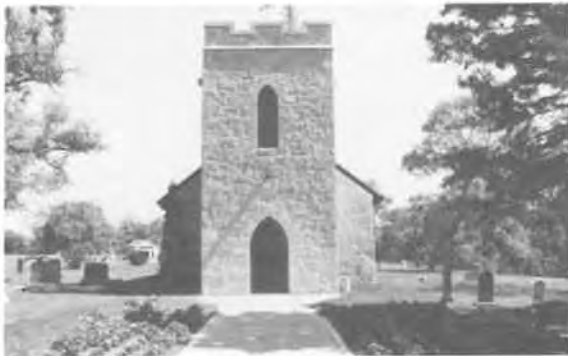
- 167) **St. Clement's Mapleton Anglican Church**  
**Construction Date:** 1860-61  
**Location:** River Lots 21 and 22  
**Present Owner:** Anglican Church of Canada  
**Present Use:** Active Congregation  
**Construction:**  
     walls - fieldstone  
     roof - wood shingles on milled wooden rafters  
**Integrity:** Unaltered  
**Condition:** Good  
**Notes:** This building is also discussed on page 47.

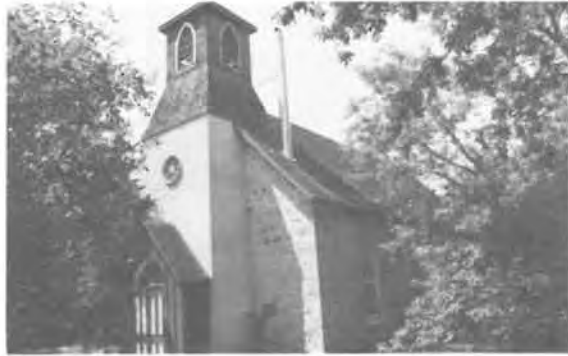
- 168) **Little Britain United Church**  
**Construction Date:** 1874  
**Location:** River Lots 123 and 124  
**Present Owner:** United Church of Canada  
**Present Use:** Active Congregation  
**Construction:**  
     walls - fieldstone  
     roof - wood shingles on timbers  
**Integrity:** Unaltered floorplan  
**Condition:** Good  
**Notes:** This building is also discussed on page 48.

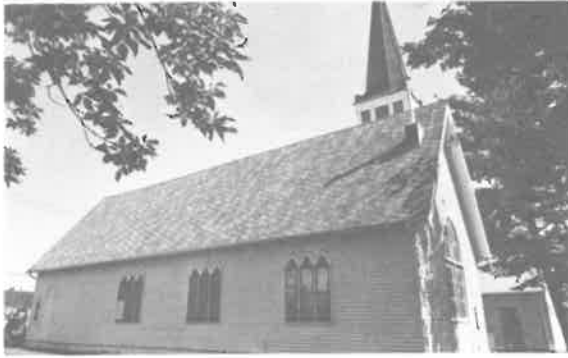
- 169) Christ Church, Anglican  
 Construction Date: 1887-94  
 Location: McLean Avenue, Selkirk  
 Present Owner: Anglican Church of Canada  
 Present Use: Active Congregation  
 Construction:  
   walls - horizontal siding on milled wooden frame  
   roof - asphalt shingles on milled wooden rafters  
 Integrity: The exterior has recently been covered with aluminum siding.  
 Condition: Good  
 Notes: This building is also discussed on pages 116-117.

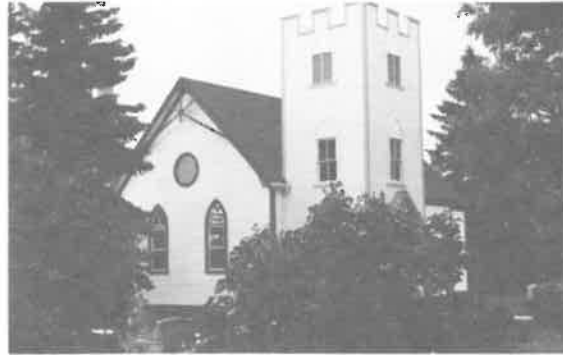
- 170) St. George's Anglican Church, Wakefield  
 Construction Date: 1904  
 Location: SE 16-15-4E  
 Present Owner: Anglican Church of Canada  
 Present Use: Active Congregation  
 Construction:  
   walls - horizontal siding on milled wooden frame  
   roof - asphalt shingles on milled wooden rafters  
 Integrity: The old Parkdale School has been attached to the west end of the church in 1967.  
 Condition: Good  
 Notes: This building is also discussed on pages 94-95.

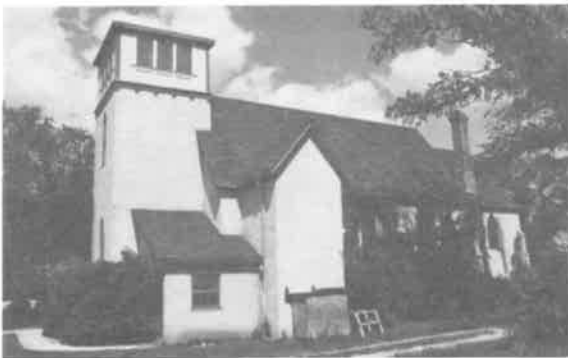
- 171) St. Thomas Anglican  
 Construction Date: 1905  
 Location: Lockport  
 Present Owner: Anglican Church of Canada  
 Present Use: Active Congregation  
 Construction:  
   walls - stucco veneer on milled wooden frame  
   roof - asphalt shingles on milled wooden rafters  
 Integrity: Largely unaltered  
 Condition: Good

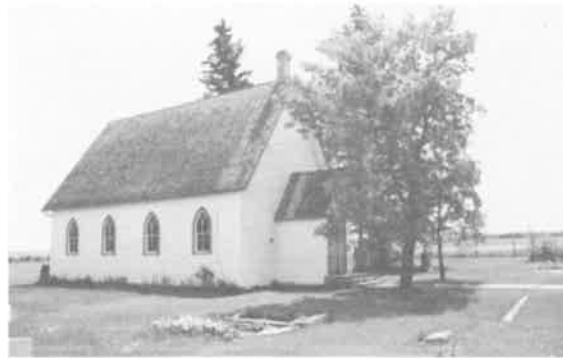
- 172) St. Matthew's Anglican Church  
 Construction Date: 1906  
 Location: SW 33-13-4E  
 Present Owner: Anglican Church of Canada  
 Present Use: Active Congregation  
 Construction:  
   walls - horizontal siding on milled wooden frame  
   roof - wood shingles on milled wooden rafters  
 Integrity: Largely unaltered  
 Condition: Good  
 Notes: This building is also discussed on pages 94-95.

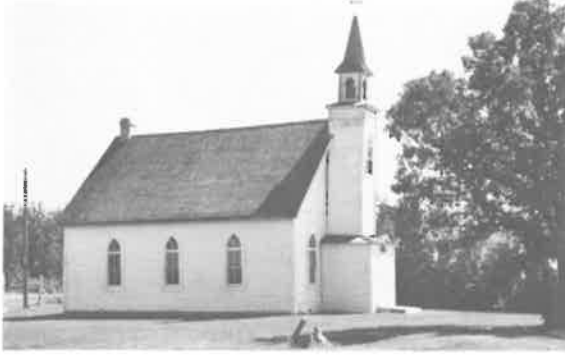
173) **St. James Anglican Church**  
**Construction Date:** 1912  
**Location:** NE 32-15-6E  
**Present Owner:** Anglican Church of Canada  
**Present Use:** Active Congregation  
**Construction:**  
 walls - horizontal siding on milled wooden frame  
 roof - asphalt shingles on milled wooden rafters  
**Integrity:** Largely unaltered floorplan  
**Condition:** Good  
**Notes:** This building is also discussed on pages 93-94.

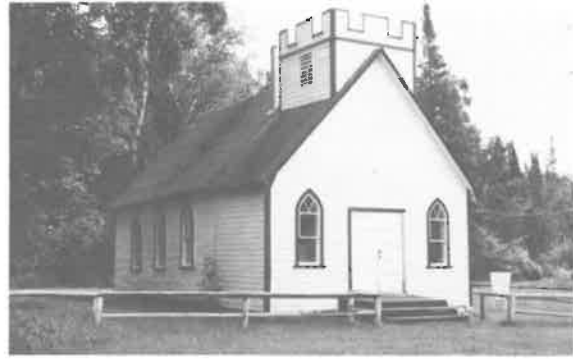
174) **St. Luke's Anglican Church, Balsam Bay**  
**Construction Date:** ca. 1920  
**Location:** SW 28-17-7E  
**Present Owner:** Anglican Church of Canada  
**Present Use:** Active Congregation  
**Construction:**  
 walls - squared dovetailed logs  
 roof - asphalt shingles on milled wooden rafters  
**Integrity:** Largely unaltered  
**Condition:** Good

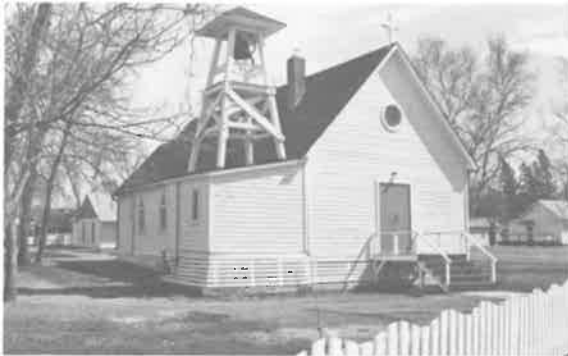
175) **St. Bartholomew's Anglican Church**  
**Construction Date:** 1909  
**Location:** Winnipeg Beach  
**Present Owner:** Anglican Church of Canada  
**Present Use:** Active Congregation  
**Construction:**  
 walls - horizontal siding on milled wooden frame  
 roof - asphalt shingles on milled wooden rafters  
**Integrity:** Largely unaltered.  
**Condition:** Good  
**Notes:** This building is also discussed on pages 133.

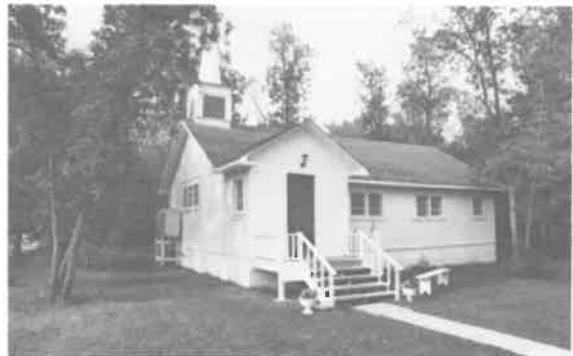
176) **All Saints Anglican Church**  
**Construction Date:** 1922  
**Location:** Whyteford  
**Present Owner:** Anglican Church of Canada  
**Present Use:** Active Congregation  
**Construction:**  
 walls - horizontal siding on milled wooden frame  
 roof - asphalt shingles on milled wooden rafters  
**Integrity:** Largely unaltered  
**Condition:** Good

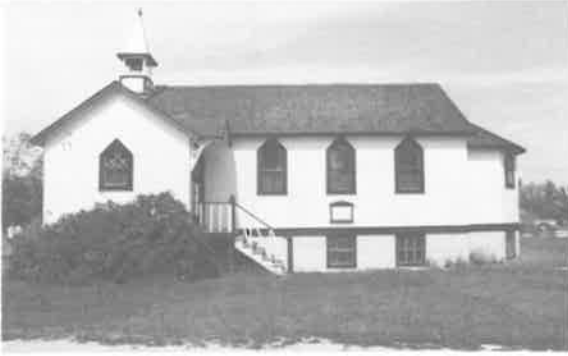
177) **St. Peter's-Dynevor Church**  
**Construction Date:** ca. 1925  
**Location:** River Lot #34  
**Present Owner:** Anglican Church of Canada  
**Present Use:** Active Congregation  
**Construction:**  
 walls - horizontal siding on milled wooden frame  
 roof - asphalt shingles on milled wooden rafters  
**Integrity:** Largely unaltered  
**Condition:** Good

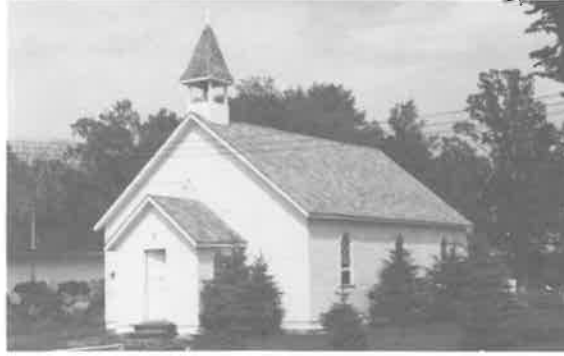
178) **St. George's Anglican Church**  
**Construction Date:** 1938  
**Location:** St. John's Boy's School/River Lot #41  
**Present Owner:** St. John's Cathedral Boy's School  
**Present Use:** School Use  
**Construction:**  
 walls - horizontal siding on milled wooden frame  
 roof - asphalt shingles on milled wooden rafters  
**Integrity:** The church has been moved onto its present site.  
**Condition:** Good

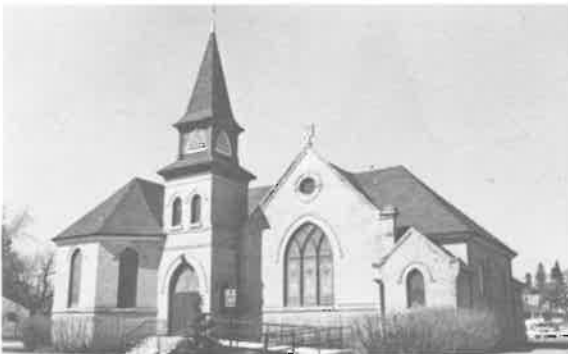
179) **Knox Presbyterian Church**  
**Construction Date:** 1904  
**Location:** Eveline Street, Selkirk  
**Present Owner:** Presbyterian Church of Canada  
**Present Use:** Active Congregation  
**Construction:**  
 walls - buff brick on wood frame  
 roof - asphalt shingles on milled wooden rafters  
**Integrity:** Largely unaltered  
**Condition:** Good  
**Notes:** This building is also discussed on pages 115 and 117.

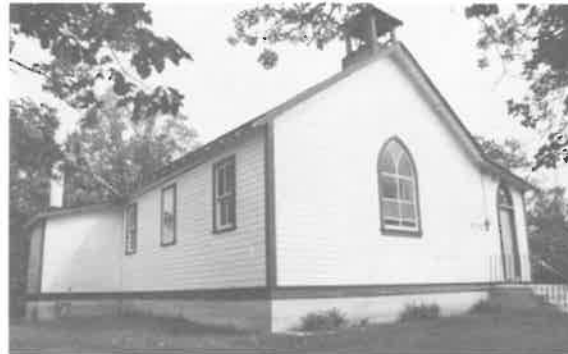
180) **MacKenzie Presbyterian Church**  
**Construction Date:** 1922  
**Location:** River Lot #120  
**Present Owner:** Presbyterian Church of Canada  
**Present Use:** Active Congregation  
**Construction:**  
 walls - horizontal siding on milled wooden frame  
 roof - asphalt shingles on milled wooden rafters  
**Integrity:** Largely unaltered  
**Condition:** Good

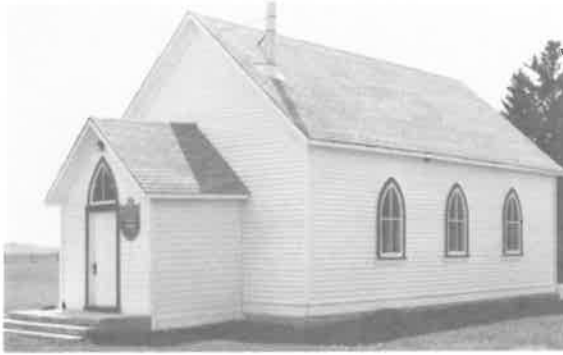
- 181) **Dunara United Church**  
**Construction Date:** 1893  
**Location:** SE 36-15-3E  
**Present Owner:** United Church of Canada  
**Present Use:** Active Congregation  
**Construction:**  
 walls - horizontal siding on milled wooden frame  
 roof - asphalt shingles on milled wooden rafters  
**Integrity:** Largely unaltered  
**Condition:** Good

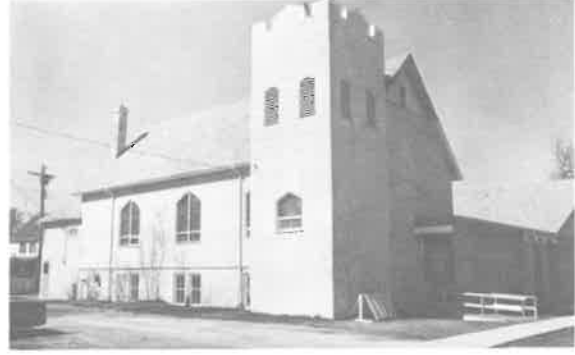
- 182) **Selkirk United Church**  
**Construction Date:** 1986  
**Location:** 202 McLean Avenue, Selkirk  
**Present Owner:** United Church of Canada  
**Present Use:** Active Congregation  
**Construction:**  
 Walls - stucco on milled wooden frame  
 roof - asphalt shingles on milled wooden rafters  
**Integrity:** The building originally stood on Dufferin Avenue.  
**Condition:** Good

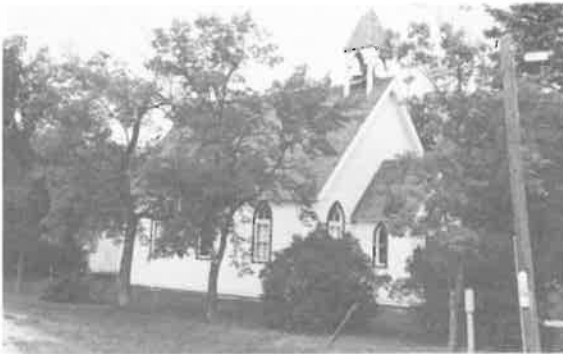
- 183) **Clandeboye United Church**  
**Construction Date:** 1901  
**Location:** Clandeboye  
**Present Owner:** United Church of Canada  
**Present Use:** Active Congregation  
**Construction:**  
 walls - horizontal siding on milled wooden frame  
 roof - wood shingles on milled wooden rafters  
**Integrity:** Largely unaltered  
**Condition:** Good  
**Notes:** This church was destroyed in 1984 to make way for a new church building.

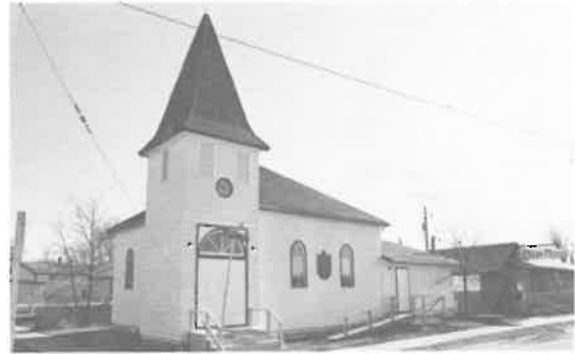
- 184) **Winnipeg Beach United Church**  
**Construction Date:** 1905  
**Location:** Winnipeg Beach  
**Present Owner:** United Church of Canada  
**Present Use:** Active Congregation  
**Construction:**  
 walls - horizontal siding on milled wooden frame  
 roof - wood shingles on milled wooden rafters  
**Integrity:** The building has recently been covered with aluminum siding.  
**Condition:** Good  
**Notes:** This building is also discussed on page 133.

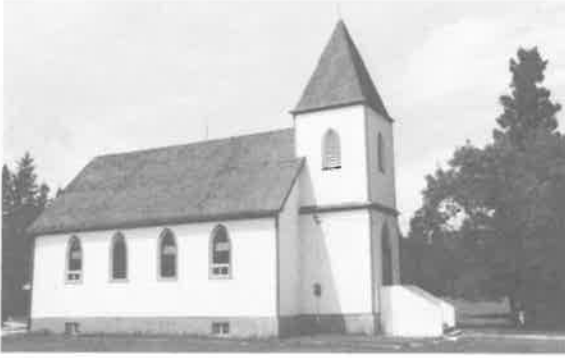
185) Cloverdale United Church  
 Construction Date: 1921  
 Location: SE 8-14-4E  
 Present Owner: United Church of Canada  
 Present Use: Active Congregation  
 Construction:  
   walls - horizontal siding on milled wooden frame  
   roof - wood shingles on milled wooden rafters  
 Integrity: Largely unaltered  
 Condition: Good  
 Notes: This building is also discussed on pages 94-95.

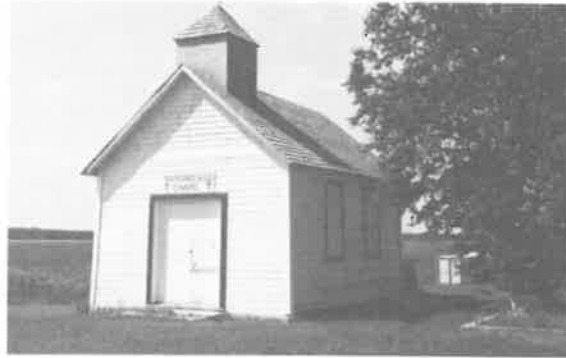
186) Mustard Seed Chapel  
 Construction Date: 1901  
 Location: SE 34-16-4E  
 Present Owner: Anglican Church of Canada  
 Present Use: Occasional Use  
 Construction:  
   walls - horizontal siding on milled wooden frame  
   roof - wood shingles on milled wooden rafters  
 Integrity: Large unaltered  
 Condition: Good

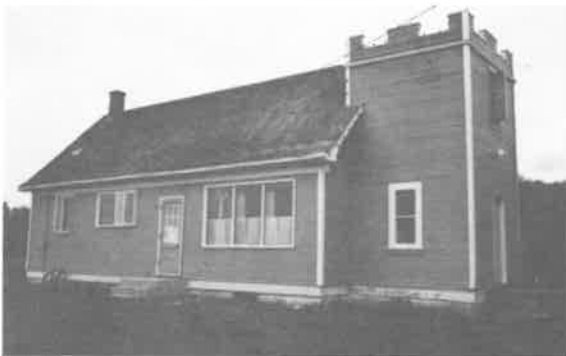
187) MacBeth Church  
 Construction Date: 1932  
 Location: SE 25-13-5E  
 Present Owner:  
 Present Use: Residence  
 Construction:  
   walls - horizontal siding on milled wooden frame  
   roof - asphalt shingles on milled wooden rafters  
 Integrity: The building has been moved and much altered to fulfill its present function.  
 Condition: Good

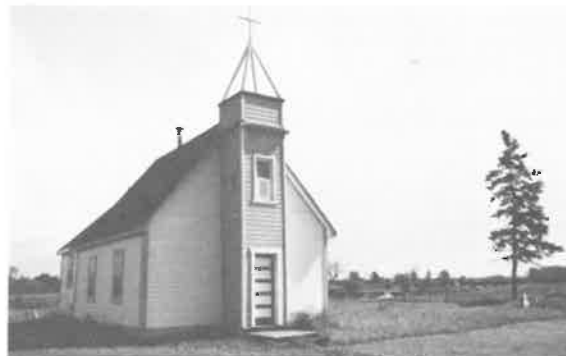
188) Scaterbury Church  
 Construction Date: ca. 1920  
 Location: River Lot #16  
 Present Owner: Roman Catholic Church of Canada  
 Present Use: Active Congregation  
 Construction:  
   walls - horizontal siding on milled wooden frame  
   roof - asphalt shingles on milled wooden rafters  
 Integrity: Largely unaltered  
 Condition: Fair

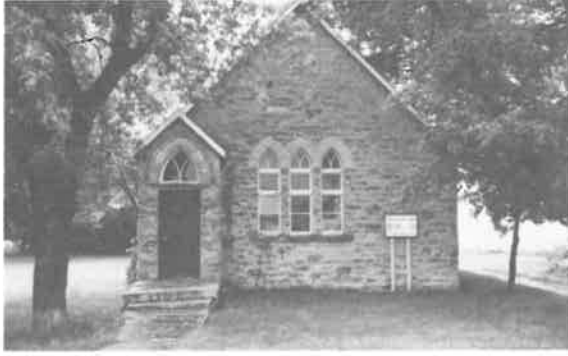
189) **Gerson Mission Church**  
**Construction Date:** 1919  
**Location:** Gerson  
**Present Owner:** Baptist Church of Canada  
**Present Use:** Active Congregation  
**Construction:**  
     walls - solid fieldstone  
     roof - asphalt shingles on milled wooden rafters  
**Integrity:** Largely unaltered  
**Condition:** Good  
**Notes:** This building is also discussed on page 125.

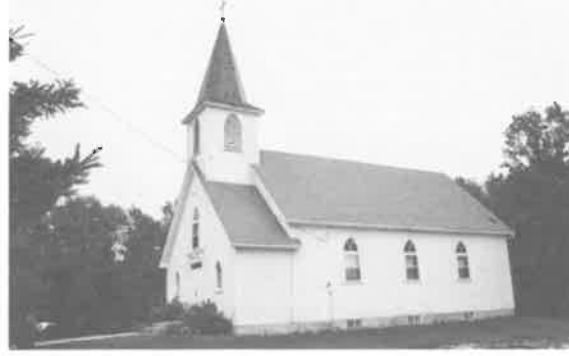
190) **St. John's Evangelical Lutheran Church**  
**Construction Date:** ca. 1920  
**Location:** SW 19-15-8E  
**Present Owner:** Lutheran Church of Canada  
**Present Use:** Active Congregation  
**Construction:**  
     walls - horizontal siding on milled wooden frame  
     roof - asphalt shingles on milled wooden rafters  
**Integrity:** Largely unaltered  
**Condition:** Good

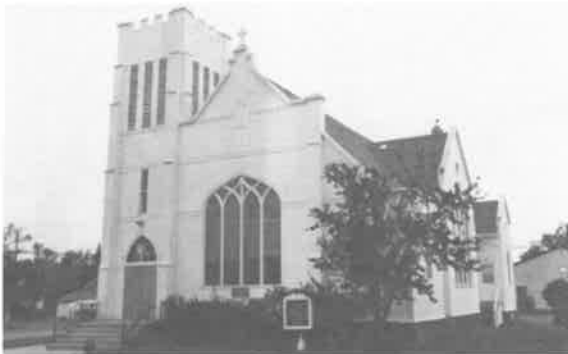
191) **Icelandic Evangelical Lutheran Church**  
**Construction Date:** 1924  
**Location:** Clandeboye Avenue, Selkirk  
**Present Owner:** Lutheran Church of Canada  
**Present Use:** Active Congregation  
**Construction:**  
     walls - horizontal siding on milled wooden frame  
     roof - asphalt shingles on milled wooden rafters  
**Integrity:** Largely unaltered  
**Condition:** Good  
**Notes:** This building is also discussed on page 117.

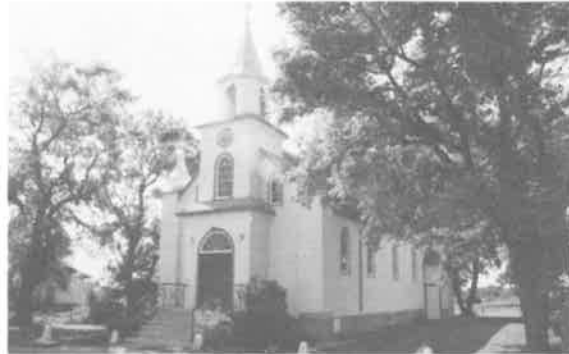
192) **St. Stanislaus Roman Catholic Church**  
**Construction Date:** ca. 1910  
**Location:** East Selkirk  
**Present Owner:** Roman Catholic Church of Canada  
**Present Use:** Active Congregation  
**Construction:**  
     walls - stucco veneer on milled wooden frame  
     roof - asphalt shingles on milled wooden rafters  
**Integrity:** Largely unaltered  
**Condition:** Good  
**Notes:** This building is also discussed on page 122.

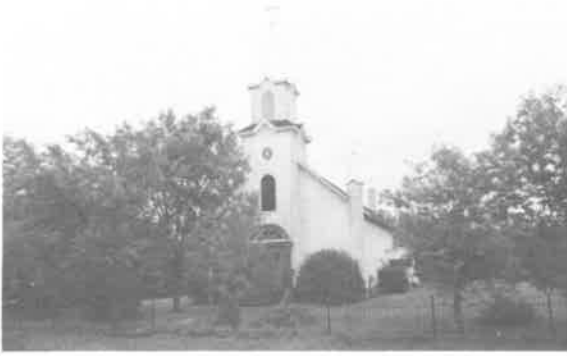
193) Sacred Heart of Jesus Roman Catholic Church  
 Construction Date: ca. 1920  
 Location: Garson  
 Present Owner: Roman Catholic Church of Canada  
 Present Use: Active Congregation  
 Construction:  
   walls - stucco veneer on milled wooden frame  
   roof - asphalt shingles on milled wooden rafters  
 Integrity: Largely unaltered  
 Condition: Good

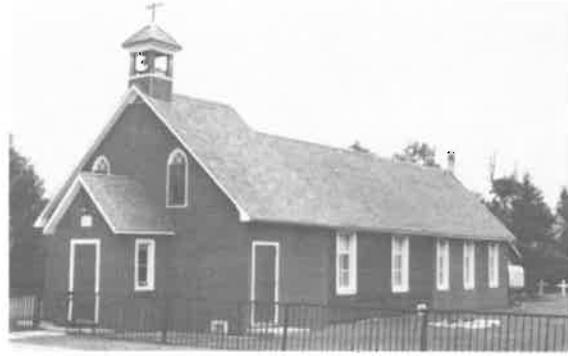
194) St. Anne's Polish Catholic Church  
 Construction Date: 1934  
 Location: Petersfield  
 Present Owner: Polish Catholic Church of Canada  
 Present Use: Active Congregation  
 Construction:  
   walls - insulbrick siding on milled wooden frame  
   roof - asphalt shingles on milled wooden rafters  
 Integrity: Largely unaltered  
 Condition: Good  
 Notes: This building is also discussed on page 127.

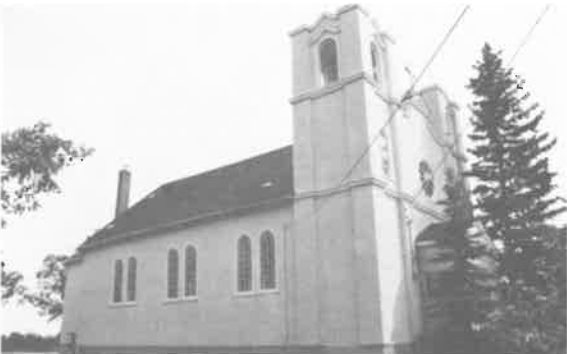
195) Corpus Christi Roman Catholic Church  
 Construction Date: 1940  
 Location: River Lots 217 & 218  
 Present Owner: Roman Catholic Church of Canada  
 Present Use: Active Congregation  
 Construction:  
   walls - stucco veneer on milled wooden frame  
   roof - asphalt shingles on milled wooden rafters  
 Integrity: Largely unaltered  
 Condition: Good  
 Notes: This building is also discussed on page 95.

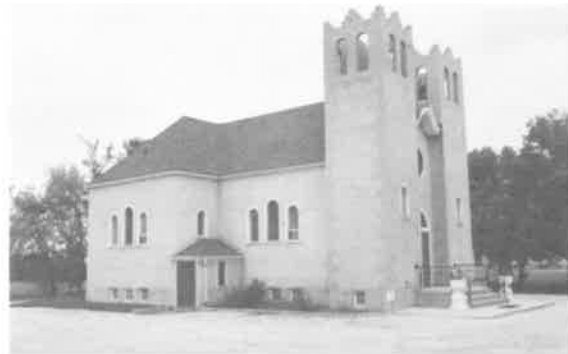
196) St. Margaret's Roman Catholic Church, Little Britain  
 Construction Date: 1943  
 Location: River Lot #120  
 Present Owner: Roman Catholic Church of Canada  
 Present Use: Active Congregation  
 Construction:  
   walls - stucco veneer on milled wooden frame  
   roof - asphalt shingles on milled wooden rafters  
 Integrity: Largely unaltered  
 Condition: Good

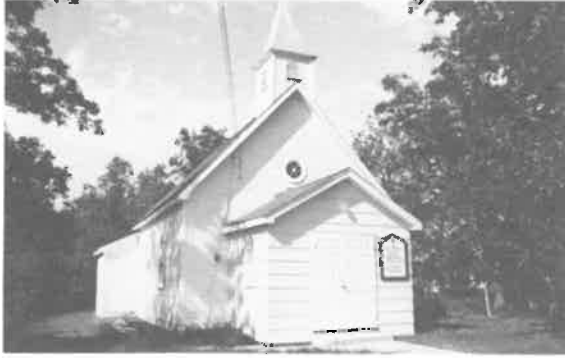
197) **St. Joseph's Polish Catholic Church**  
**Construction Date:** ca. 1920  
**Location:** Libau  
**Present Owner:** Polish Catholic Church of Canada  
**Present Use:** Active Congregation  
**Construction:**  
 walls - aluminum siding on milled wooden frame  
 roof - asphalt shingles on milled wooden rafters  
**Integrity:** Largely unaltered  
**Condition:** Good

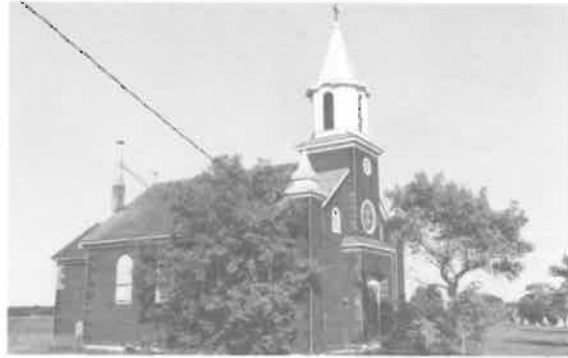
198) **Sacred Heart Chapel, Victoria Park**  
**Construction Date:** 1937  
**Location:** River Lot #70  
**Present Owner:**  
**Present Use:** Vacant  
**Construction:**  
 walls - insulbrick siding on milled wooden frame  
 roof - wood shingles on milled wooden rafters  
**Integrity:** Largely unaltered  
**Condition:** Poor  
**Notes:** This building has been dismantled and the hall section used as a private residence.

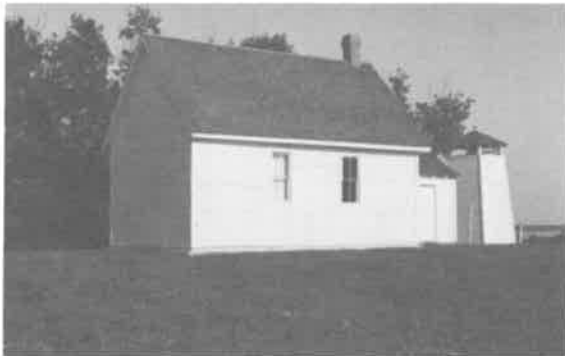
199) **Holy Rosary Polish Catholic Church**  
**Construction Date:** ca. 1910  
**Location:** SE 34-17-3E  
**Present Owner:** Polish Catholic Church of Canada  
**Present Use:** Occasional service  
**Construction:**  
 walls - horizontal siding on milled wooden frame  
 roof - asphalt shingles on milled wooden rafters  
**Integrity:** Unaltered  
**Condition:** Good

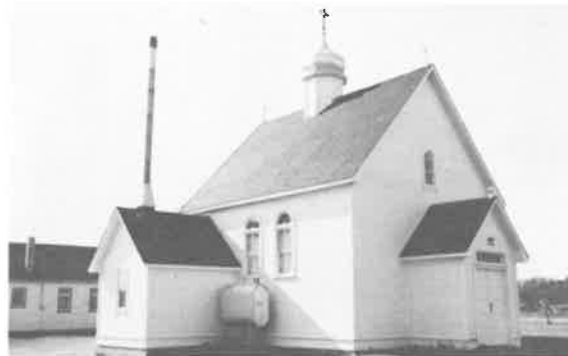
200) **St. John the Baptist Ukrainian Catholic Church**  
**Construction Date:** ca. 1920  
**Location:** NE 34-15-6E  
**Present Owner:** Ukrainian Catholic Church of Canada  
**Present Use:** Active Congregation  
**Construction:**  
 walls - horizontal siding on milled wooden frame  
 roof - asphalt shingles on milled wooden rafters  
**Integrity:** Largely unaltered  
**Condition:** Good

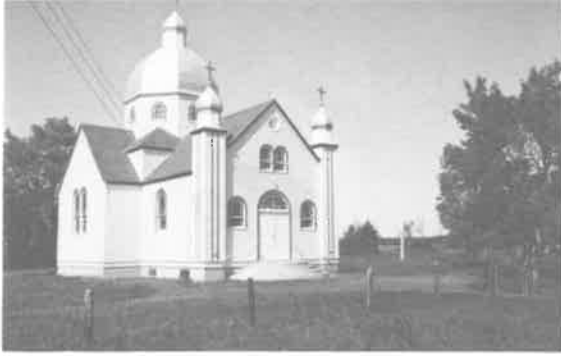
201) **St. Peter & St. Paul Ukrainian Catholic Church**  
**Construction Date:** ca. 1930  
**Location:** SE 19-16-8E  
**Present Owner:** Ukrainian Catholic Church of Canada  
**Present Use:** Active Congregation  
**Construction:**  
     walls - horizontal siding on milled wooden frame  
     roof - asphalt shingles on milled wooden rafters  
**Integrity:** Largely unaltered  
**Condition:** Good

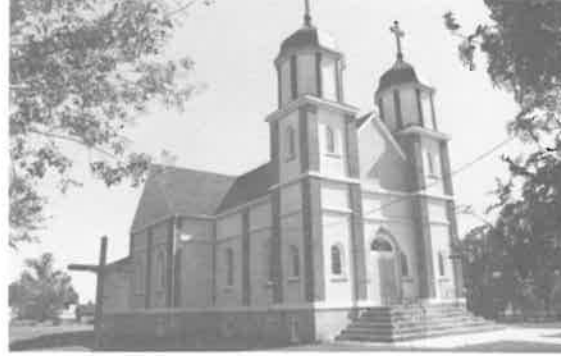
202) **Ukrainian Catholic Church**  
**Construction Date:** 1951  
**Location:** East Selkirk  
**Present Owner:** Ukrainian Catholic Church of Canada  
**Present Use:** Active Congregation  
**Construction:**  
     walls - stucco veneer on milled wooden frame  
     roof - asphalt shingles on milled wooden rafters  
**Integrity:** Largely unaltered  
**Condition:** Good  
**Notes:** This building is also discussed on page 122.

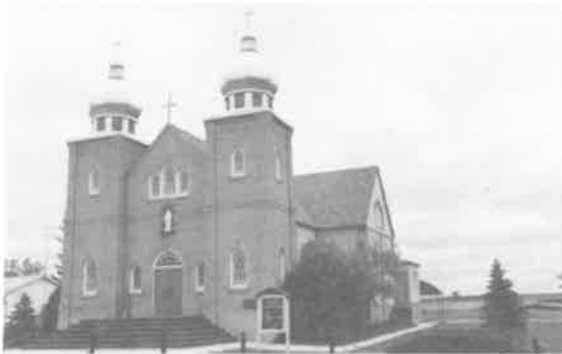
203) **Holy Trinity Ukrainian Catholic Church**  
**Construction Date:** 1952  
**Location:** River Lots #201-204  
**Present Owner:** Ukrainian Catholic Church of Canada  
**Present Use:** Active Congregation  
**Construction:**  
     walls - stucco veneer on milled wooden frame  
     roof - asphalt shingles on milled wooden rafters  
**Integrity:** Largely unaltered  
**Condition:** Good  
**Notes:** This building is also discussed on page 100.

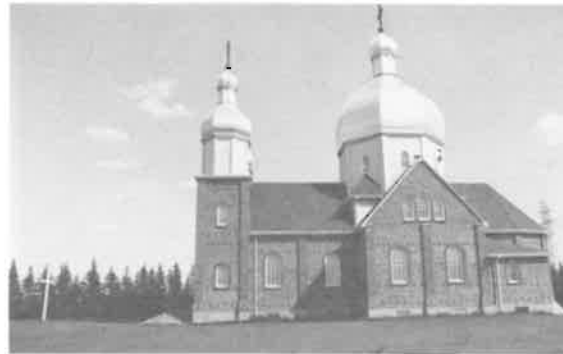
204) **Blessed Virgin Mary Ukrainian Catholic Church**  
**Construction Date:** 1958-60  
**Location:** River Lots 78 & 79  
**Present Owner:** Ukrainian Catholic Church of Canada  
**Present Use:** Active Congregation  
**Construction:**  
     walls - buff brick on wood frame  
     roof - asphalt shingles on milled wooden rafters  
**Integrity:** Unaltered floorplan  
**Condition:** Good  
**Notes:** This building is also discussed on page 100.

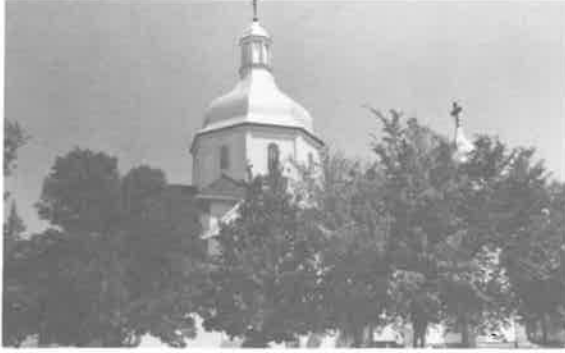
- 205) **Ukrainian Greek Catholic Church of Holy Eucharist**  
**Construction Date:** 1955  
**Location:** Sophia Street, Selkirk  
**Present Owner:** Ukrainian Catholic Church of Canada  
**Present Use:** Active Congregation  
**Construction:**  
 walls - stucco veneer on milled wooden frame  
 roof - asphalt shingles on milled wooden rafters  
**Integrity:** Largely unaltered  
**Condition:** Good  
**Notes:** This building is also discussed on page 117.
