## Schools

## Stores

## Community Residences

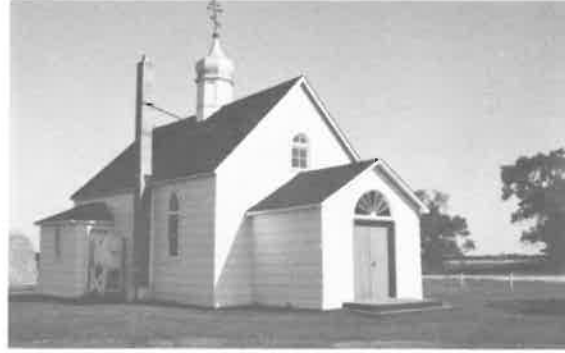
- 206) **Ukrainian Orthodox Church of the Holy Trinity**  
**Construction Date:** 1906  
**Location:** SW 27-15-6E  
**Present Owner:** Ukrainian Orthodox Church of Canada  
**Present Use:** Active Congregation  
**Construction:**  
 walls - horizontal siding on milled wooden frame  
 roof - asphalt shingles on milled wooden rafters  
**Integrity:** Largely unaltered  
**Condition:** Good  
**Notes:** This building is also discussed on page 98.

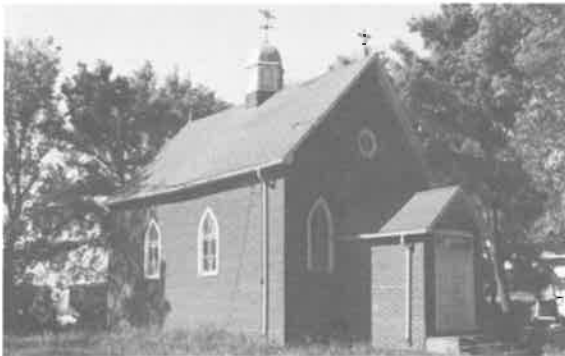
- 207) **St. Michael's Ukrainian Greek Orthodox Church**  
**Construction Date:** 1920  
**Location:** East Selkirk  
**Present Owner:** Ukrainian Greek Orthodox Church of Canada  
**Present Use:** Vacant  
**Construction:**  
 walls - asphalt shingles on milled wooden frame  
 roof - asphalt shingles on milled wooden rafters  
**Integrity:** Largely unaltered  
**Condition:** Fair  
**Notes:** This building has been demolished since the survey was undertaken.

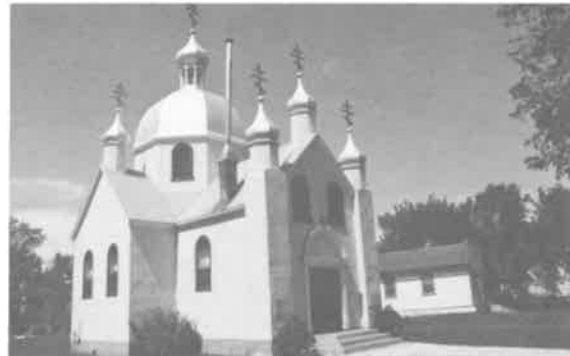
- 208) **St. Nicholas Ukrainian Greek Orthodox Church**  
**Construction Date:** 1945  
**Location:** River Lots #183-185  
**Present Owner:** Ukrainian Greek Orthodox Church of Canada  
**Present Use:** Active Congregation  
**Construction:**  
 walls - stucco veneer on milled wooden frame  
 roof - asphalt shingles on milled wooden rafters  
**Integrity:** Largely unaltered  
**Condition:** Good  
**Notes:** This building is also discussed on pages 98-99.

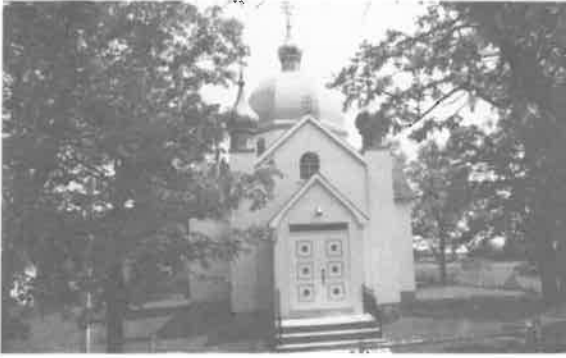
209) **St. Nicholas Orthodox Church of Narol**  
**Construction Date:** 1948 or 1952  
**Location:** River Lot #228  
**Present Owner:** Ukrainian Orthodox Church of Canada  
**Present Use:** Active Congregation  
**Construction:**  
 wall - stucco veneer on milled wooden frame  
 roof - wood shingles on milled wooden rafters  
**Integrity:** Largely unaltered  
**Condition:** Good  
**Notes:** This building is also discussed on pages 98-99.

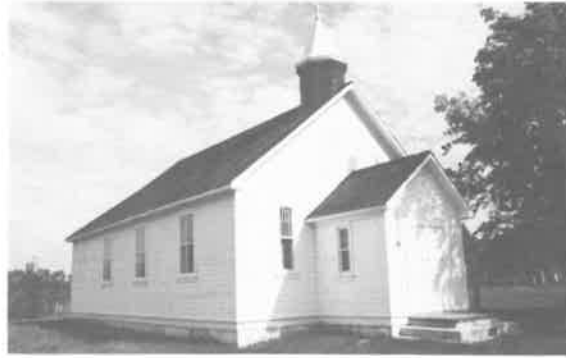
210) **Libau Lutheran Church**  
**Construction Date:** ca. 1920  
**Location:** Libau  
**Present Owner:** Lutheran Church of Canada  
**Present Use:** Active Congregation  
**Construction:**  
 walls - horizontal siding on milled wooden frame  
 roof - wood shingles on milled wooden rafters  
**Integrity:** Largely unaltered  
**Condition:** Good  
**Notes:** This building is also discussed on page 128.

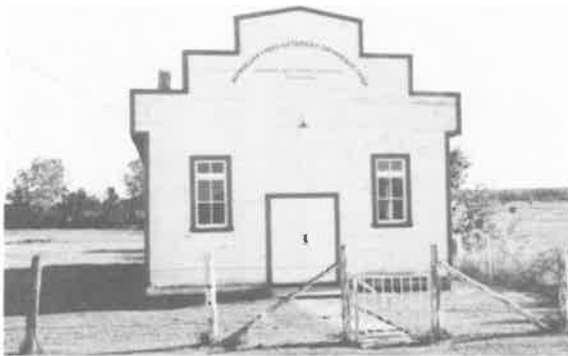
211) **Poplar Park Ukrainian Greek Catholic Parish Hall**  
**Construction Date:** 1923  
**Location:** NE 34-15-6E  
**Present Owner:** Ukrainian Greek Catholic Church of Canada  
**Present Use:** Active Hall  
**Construction:**  
 walls - horizontal siding on milled wooden frame  
 roof - asphalt shingles on milled wooden rafters  
**Integrity:** Unaltered  
**Condition:** Good  
**Notes:** This building is also discussed on page 101.

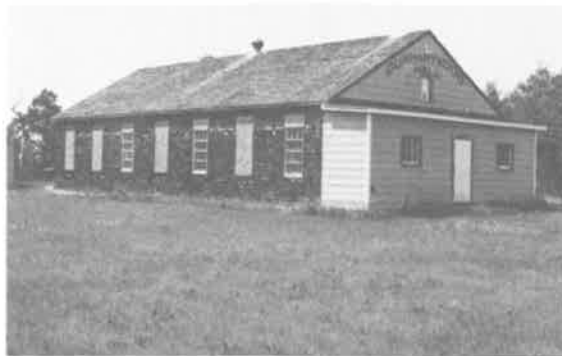
212) **Dunhartwood Hall**  
**Construction Date:** ca. 1940  
**Location:** SE 36-15-3E  
**Present Owner:**  
**Present Use:** Occasional Use  
**Construction:**  
 walls - wood shingles on milled wooden frame  
 roof - wood shingles on milled wooden rafters  
**Integrity:** A porch addition of recent construction mars the facade.  
**Condition:** Good  
**Notes:** This building is also discussed on page 101.

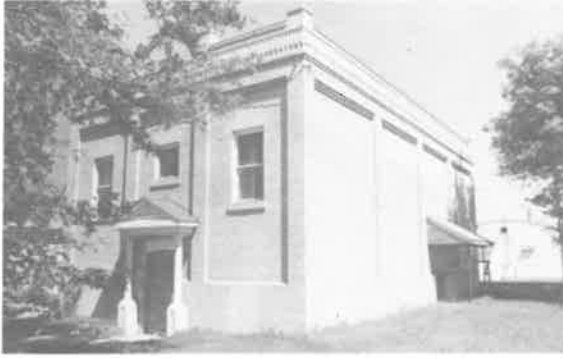
- 213) **Masonic Temple**  
**Construction Date:** 1871  
**Location:** Eaton Avenue, Selkirk  
**Present Owner:** Lisgar Lodge No. 2 AF & AM  
**Present Use:** Active lodge  
**Construction:**  
 walls - buff brick veneer on milled wooden frame  
 roof - built-up roofing  
**Integrity:** The interior has been altered  
**Condition:** Good  
**Notes:** This building is also discussed on page 117.

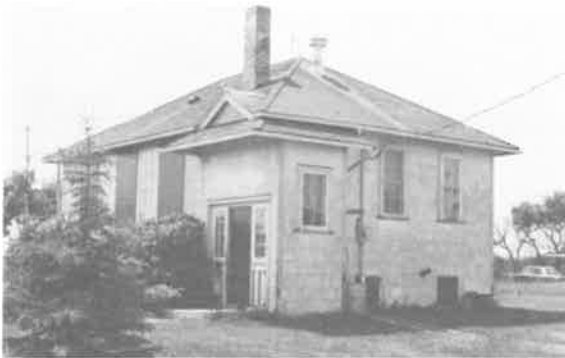
- 215) **Norwood School**  
**Construction Date:**  
**Location:** NE 14-15-3E  
**Present Owner:** Mr. Waite  
**Present Use:** Residence  
**Construction:**  
 walls - asphalt shingles on milled wooden frame  
 roof - wood shingles on milled wooden rafters  
**Integrity:** The interior has been much altered for its present function  
**Condition:** Good  
**Notes:** This building is also discussed on page 103.

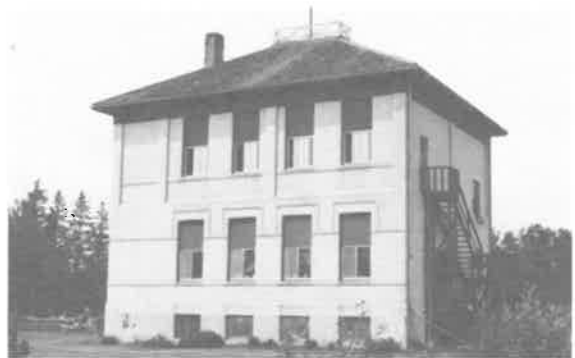
- 216) **Petersfield School**  
**Construction Date:** ca. 1915  
**Location:** Petersfield  
**Present Owner:** Larry Jackson  
**Present Use:** Residence  
**Construction:**  
 walls - buff brick on milled wooden frame  
 roof - wood shingles on milled wooden rafters  
**Integrity:** Interior has been altered for its present function  
**Condition:** Good  
**Notes:** This building is also discussed on page 127.

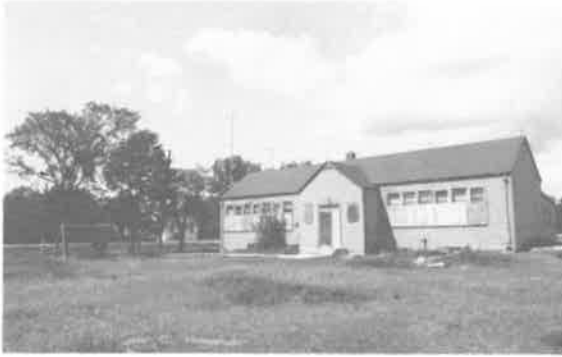
- 217) **Cloverdale School**  
**Construction Date:**  
**Location:** NW 4-14-4E  
**Present Owner:** Jack Harriott  
**Present Use:** Vacant  
**Construction:**  
 walls - wood shingles on milled wooden frame  
 roof - asphalt shingles on milled wooden rafters  
**Integrity:** Unaltered  
**Condition:** Fair

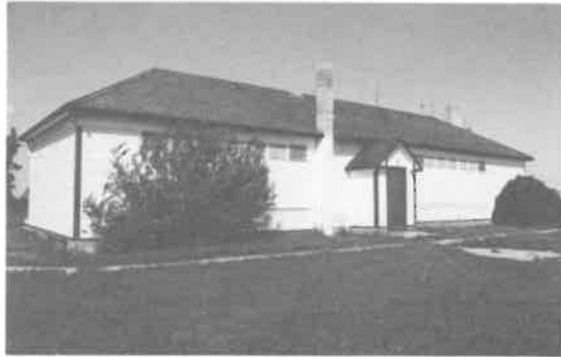
- 218) **Rosedale School**  
**Construction Date:** ca. 1920  
**Location:** River Lot #83  
**Present Owner:** United Croats Association  
**Present Use:** Vacant  
**Construction:**  
 walls - horizontal siding on milled wooden frame  
 roof - wood shingles on milled wooden rafters  
**Integrity:** Unaltered  
**Condition:** Good  
**Notes:** This building is also discussed on page 104.

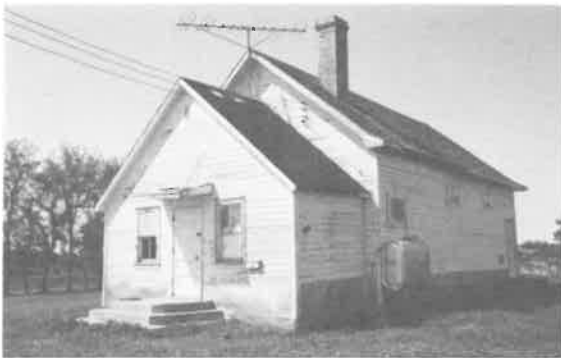
- 219) **Sheffield School**  
**Construction Date:** ca. 1925  
**Location:** SW 3-16-6E  
**Present Owner:** R. Gutterson  
**Present Use:** Vacant  
**Construction:**  
 walls - horizontal siding on milled wooden frame  
 roof - wood shingles on milled wooden rafters  
**Integrity:** Unaltered  
**Condition:** Fair  
**Notes:** This building is also discussed on page 104.

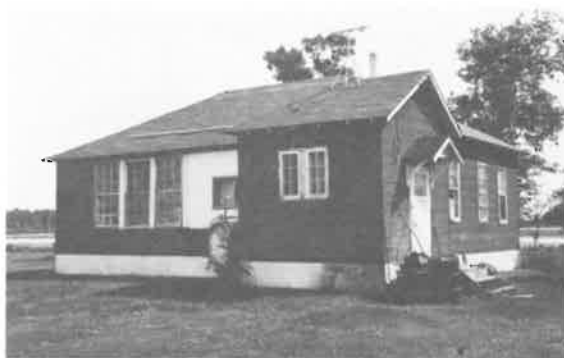
- 220) **Lilleydale School**  
**Construction Date:** ca. 1925  
**Location:** SE 11-14-5  
**Present Owner:** W. Jacyk  
**Present Use:** Storage  
**Construction:**  
 walls - insulbrick veneer on milled wooden frame  
 roof - asphalt shingles on milled wooden rafters  
**Integrity:** Unaltered  
**Condition:** Good

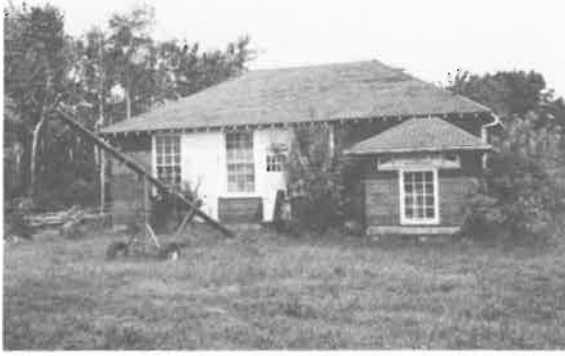
221) Brookside School  
 Construction Date: ca. 1925  
 Location: SE 11-14-5E  
 Present Owner: W. Jacyk  
 Present Use: Storage  
 Construction:  
   walls - insulbrick veneer on milled wooden frame  
   roof - asphalt shingles on milled wooden rafters  
 Integrity: Unaltered  
 Condition: Good

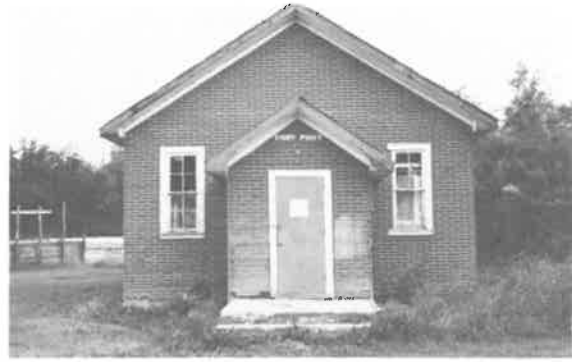
222) Stony Point School  
 Construction Date: ca. 1925  
 Location: SE 6-17-7E  
 Present Owner: R.M. of St. Clements  
 Present Use: Vacant  
 Construction:  
   walls - insulbrick veneer on milled wooden frame  
   roof - asphalt shingles on milled wooden rafters  
 Integrity: Unaltered  
 Condition: Poor

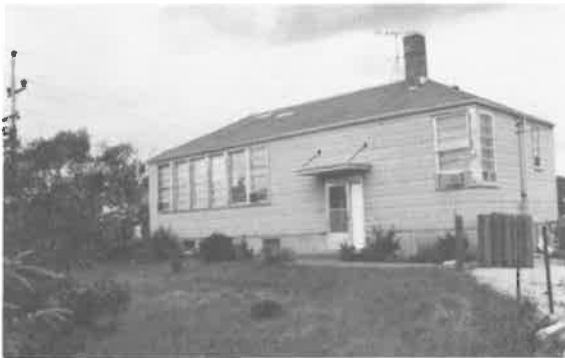
223) Earl Grey School  
 Construction Date: ca. 1925  
 Location: SW 36-13-3E  
 Present Owner: L. LeBlanc  
 Present Use: Residence  
 Construction:  
   walls - wood shingles on milled wooden frame  
   roof - asphalt shingles on milled wooden rafters  
 Integrity: The interior has undergone renovations for its present function  
 Condition: Good  
 Notes: This building is also discussed on page 104.

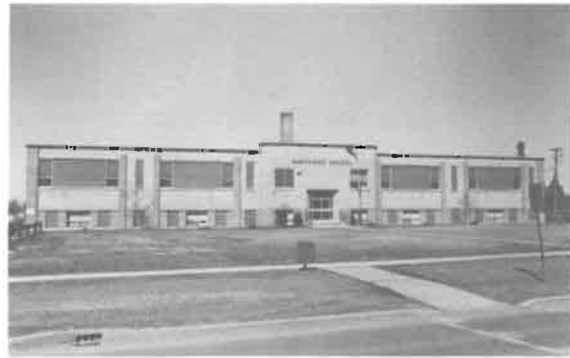
224) Daerwood School  
 Construction Date: 1949  
 Location: Main Street, Selkirk  
 Present Owner: Town of Selkirk  
 Present Use: Active School  
 Construction:  
   walls - buff brick on milled wooden frame  
   roof - built-up roofing  
 Integrity: Largely unaltered  
 Condition: Good

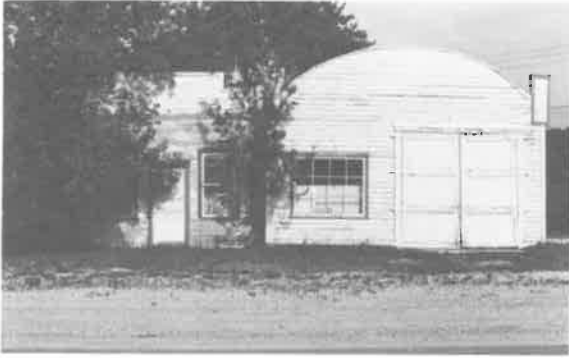
- 225) **General Store**  
**Construction Date:** 1907  
**Location:** Petersfield  
**Present Owner:** Mrs. J. Armstrong  
**Present Use:** Storage  
**Construction:**  
    walls - horizontal siding on milled wooden frame  
    roof - wood shingles on milled wooden rafters  
**Integrity:** Unaltered  
**Condition:** Fair  
**Notes:** This building is also discussed on page 127.

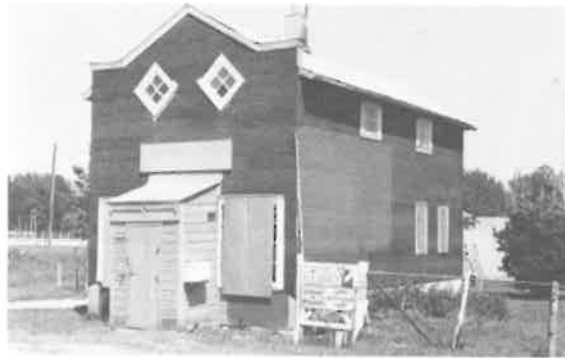
- 226) **Netley Airport Store**  
**Construction Date:** ca. 1915  
**Location:** NW 15-16-4E  
**Present Owner:** Block Brothers Realty  
**Present Use:** Vacant  
**Construction:**  
    walls - insulbrick siding on milled wooden frame  
    roof - asphalt shingles on milled wooden rafters  
**Integrity:** The interior has been altered several times  
**Condition:** Fair  
**Notes:** This building is also discussed on page 105.

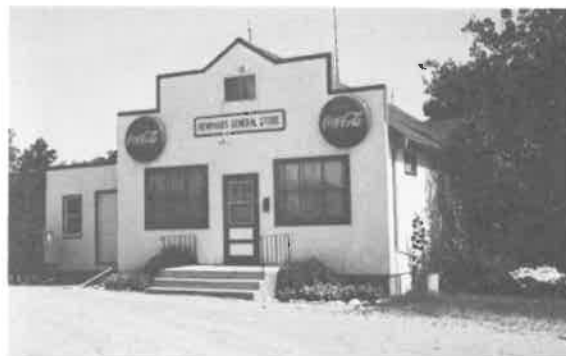
- 228) **Newman's General Store**  
**Construction Date:** ca. 1920  
**Location:** SW 19-16-8E  
**Present Owner:** Mr. Newman  
**Present Use:** Vacant  
**Construction:**  
    walls - stucco veneer on milled wooden frame  
    roof - asphalt shingles on milled wooden rafters  
**Integrity:** Unaltered  
**Condition:** Good  
**Notes:** This building is also discussed on page 105.

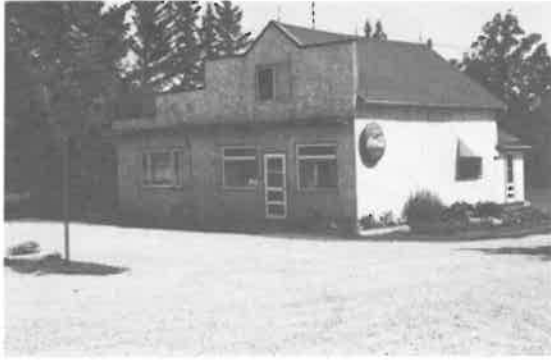
229) **General Store**  
**Construction Date:** ca. 1920  
**Location:** NW 18-16-8E  
**Present Owner:**  
**Present Use:** Vacant  
**Construction:**  
 walls - stucco veneer on milled wooden frame  
 roof - asphalt shingles on milled wooden rafters  
**Integrity:** Unaltered  
**Condition:** Good

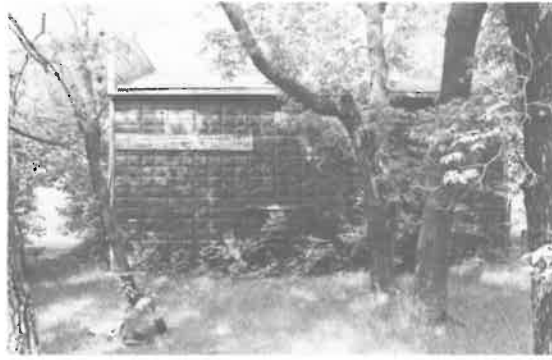
230) **General Store**  
**Construction Date:** ca. 1910  
**Location:** SE 3-15-4E  
**Present Owner:** M. Zelyk  
**Present Use:** Vacant  
**Construction:**  
 walls - pressed tin on milled wooden frame  
 roof - asphalt shingles on milled wooden rafters  
**Integrity:** Both interior and exterior have been altered.  
**Condition:** Fair

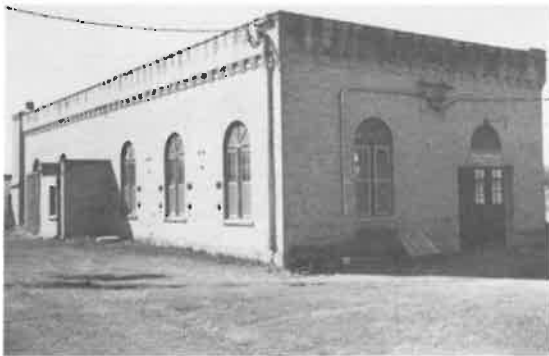
231) **Power Station**  
**Construction Date:** 1910  
**Location:** Lockport  
**Present Owner:** Department of Public Works  
**Present Use:** Functioning Power Station  
**Construction:**  
 walls - buff brick veneer on milled wooden frame  
 roof - built up roofing  
**Integrity:** Largely unaltered  
**Condition:** Good  
**Notes:** This building is also discussed on page 129.

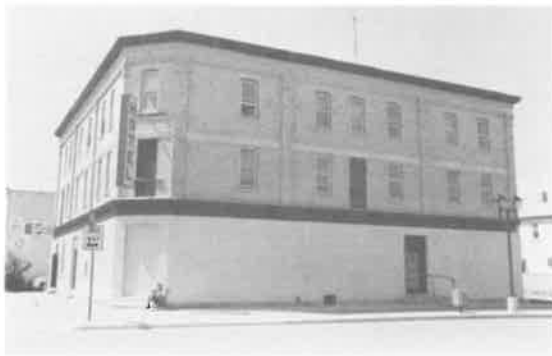
232) **Merchant's Hotel**  
**Construction Date:** 1903  
**Location:** Manitoba & Eveline, Selkirk  
**Present Owner:** Verna Konowalchuk  
**Present Use:** Functioning Hotel  
**Construction:**  
 walls - buff brick on milled wooden frame  
 roof - built-up tar and gravel  
**Integrity:** Both interior and exterior have been altered.  
**Condition:** Good  
**Notes:** This building is also discussed on page 114.

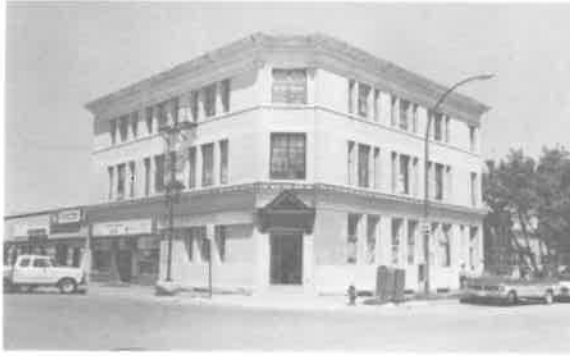
233) Former Dominion Bank  
 Construction Date: ca. 1900  
 Location: Manitoba & Eveline, Selkirk  
 Present Owner:  
 Present Use: Various businesses and offices  
 Construction:  
   walls - buff brick on milled wooden frame  
   roof - built-up tar and gravel  
 Integrity: Both interior and exterior have been altered  
 Condition: Good  
 Notes: This building is also discussed on page 114.

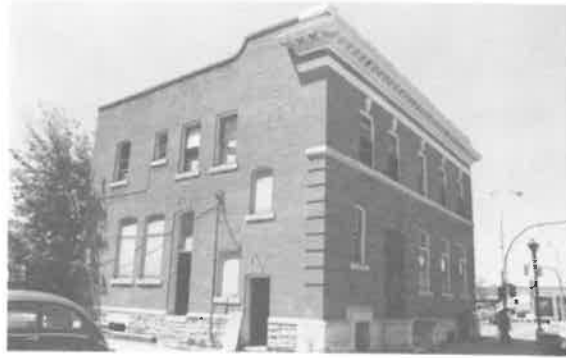
234) Former Custom's Office/Post Office  
 Construction Date: 1905  
 Location: Main Street, Selkirk  
 Present Owner: Town of Selkirk  
 Present Use: Vacant  
 Construction:  
   walls - red brick on milled wooden frame  
   roof - built-up tar and gravel  
 Integrity: Basically unaltered  
 Condition: Good  
 Notes: This building is also discussed on pages 110-111.

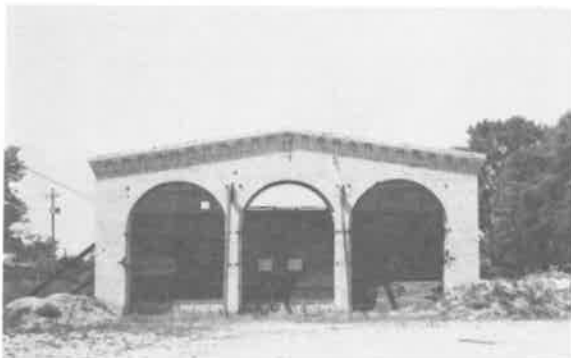
235) Rail Car Garage  
 Construction Date:  
 Location: Eveline Street, Selkirk  
 Present Owner:  
 Present Use: Church  
 Construction:  
   walls - buff brick cavity wall  
   roof - non-existent  
 Integrity: The roof has been removed and the walls are precariously supported  
 Condition: Fair  
 Notes: The building has recently been renovated to accommodate a church.

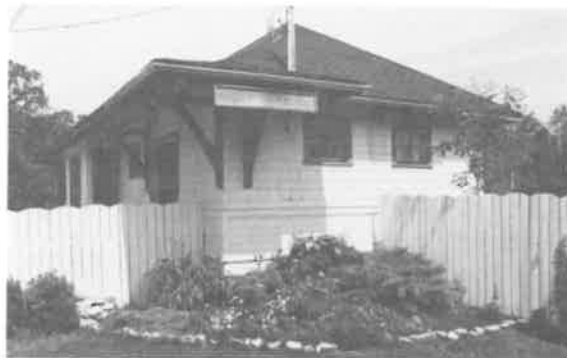
236) East Selkirk Rail Station  
 Construction Date:  
 Location:  
 Present Owner: Mr. R. Andryo  
 Present Use: Workshop  
 Construction:  
   walls - horizontal siding on milled wooden frame  
   roof - asphalt shingles on milled wooden rafters  
 Integrity: The interior has been much altered for its present function  
 Condition: Fair

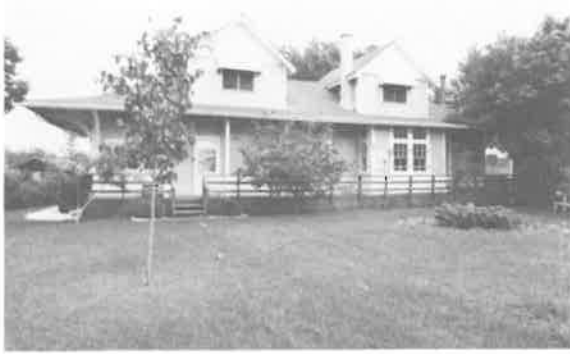
- 237) **Former Petersfield Rail Station**  
**Construction Date:** 1929  
**Location:** NE 23-15-4E  
**Present Owner:** Mr. Houghton  
**Present Use:** Residence  
**Construction:**  
 walls - horizontal siding on milled wooden frame  
 roof - asphalt shingles on milled wooden rafters  
**Integrity:** The interior has been renovated for its current function  
**Condition:** Good  
**Notes:** This building is also discussed on page 127.

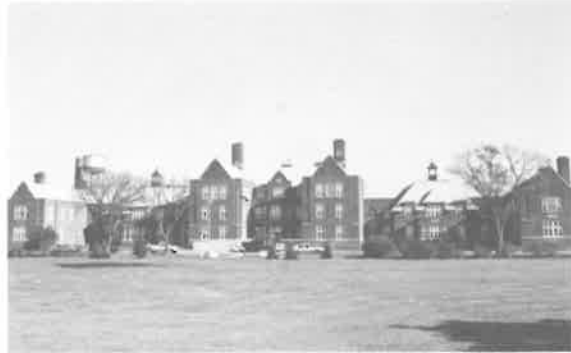
- 238) **Reception Hospital**  
**Construction Date:** 1922  
**Location:** Selkirk Mental Health Centre  
**Present Owner:** Selkirk Mental Health Centre  
**Present Use:** Functioning Hospital  
**Construction:**  
 walls - red brick veneer on milled wooden frame  
 roof - asphalt shingles on sloped surfaces; built-up roofing on flat surfaces  
**Integrity:** Largely unaltered  
**Condition:** Good  
**Notes:** This building is also discussed on page 113.

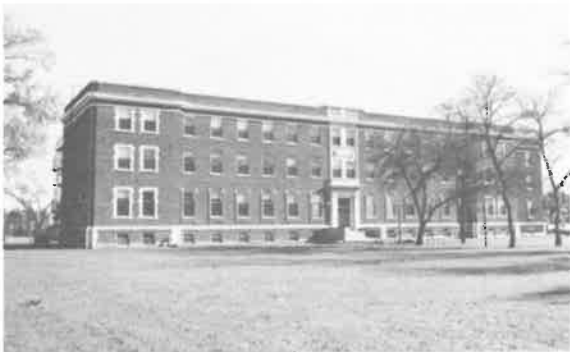
- 239) **Nurses Home**  
**Construction Date:** 1926  
**Location:** Selkirk Mental Health Centre  
**Present Owner:** Selkirk Mental Health Centre  
**Present Use:** Residential Facility  
**Construction:**  
 walls - red brick veneer and limestone details on milled wooden frame  
 roof - built-up roofing  
**Integrity:** Largely unaltered  
**Condition:** Good

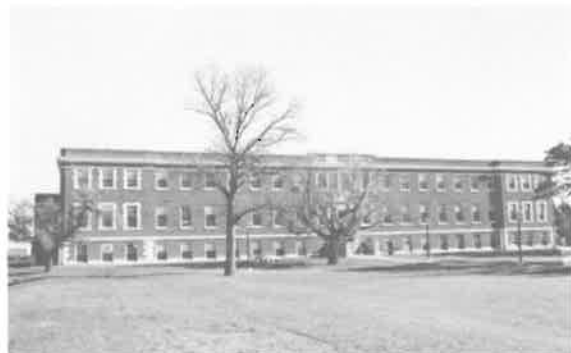
- 240) **B Unit Building**  
**Construction Date:**  
**Location:** Selkirk Mental Health Centre  
**Present Owner:** Selkirk Mental Health Centre  
**Present Use:** Residential facility  
**Construction:**  
 walls - red brick veneer and limestone details on milled wooden frame  
 roof - built-up roofing  
**Integrity:** Largely unaltered  
**Condition:** Good

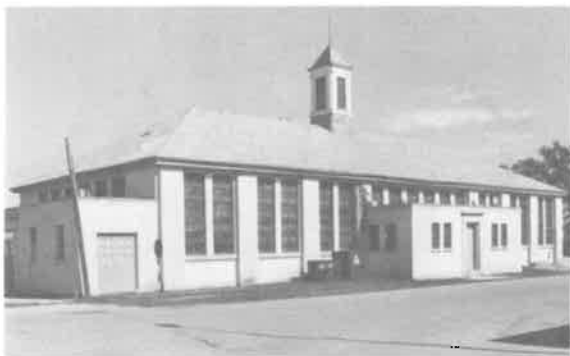
241) **Laundry Building**  
**Construction Date:** 1920  
**Location:** Selkirk Mental Health Centre  
**Present Owner:** Selkirk Mental Health Centre  
**Present Use:** Laundry facility  
**Construction:**  
 walls - stucco veneer on milled wooden frame  
 roof - asphalt shingles  
**Integrity:** Largely unaltered  
**Condition:** Good

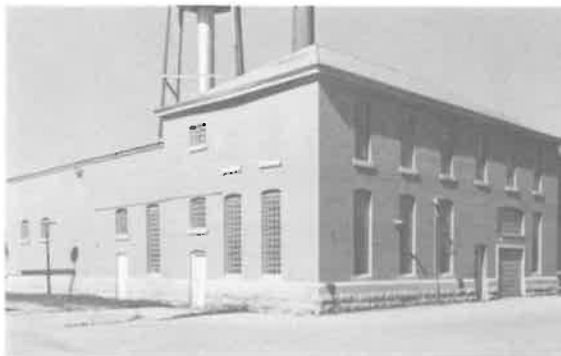
242) **Old Power House**  
**Construction Date:** 1921  
**Location:** Selkirk Mental Health Centre  
**Present Owner:** Selkirk Mental Health Centre  
**Construction:**  
 walls - brick veneer on milled wooden frame  
 roof - built-up roofing  
**Integrity:** Some window openings have been bricked in.  
**Condition:** Good

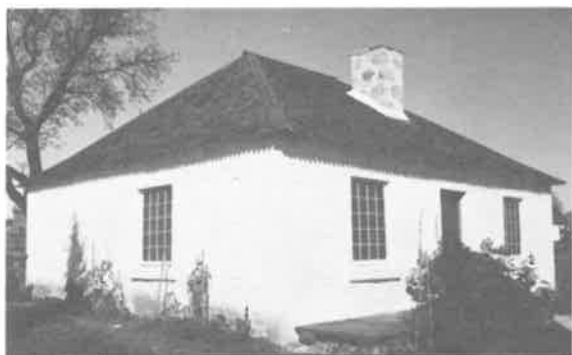
243) **Ross Cottage**  
**Construction Date:** 1840's  
**Location:** Lower Fort Garry National Historic Park  
**Present Owner:** Parks Canada  
**Present Use:** Display  
**Construction:**  
 walls - dressed fieldstone  
 roof - wood shingles on hewn timber rafters  
**Integrity:** The building has been carefully restored.  
**Condition:** Good

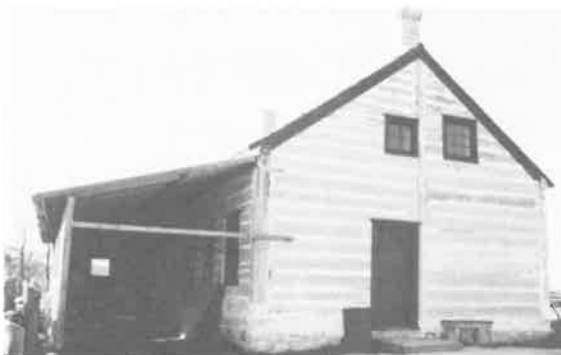
244) **Farm Manager's House**  
**Construction Date:** 1830's  
**Location:** Lower Fort Garry National Historic Park  
**Present Owner:** Parks Canada  
**Present Use:** Display  
**Construction:**  
 walls - Red River framed logs  
 roof - wood shingles on hewn timber rafters  
**Integrity:** The building has been carefully restored.  
**Condition:** Good

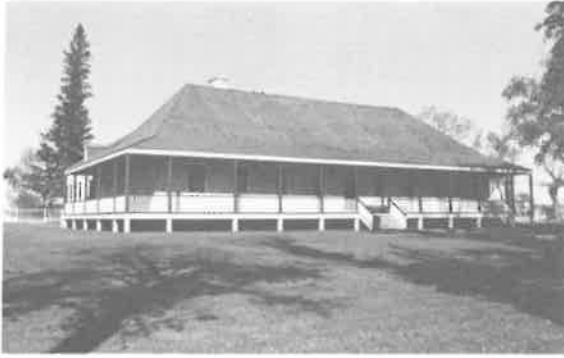
245) **Big House**  
**Construction Date:** 1831  
**Location:** Lower Fort Garry National Historic Park  
**Present Owner:** Parks Canada  
**Present Use:** Display  
**Construction:**  
 walls - dressed limestone  
 roof - wood shingles on hewn timber rafters  
**Integrity:** The building has been carefully restored  
**Condition:** Good  
**Notes:** This building is also discussed on page 32.

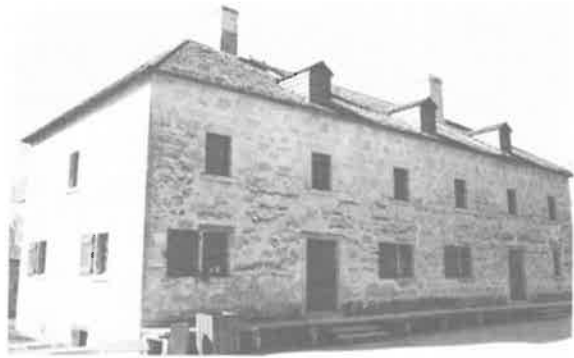
246) **Fur House**  
**Construction Date:** 1831  
**Location:** Lower Fort Garry National Historic Park  
**Present Owner:** Parks Canada  
**Present Use:** Display  
**Construction:**  
 walls - dressed limestone  
 roof - wood shingles on hewn timber rafters  
**Integrity:** The building has been carefully restored  
**Condition:** Good  
**Notes:** This building is also discussed on page 33.

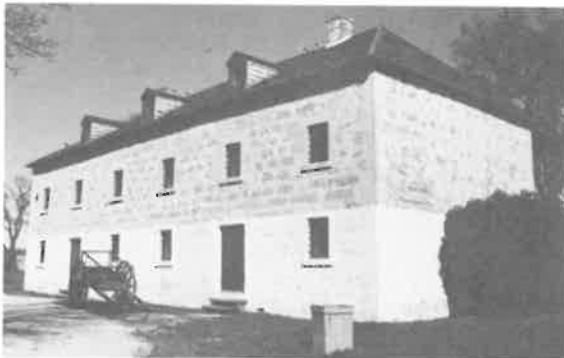
247) **Warehouse Building**  
**Construction Date:** 1830s  
**Location:** Lower Fort Garry National Historic Park  
**Present Use:** Display  
**Construction:**  
 walls - dressed limestone  
 roof - wood shingles on hewn timber rafters  
**Integrity:** The building has been carefully restored  
**Condition:** Good  
**Notes:** This building is also discussed on page 33.

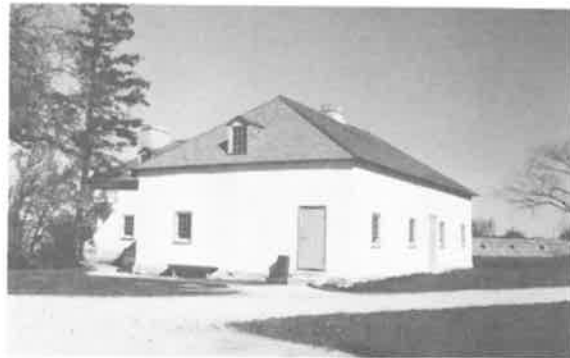
248) **Men's House**  
**Construction Date:** 1850s  
**Location:** Lower Fort Garry National Historic Park  
**Present Owner:** Parks Canada  
**Present Use:** Display  
**Construction:**  
 walls - dressed limestone  
 roof - wooden shingles on hewn timber rafters  
**Integrity:** The building has been carefully restored  
**Condition:** Good

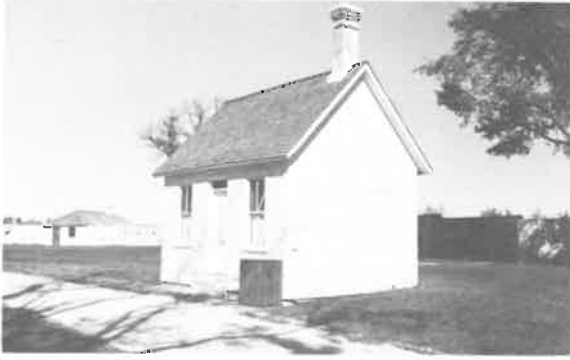
249) **Doctor's Office**  
**Construction Date:** 1885  
**Location:** Lower Fort Garry National Historic Park  
**Present Owner:** Parks Canada  
**Present Use:** Storage  
**Construction:**  
 walls - horizontal siding on milled wooden frame  
 roof - wood shingles on milled wooden rafters  
**Integrity:** The building has been carefully restored.  
**Condition:** Good

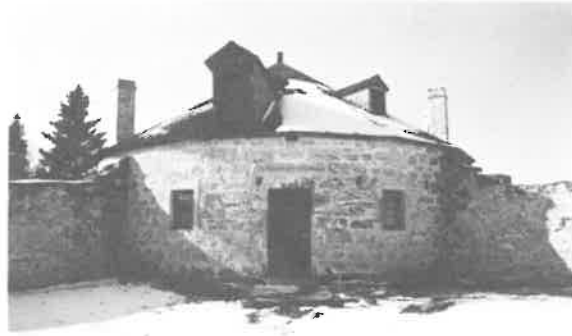
250) **Southwest Bastion**  
**Construction Date:** 1840s  
**Location:** Lower Fort Garry National Historic Park  
**Present Owner:** Parks Canada  
**Present Use:** Display  
**Construction:**  
 walls - dressed limestone  
 roof - wood shingles on hewn timber rafters  
**Integrity:** The structure has been carefully restored.  
**Condition:** Good

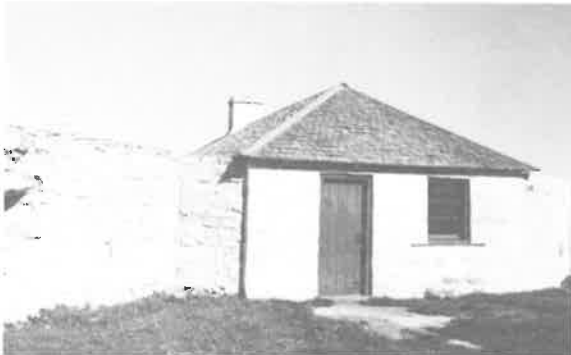
251) **Northwest Bastion**  
**Construction Date:** 1840s  
**Location:** Lower Fort Garry National Historic Park  
**Present Owner:** Parks Canada  
**Present Use:** Display  
**Construction:**  
 walls - dressed limestone  
 roof - wood shingles on hewn timber rafters  
**Integrity:** The structure has been carefully restored.  
**Condition:** Good
