ARCHITECTURAL HERITAGE

The Selkirk and District

Planning Area

David
Butterfield

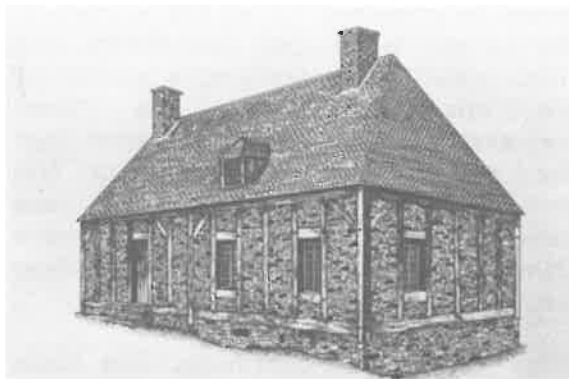
Plate 12. "Maison en columbage", a very common construction procedure used in New France during the seventeenth century (From: Building a House in New France, p. 24.)

Red River frame construction had its origins both in Europe and New France. Its forerunner, the "maison en columbage" of New France, popular from 1630 until the late eighteenth century, had been inherited from France (Plate 12).¹¹ The French

ancestor, "columbage Pierrote", was a medieval half-timbered house that was constructed using closely spaced wooden studs, the intervening spaces of which were filled with a mixture of mortar and stone. Transplanted to the extreme climate of New France, the mortar and stone mixture fared poorly and was eventually substituted with logs, a better insulator. Initially, these wooden inserts were, like the structural posts, vertical. However, this procedure also proved imperfect, as the vertical filler logs were not weathertight and shrank and warped over time, occasionally falling from the building. Soon short, horizontal members, joined to the posts in a tongue-and-groove manner, arose as the best solution.

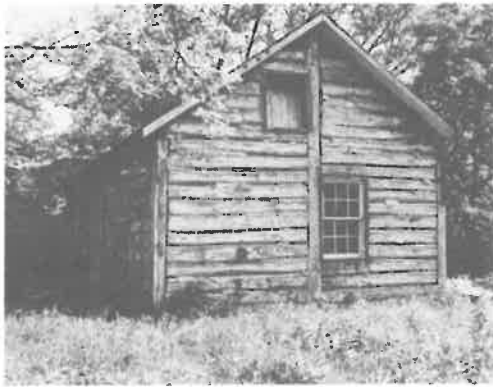
Plate 16. The former McDonald house.

indeed it once sat in the middle of that street before the Town of Selkirk was formed -- and was moved to Selkirk Park in 1965 (Plate 16). The Red River frame house was certainly built before 1865 and may date from the late 1850s. The structure was constructed by John and Sarah McDonald, English mixed bloods, who squatted on River Lot 48 before the area was surveyed. John McDonald was a freighter who travelled frequently to St. Paul while Sarah tended the farm and raised their ten children.

The building has been reroofed recently (it originally was thatched) and the interior has been altered, although

some elements of the nineteenth century remain. The poor condition of the log walls is actually the outcome of lean-to additions made many years ago. As these wood framed additions were affixed to the original Red River frame walls those originally exterior walls, with window and door openings, became interior partitions. Many of the openings were no longer required and were filled with short log members and plastered over. Only when the additions were removed, the building relocated and the plaster left to the elements did the original fenestration pattern re-emerge.

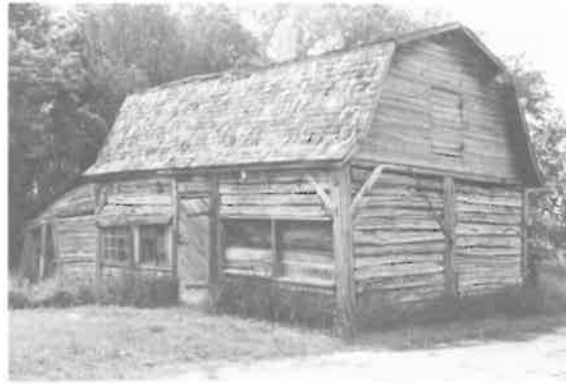
Plate 18. Kuhn barn, just south of Lower Fort Garry.

In addition to the McDonald house in Selkirk there are, of Red River frame, two barns in the planning area. The first of these is a 1920 recycling of the original timbers from a ca. 1860 barn (Plate 18). When part of the farm, near Lower Fort Garry, was sold after the turn of the century, the old, large Red River frame barn became impractical and was dismantled. Suitable vertical posts and horizontal filler logs were reclaimed and used in a smaller new barn, as were the original hand-forged hinges and locks (Plate 19). The original thatch roof of the old barn had long since been replaced by a wooden gable roof and in the new barn this was succeeded by a more modern gambrel.

A physical reconstruction of the original barn is not strictly possible. Local evidence and a knowledge of Red River frame traditions, though, can provide some sense of the original structure. Approximately ten metres long and five metres wide, the walls were comprised of horizontal logs set between uprights about two metres apart (Plate 20). Two large doors, on opposing sides of the barn, provided access for the ten cattle that were kept inside¹⁷. Three small windows on the south side lit the interior. The floor of the barn was covered with rough planking and the roof was likely thatched in the local manner.

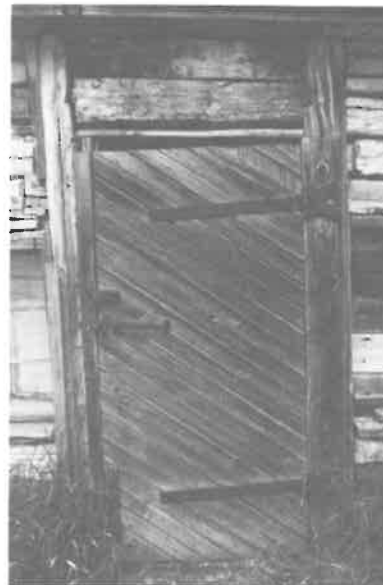
Plate 19. The original hand-forged locks and hinges were used on the reconstruction of the Kuhn barn.

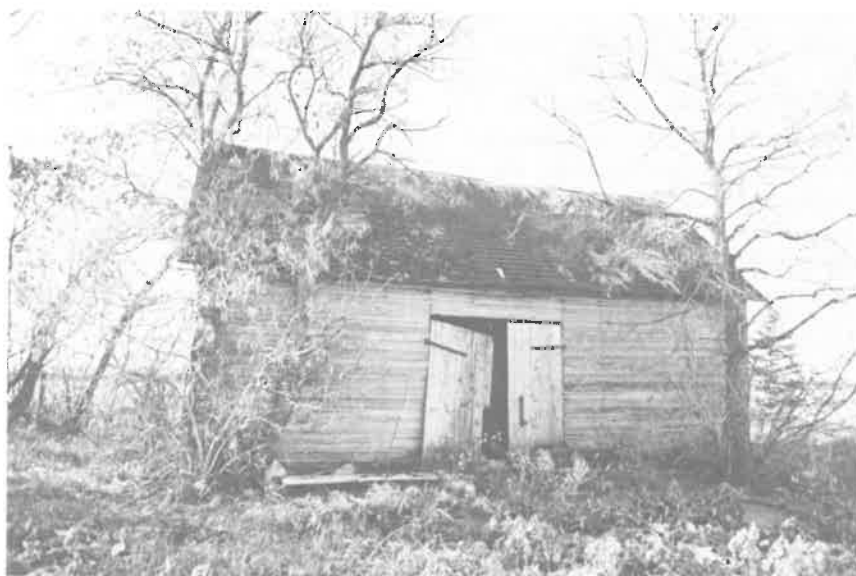
Plate 21. Red River frame barn at SW10-14-4E.

The second of the two Red River frame barns to be found in the area is a much more significant structure (Plate 21). Several factors suggest that this building, which was moved in the 1920s, may have originally stood in Lower Fort Garry. Its wall logs are oak, a much more durable wood than was typically used by farming settlers. Carefully cut beaded beams, often used in residential construction at the Fort, imply that the structure was built from components

Today the old barn is in poor condition, due in large measure to a deteriorated roof. The logs are protected by cove siding but several on the south side are, nevertheless, rotting. A number of trees are growing up beside the structure but do not appear to have heaved the rough stone foundation, which currently provides an adequate level support for the walls.

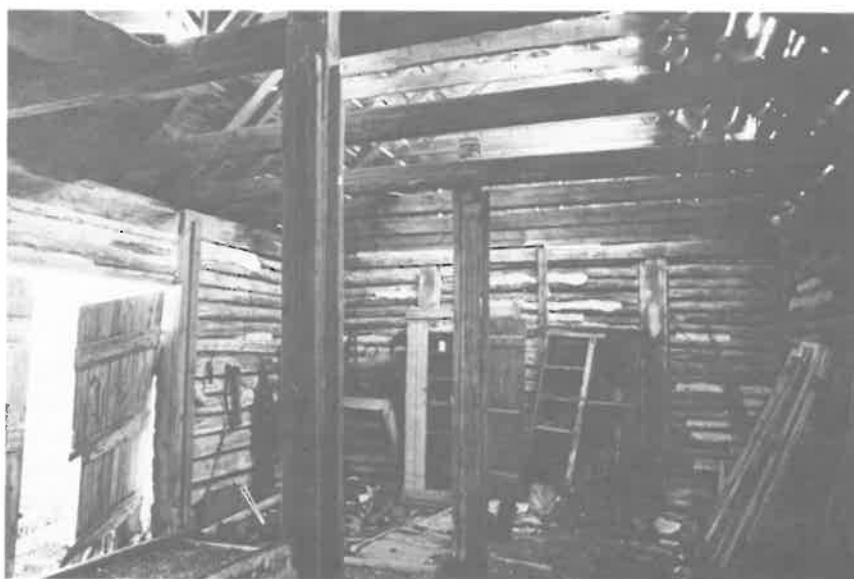
Plate 22. The interior of the barn at SW10-14-4E reveals the beaded beams and the differently finished wall logs -- the lower ones are squared, the upper ones are left rounded -- that suggest the structure was composed of pieces from several buildings.

scavenged from other buildings and may have been used in the Fort's yard for some utilitarian purpose. Most telling is the presence on two of the barn doors of hand-forged hinges and wrought nails, both very typical of the hardware used at the Lower Fort (Plate 22).

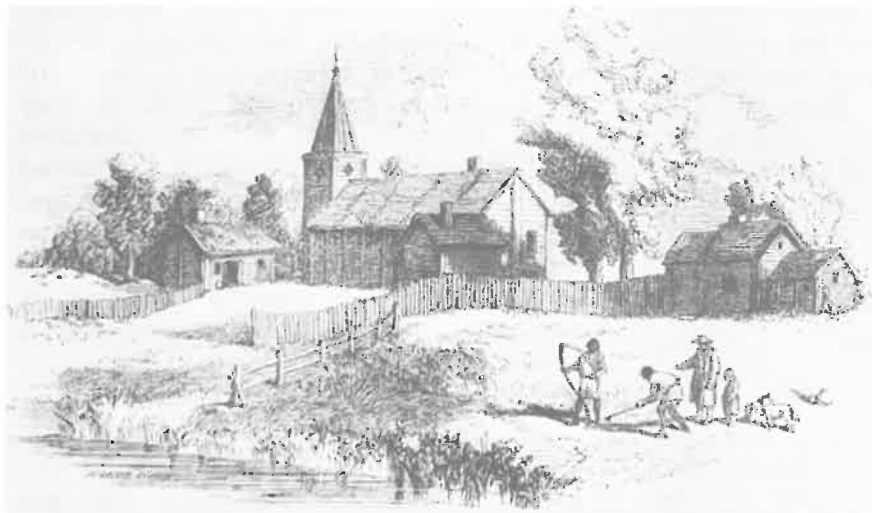
Plate 25. The Red River frame church and school at St. John's. (PAM)

The Red River frame church in the Parish of St. John's, south of the planning area, constructed by the Reverend James West, was of simple design (Plate 25). A bell tower of Red River frame construction was lit by diamond-shaped windows and topped with a steeple of hewn timbers. The

nave, covered with a thatched roof, was lit along its length by small windows set near the roof line and spaced according to the structural intervals. The school was considerably simpler but did have a vestibule and small addition at the back.

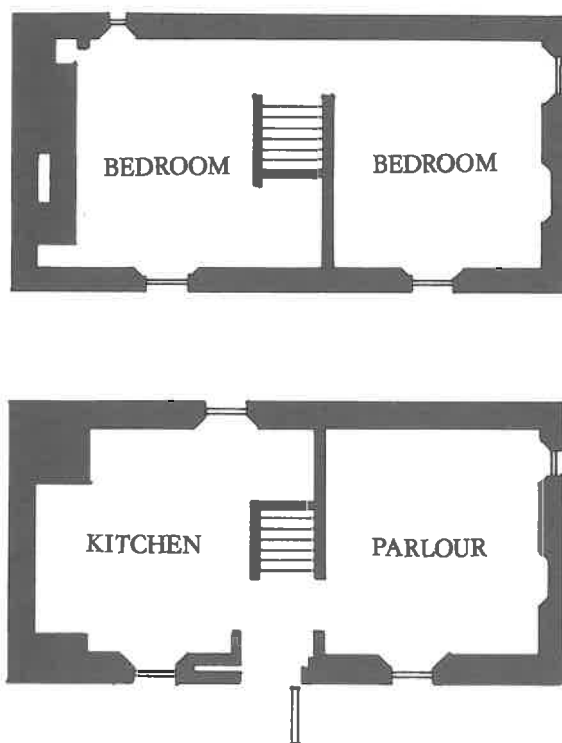
Plate 31. Plans of a typical laird's house.

gable or, occasionally, a hip roof. It was usually built of stone and lime mortar and was roofed with slate, pantile (a building slate with an "S" cross section), stone or, sometimes, thatch. Within the building a central staircase led from a small entrance vestibule to the upper floor (Plate 31). The two main rooms on either floor, which flanked the staircase, extended from front to back. A kitchen and parlour comprised the two ground floor rooms. Bedrooms were in the second storey and the attic was used for storage. Large fireplaces at either end of the building provided heat for warmth and cooking.

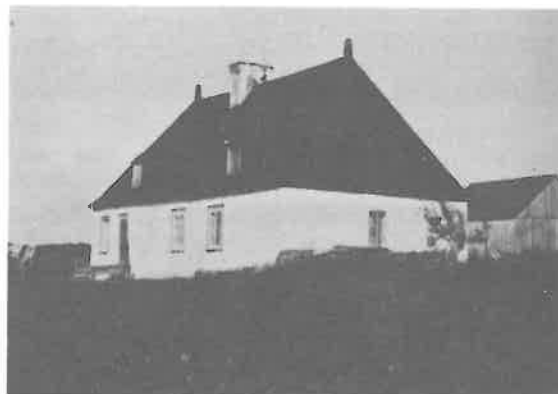
Plate 32. A typical Quebec stone house. (From: *The Old Architecture of Quebec*, p. 56.)

evident, but the basic nature of domestic stone architecture is common: an oblong building with low whitewashed walls, high pitched roof and a large stone chimney in the centre (Plate 32). A large attic occupied the tall roof, which was punctuated by small dormer windows. The main door was usually set off centre and opened into a large room, known as the "summer room", with a fireplace for cooking and, in the corner, a ladder to the attic (Plate 33). From the "summer room" a door lead to the elaborately decorated "winter room", used during the winter as family quarters but in summer as a state room for receiving distinguished visitors. Off the "winter room" might be located two small bedrooms for the parents; children slept in the cubicled space in the attic, also used as a storage space.

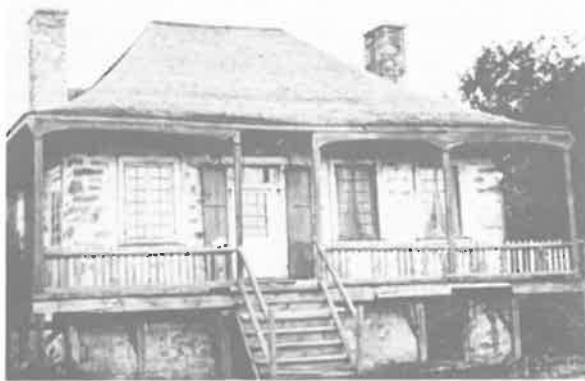
Plate 34. The distinctive bellcast roof and verandah of Quebec houses are evident here. (From: The Old Architecture of Quebec, p. 64.)

The construction of these houses relied on the great knowledge of skilled peasant carpenters and stone masons. Of particular interest was the construction of the roof; framed with heavy timbers, its mortised and tenoned joints were secured with long wooden pegs. Roofs of earlier Quebec houses did not have greatly extended eaves. Only later were they extended, to keep snow away from windows and the wall head, creating a distinctive bellcast shape (Plate 34).

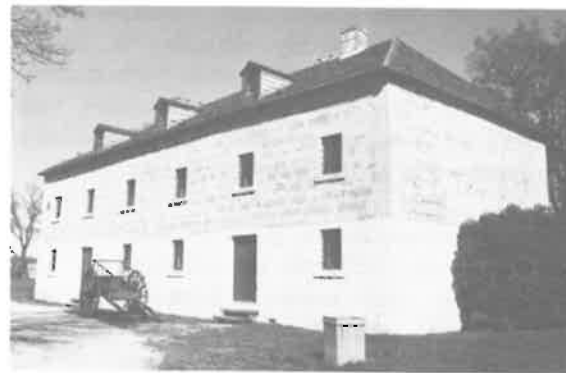
Plate 38. The Warehouse Building, almost identical to the Fur House on the other side of the yard.

More pervasive as an influence was the work of masons of English and Scottish origin. Two of the stone buildings at the Lower Fort, the Fur House, also built in 1831, and the Warehouse Building, of the same decade, are straightforward, unadorned buildings of excellent quality, without the light-hearted architectural sense of the Big House. They represent the first appearance of the typical "laird's house" in southern Manitoba (Plates 37 and 38). Other stone warehouses, now demolished, of similar nature were built in the early 1830s and were also large

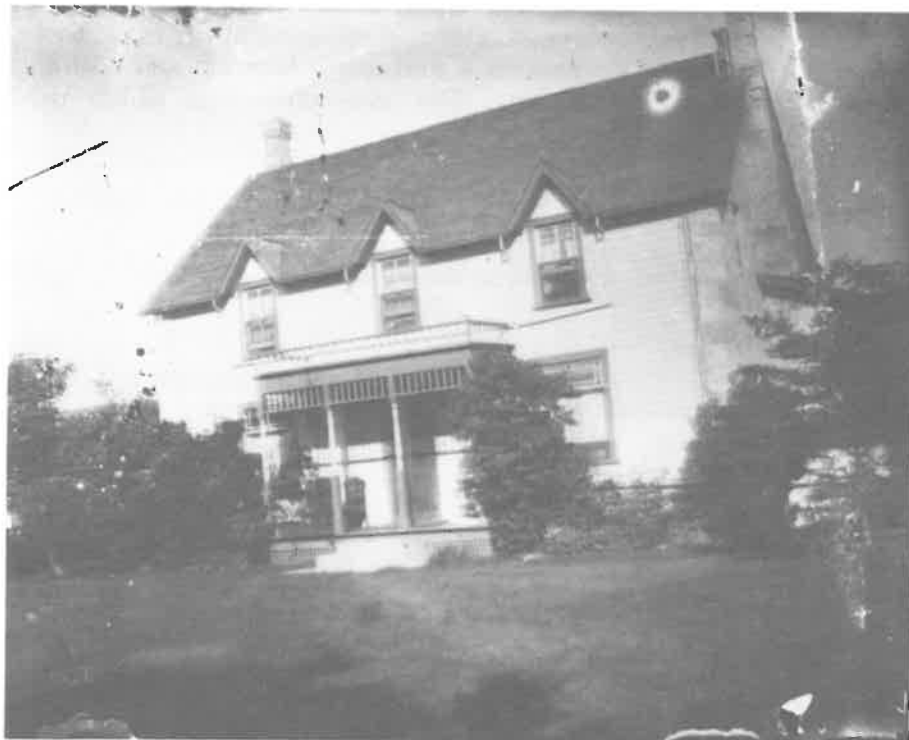
Plate 40. Firth house, also known as Hay house. (Courtesy: Mr. Rudi Isbach)

By the 1890s the house appears to have settled dramatically. It was purchased by several brothers from Winnipeg, the Mawsons, who undertook considerable stabilization work (Plate 40). The front stone wall was removed and replaced by a much lighter wood frame wall. All interior construction and finishes were removed and a whole new house, essentially, was built inside the three remaining stone walls. The new roof admitted three dormers on the riverside facade.

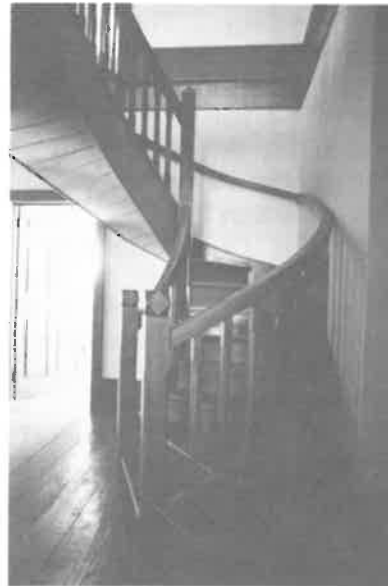
Plate 45. The staircase at St. Andrew's Rectory. (Courtesy: St. Andrew's Rectory National Historic Park, Environment Canada, Parks)

The old rectory has recently been restored to its former glory by the National Parks Branch and has been designated as a Federal Historic Site. The stone walls were carefully dismantled and rebuilt. The unusual doubly curved staircase that once graced the central hallway was reconstructed following traces of the original (Plate 45). The interior was

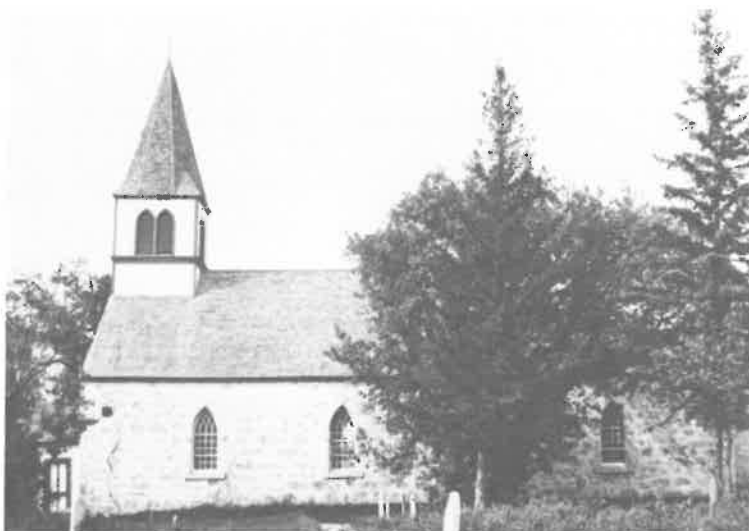
Top Left:
Plate 53. St. Peter's Anglican Church.

Bottom Left and Right:
Plate 54. Floor plan and cross section of St. Peter's Anglican Church.

Stones for the walls were lifted into place by block and tackle and set with mortar produced at a nearby kiln. Glass for the windows was shipped from Britain. Construction on the church was interrupted during the summer by the shortage of funds, provisions and masons. The eight metre long rafters had just been floated downriver, enabling the structure to be roofed by winter, but the church could not be completed until the following year (Plate 53). Various improvements were made during the ensuing years. A stone wall along the south side of the cemetery was torn down around 1875 and its stones used to construct a chancel and vestry, thus providing St. Peter's with the only proper chancel among the three Anglican stone churches in the settlement (Plate 54). The original tower, unsafe by 1880 was dismantled. The present wooden bell tower dates from 1904, the spire, a later addition.

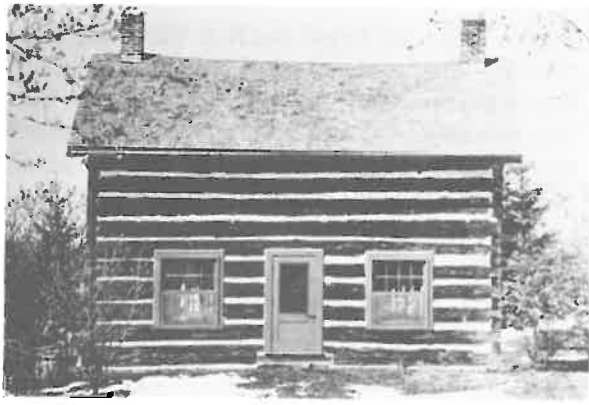
Plate 59. A typical log house in Ontario.

In domestic architecture, developments proceeded gradually, the initial structures typically of log construction. The simple log houses were usually small structures of rectangular form and simple plan. A formal front facade placed a door in the centre with a window at either side (Plate 59). The walls were connected at the corners with dovetail or saddlenotch joints.

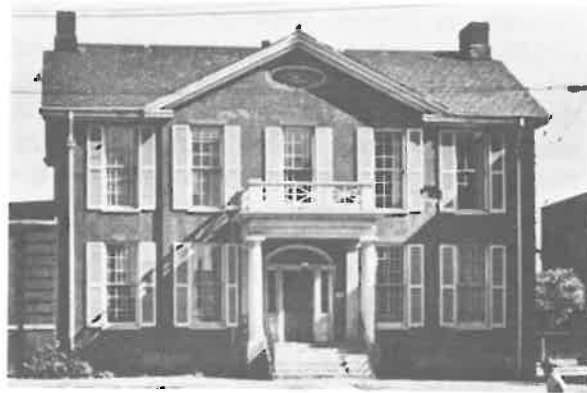
Plate 61. The central plan of Georgian houses is evident in this Toronto house, but here is modified by Neo-classical features. (From: The Ancestral Roof, p. 39.)

pediment became an identifiable feature that interrupted the otherwise powerful expanse of the Georgian roof slope (Plate 61). Pilasters and narrow shutters were often used to enliven the facade.

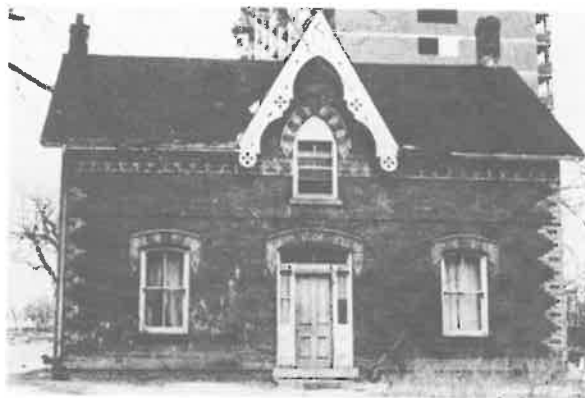
Plate 62. An example of the influences of the Gothic Revival around 1875, here in Etobicoke. (From: Gothic Revival in Canadian Architecture, p. 143.)

The first signs of the Gothic Revival were superficial and had little effect upon the basic scheme of the Georgian house; onto a symmetrical facade was added a simple small gable above the central door with a decorative pointed window providing light to the second floor hall. Not until the 1850s was the vertical, detail-rich sense of the Victorian Gothic embraced. The central gable, pointed windows and fantastic mouldings of Gothic inspiration finally conspired to produce the most common expression of the style (Plate 62).

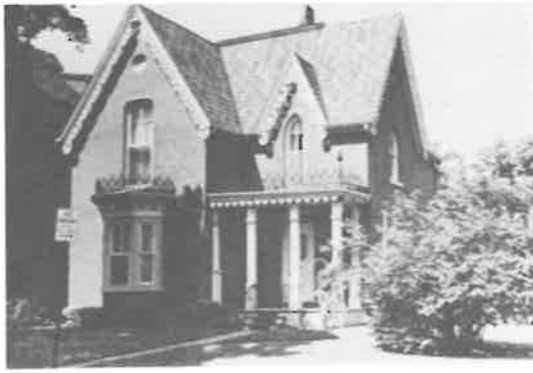
Plate 63. An L-shaped plan gives this 1875 Gothic Revival house in Hamilton variety and a sense of the picturesque. (From: Gothic Revival in Canadian Architecture, p. 149.)

The high Victorian Gothic of the late nineteenth century in Ontario -- that most fashionable at the time when migrants began moving west -- was more picturesque. One important characteristic of these new houses was the development of an asymmetrical plan, often an L- or T-shape that produced an interior arrangement with sitting rooms in either wing (Plate 63). In addition, the flexibility of the plan allowed a 1 1/2 storey structure to contain the same number of rooms as a

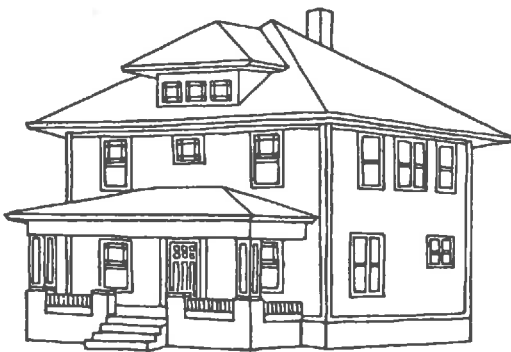
Plate 64. An example of the American Four Square.

During the latter half of the nineteenth century a sturdy house of square proportions, symmetrical facade and with a shallow hipped roof gained popularity throughout mid-western North America. Known as the Four Square, such houses were very popular in both urban and rural circumstances

(Plate 64). In town such a building was often the object of more detail application than its counterpart in the countryside. These commodious houses were able to accommodate the spatial requirements of a large family; in the countryside the Four Square was often designed with separate rooms and entrance for servants or labourers. This house type gained widespread appeal through the marketing strategies of large department stores and lumber yards, which provided catalogue designs and, occasionally, prefabricated houses.

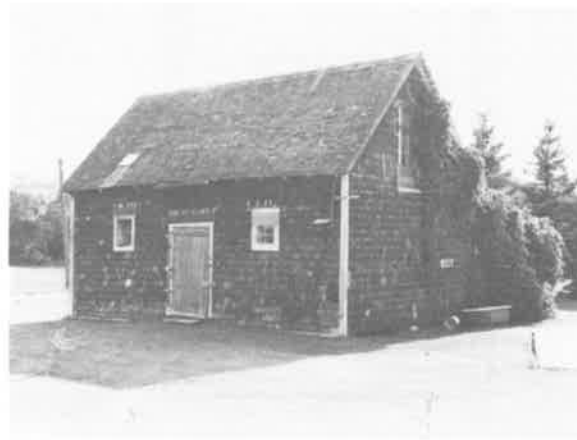
Plate 70. Hawkins house at SW12-17-3E, a typical log structure of the 1880s within the planning area.

Plan considerations for such structures were minimal (Plate 70). Often two ground floor rooms -- one for cooking and one for family activities -- were separated by some partition, perhaps of log, sometimes merely of fabric. A staircase might control the location and size of rooms (Plate 71). If an upper floor existed it was often open and used for sleeping and general storage.

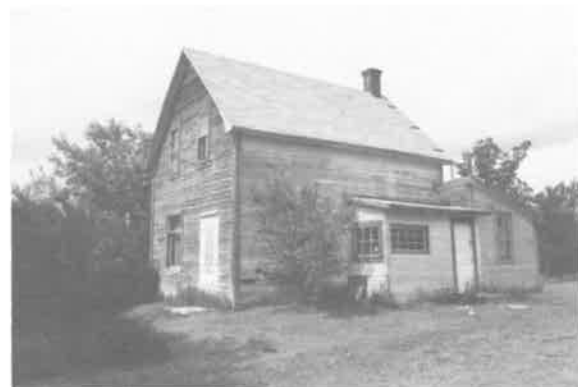
Plate 73. Former MacArthur house, near Little Britain.

back of the hall and parlour. A good remaining example of such a structure is the former MacArthur house near Little Britain (Plate 73). In this case the formal entrance (in many houses rarely used) is on the right side. A parlour to the left and a dining room and kitchen behind describes the familiar side hall plan (Plate 74). As

was typical for such structures the kitchen is located in a shed-roofed portion at the back. Often the construction of such a shed preceded the erection of the larger house (Plate 75). The family lived in the smaller structure and when the new house was built onto it, this shed was relegated to a kitchen, workshop or storage function. A seam between the shed and main structure of the former MacArthur house suggests that this may have been the case here.

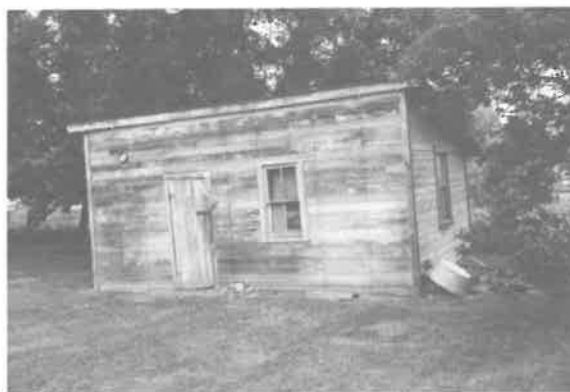
Plate 75. A shed-roofed structure like this one near Gonor was often used as an initial shelter by pioneers.

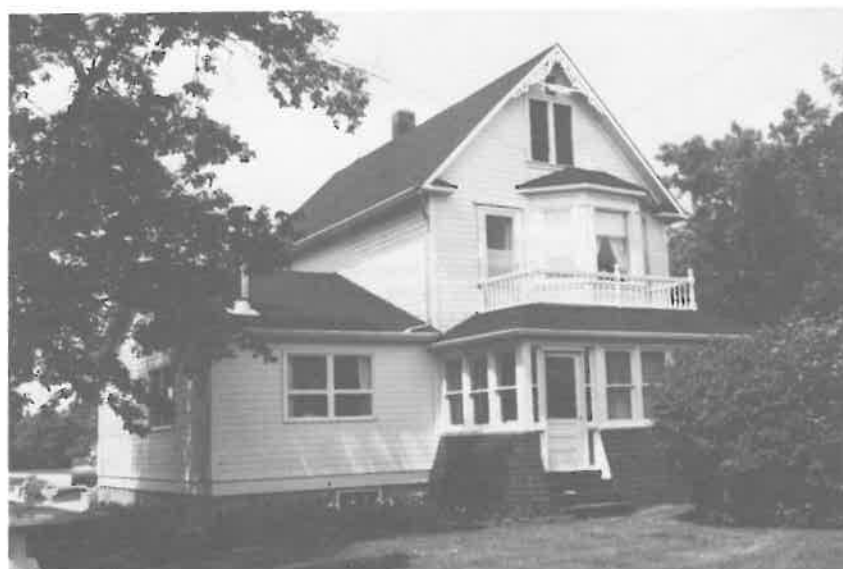
Plate 76. This side hall house, just north of Little Britain United Church, was treated with several details, including bay windows, a verandah, window surrounds and a small delicate bargeboard.

The asymmetrical and vertically massed front facade, often an austere surface when built by those of limited means, was given considerable variety by others, incorporating Gothic Revival details, elaborately carved bargeboards or an elegant verandah (Plate 76). Windows, especially those at the front, were also frequently accorded attention and, with coloured glass arranged in imaginative designs, could provide a show of elegance, even prestige (Plate 77).

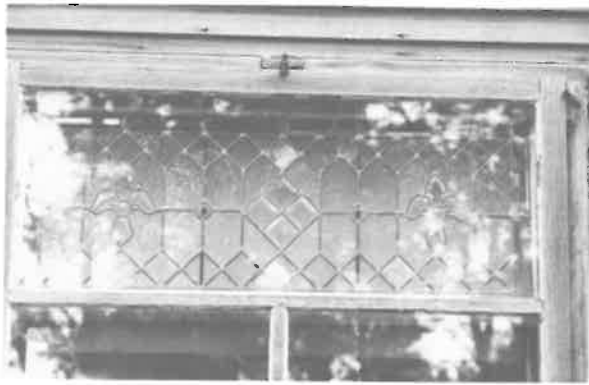
Plate 77. A selection of window designs that were used to dignify the rather plain faces of typical side hall houses.

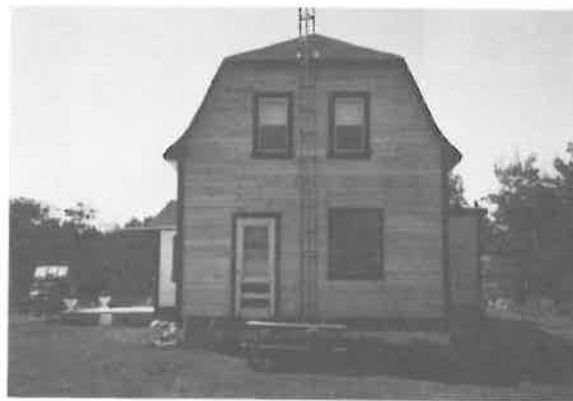
Plate 78. The hipped gambrel roof on this house is distinctive.

Occasionally in the planning area the side hall plan was transformed by an unusual roof treatment. One notable example of such an approach is to be found at NE18-14-6E, where a hipped gambrel roof was used (Plate 78). The typical stark facade is here lightened by the interesting nature of the roof.

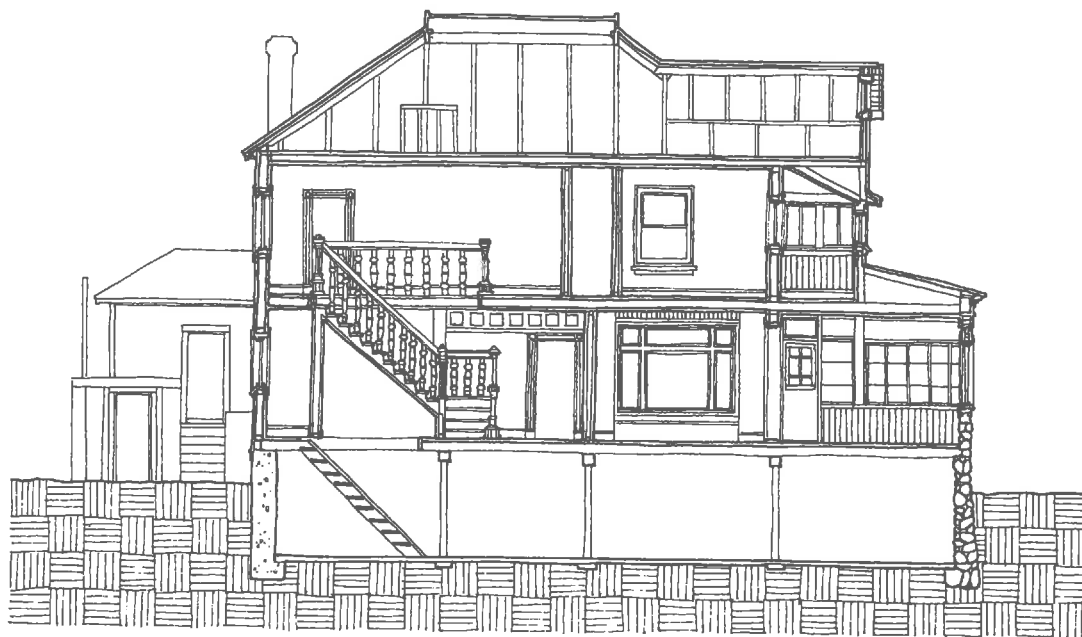
Plate 84. Cross section A-A of the former Summerscales house.

the Four Square house and is oriented to the south on a central plan, it stands firmly apart from others of its type (Plate 83). A broad enclosed verandah overlooking the Red River and an open verandah on the south side, carefully crafted dormer windows and a subtle range of window shapes and designs lifts this house above the vernacular Four Square. However, it is its rich interior that truly separates this house from almost any other of its age in the planning area (Plate 84). The plan itself is a careful balance of spaces, with small parlours at the front and dining room and kitchen at the back. The carefully turned and joined woodwork of the entrance foyer, the numerous staircase details, the window and door casings, baseboards, wainscotting and decorative plaster are

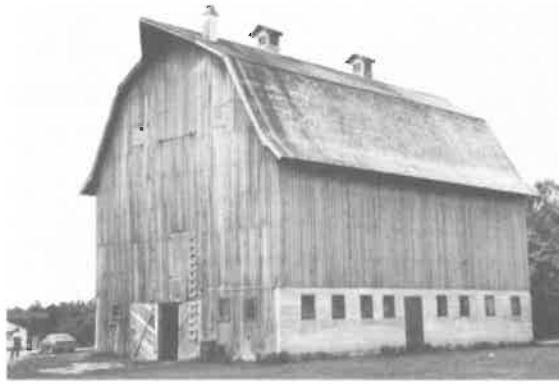
Plate 89. Cross section A-A of the Overwater barn. The loft floor is unnecessarily strong, built of two layers of 40x200s.

time-honoured traditions of the Ontario barn -- a fieldstone stable, a huge loft composed of a majestic network of timbers -- were often only met halfway, perhaps in the stable plan and with some of the construction procedures. Certainly there must have been a few early barns with both the distinctive loft construction and stable plan. Remnants of a fieldstone stable standing near the south access of River Road may have been such a building. But today only the old Overwater barn, also off River Road, conveys any sense of an Ontario heritage (Plate 87). The foundation and stable walls are of fieldstone but the longitudinal aisle plan, the gambrel roof and the light wood framework of the loft make this a building of the modern era (Plates 88, 89 and 90).

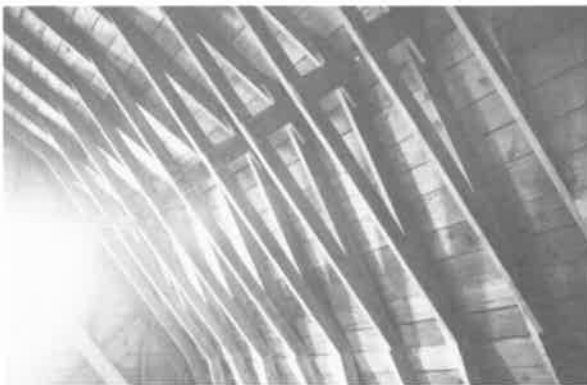
Plate 88. Detail of typical rafter construction in a gambrel-roofed barn.

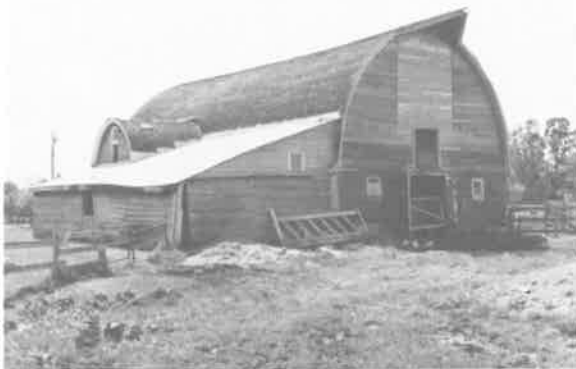
Plate 96. Jenkins barn at SE8-14-4E.

SE8-14-4E, with a giant vaulted loft, was especially common (Plate 96). The same longitudinal plan as the Overwater barn (by now of great popularity for dairy cattle production) is in this case even more streamlined. The Jenkins barn is also distinguished by the elimination of monolithic stable walls, relying instead upon a continuation of the wood frame structure to enclose the stable area (Plates 97, 98 and 99). In the loft the smooth contour is created with built-up profiled planks that constitute the main structural members.

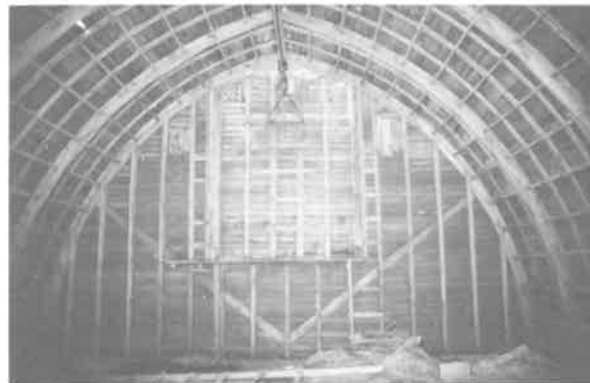
Plate 98. Detail of typical rafter construction in a vaulted loft.

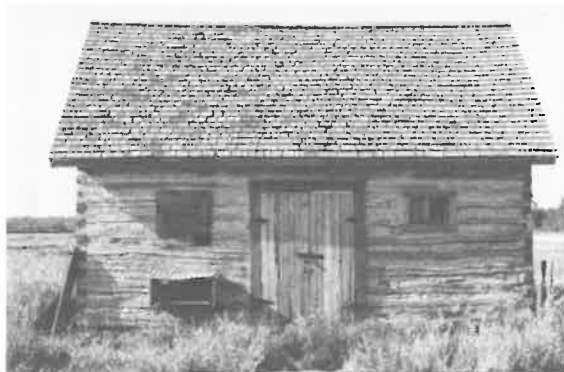
Plate 100. Husluk log granary at NE24-17-3E.

The popularity of cereal crops in the West required the introduction of some form of large-scale grain storage. Before the advent of large, complex threshing machines, most farmers thrashed their grain in the barn (typically in the loft) and grain bins would be located in the barn itself. The first small isolated structures used to store grain were often constructed of roughly hewn and hastily joined logs, chinked to prevent loss of grain through the cracks (Plate 100).

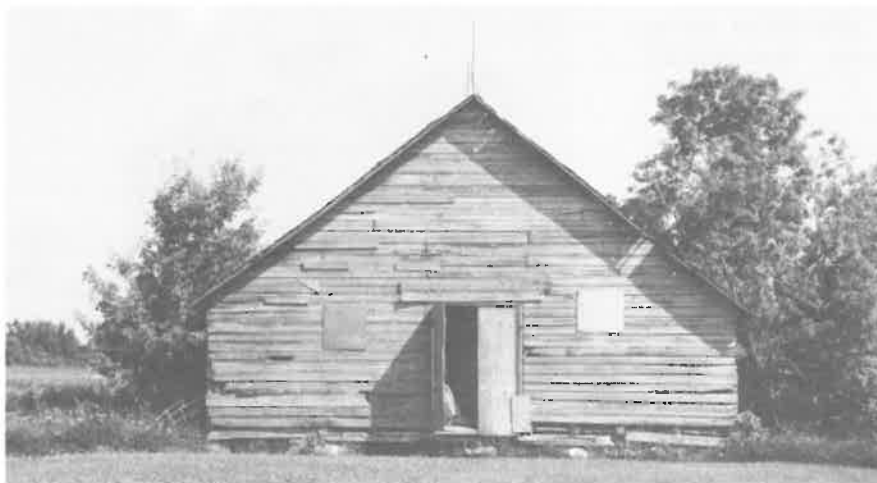
Plate 101. Allison granary at NE12-17-3E.

While these wood-framed structures were certainly an improvement over their log predecessors, the actual grain handling procedure remained labour intensive. For example, grain bags were manually deposited in a granary at NE12-17-3E which, unlike contemporary structures, did not have a central alley into which a wagon could be driven (Plates 101 and 102). Only with the introduction of

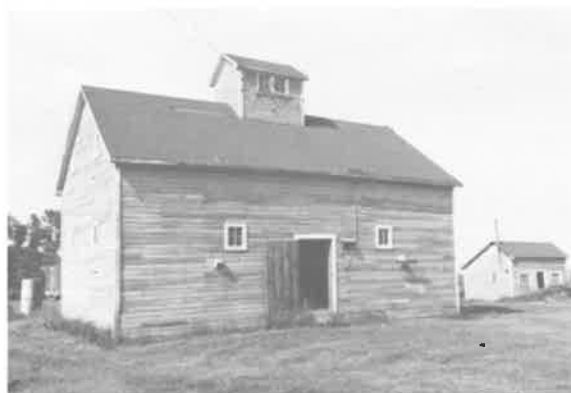
Plate 103. Macklin elevator at SE1-15-4E.

A small grain elevator at SE1-15-4E is one of only three remaining in the planning area (Plate 103). A central corridor separates the building into two basic storage areas, each subdivided into bins (Plate 104). The bin walls were cribbed; that is, they were built of 40 x 80s stacked atop one another to create a strong solid wall (Plate 105). A series of chutes, pipes and spouts permitted grain to be transferred, via the distribution box, from bin to bin or from bins to wagons or trucks waiting outside the building.

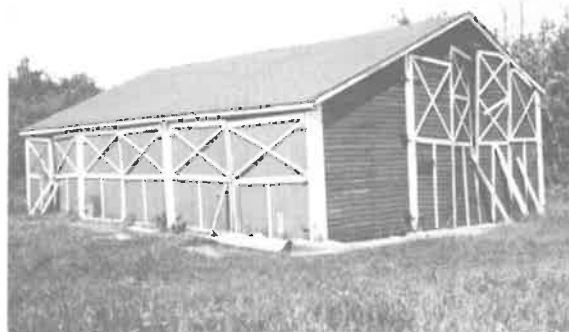
Plate 106. Log machinery shed, SE34-13-3E.

Farm equipment, like agricultural produce, required storage facilities with specific forms and functions. These simple storage buildings were usually plain in appearance, differentiated from each other only by the form and detail requirements of the specific machinery stored. For instance a simple log structure at SE34-13-3E exhibits the tall doors necessary for a threshing machine to enter (Plate 106). Wood-framed buildings, similar in proportion and fenestration to log buildings quickly replaced the rougher structures. Ever larger frame structures were built to house the growing numbers and size of machines needed on the farms of the late nineteenth and early twentieth centuries. Whereas previously a number of small sheds were frequently found scattered on a farmyard, it became increasingly common to store three or four pieces of equipment in a single, large building instead (Plate 107). A very interesting building, at NE2-16-3E, not only provided space for several pieces of tillage equipment in the angled wings, but also housed work crews in its central portion (Plate 108). A shed type of apparently local inspiration was built in the northeastern parts of the planning area. Tall and long, these buildings accommodated cattle and feed storage in one half with the other half reserved for machines (Plate 109).

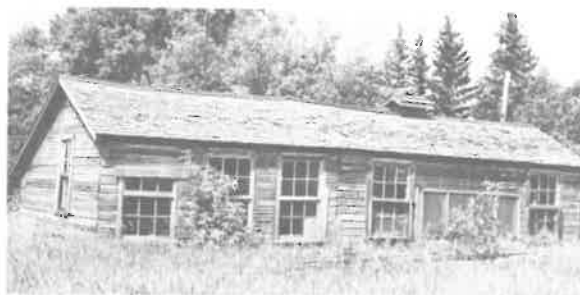
Plate 111. Chicken coop at SE22-16-3E.

A chicken coop at SE22-16-3E is representative of the few coops left in the planning area (Plate 111). The window wall on the south side provided excellent light conditions inside. A vent permitted foul air to escape through the roof. The interior of this building featured the nests, roosts and runs of a well-planned operation.

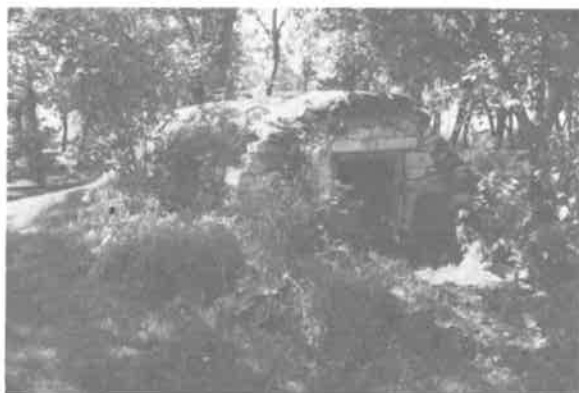
Plate 112. Root cellar at SE2-13-5E.

planning area several cellars of distinct construction and form were built on the farms on the east side of the Red (Plate 112). A vault created with roughly cut fieldstones ensured a cool dry environment (Plate 113). A milk cellar near the southern access to River Road, also of stone construction, is given some pride of place with its neat stonework and little gabled roof (Plate 114).

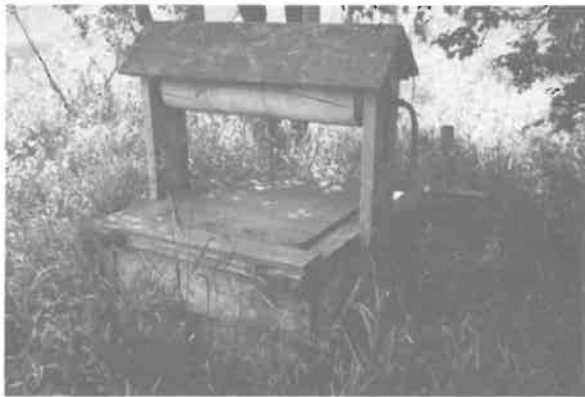
Left:
Plate 115. An old well head.

Before the advent of indoor plumbing, water and toilet facilities were located outside. A well was an important, albeit small, feature on the farmsite. A few original well heads still exist in the planning area and, like that at SE24-13-3E, are utilitarian but effective pieces of work (Plate 115). Outhouses, or necessities as they might more politely be called, were also lost with twentieth century improvements. These little buildings were simply constructed with a wood frame of 40 x 80s, sheathed with drop siding and covered with a pitched roof (Plate 116). The roof could be decorated (although in this case it is not) as could the window openings above the door or on the side.

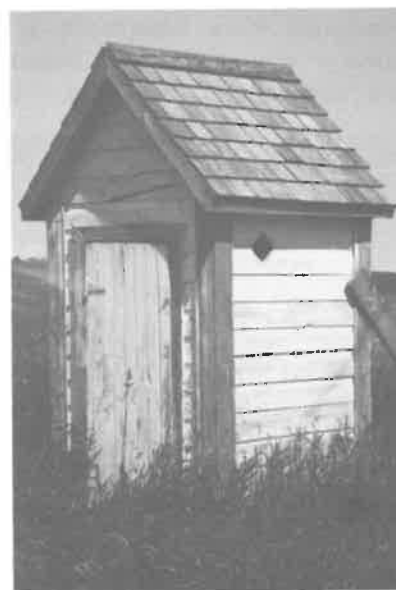
Bottom Right:
Plate 116. This outhouse is vented on its side through a tiny diamond-shaped opening.

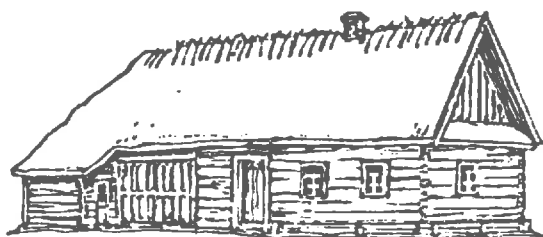
Plate 121. A typical Galician folk house.

Galician houses displayed the familiar influences of northwestern Europe (Plate 121). Most Galician houses had only two rooms and a simple gable or hipped gable roof. Rarely did they have the prominent overhang of the Bukovynian houses and their use of eave brackets was less common and always less pronounced. Galician houses were not without distinctive elements, however. The buildings with gable roofs frequently had on each gable end, at the eave level, a distinctive pent extension to protect the plaster from rainwater damage. The gable itself was not plastered, but was generally filled with vertical weatherboards; sometimes decoratively carved.

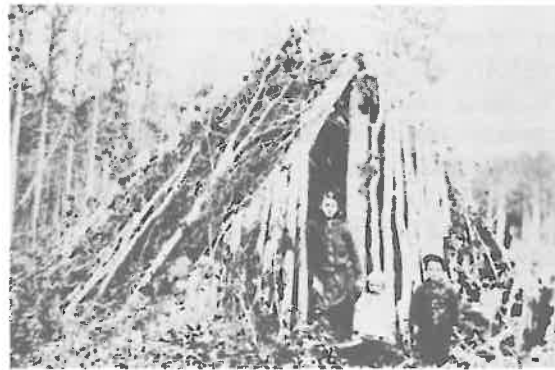
Plate 122. A "budah".

The careful traditions of their homeland were of little use to the settlers in their first year in Manitoba. Initial shelters built by those who arrived early in the year were of a temporary nature and were typically occupied for a month or so while more substantial structures were built. Such shelters, known as "budahs" or "zemliankas" were usually crude one-room huts, simple lean-tos or tipis built of small trees and branches (Plate 122). If the settlers arrived too late in the season to construct a proper house, a slightly more substantial pit shelter would be built in which to pass the winter. Given the temporary aspect of these initial structures it is not surprising that none have survived in the planning area.

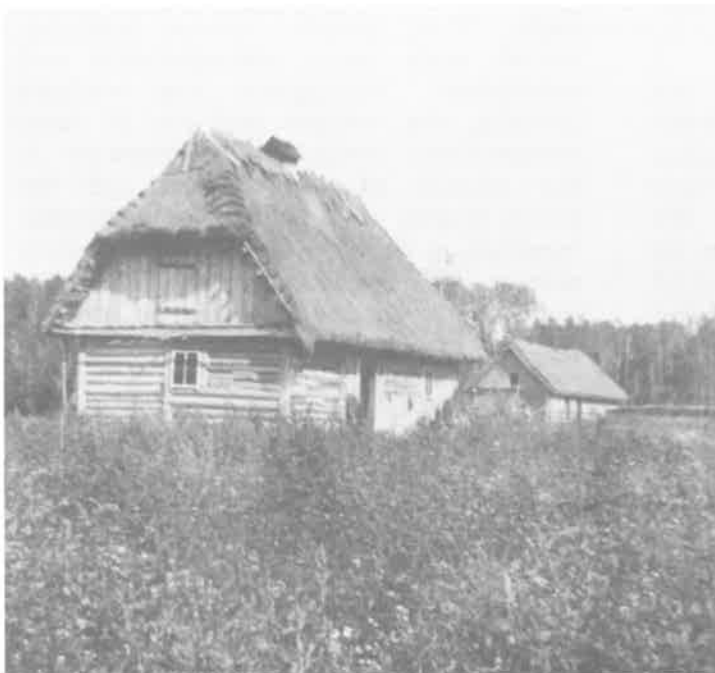
Plate 123. Early Ukrainian log house.

The walls of these early homes were usually built of slender unpeeled poplar logs (Plate 123). The corners were secured with crudely fashioned dovetail joints or the simpler and thereby more popular saddlenotches. The roofs were either stacked with grass or roughly thatched. Depending on the care with which it was constructed, and the economic progress of the settler, an early home such as

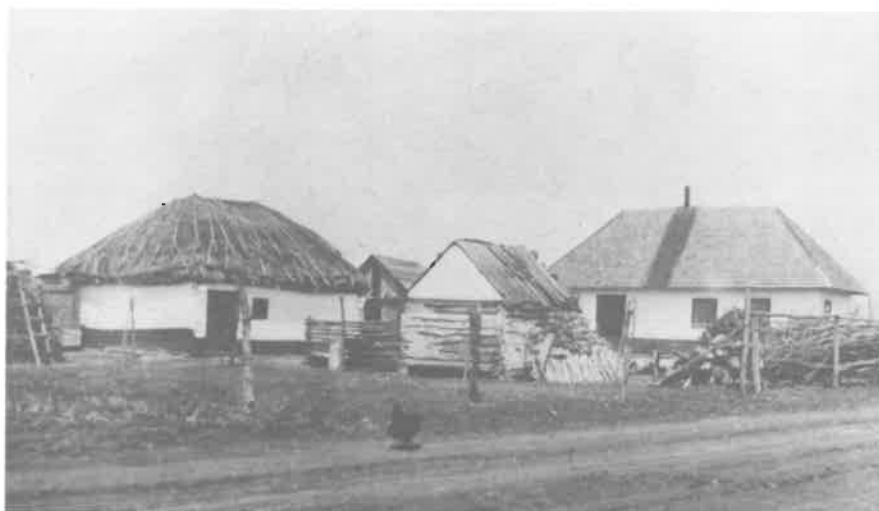
There are at least four traditional Ukrainian folk houses in the planning area: three Galician and one Bukovynian. Unfortunately two of the Galician houses are in poor states of preservation. And yet the poorest of these is one of the most interesting specimens of building construction in the area. Built on the east side of the Red, within the Ukrainian enclave that settled around the turn of the century, the former Arnsey house is now a ruin (Plate 124 and number 54 in the Selected Inventory). The house reflects Galician planning concepts but was, and is, covered with a hipped roof, more typical of Bukovynian houses (Plate 125).

Plate 124. Former Arnsey farmstead. The present building is on the right, its pioneer precursor on the left. Since this photograph was taken the front wall of the later house has been removed and the structure is collapsing.

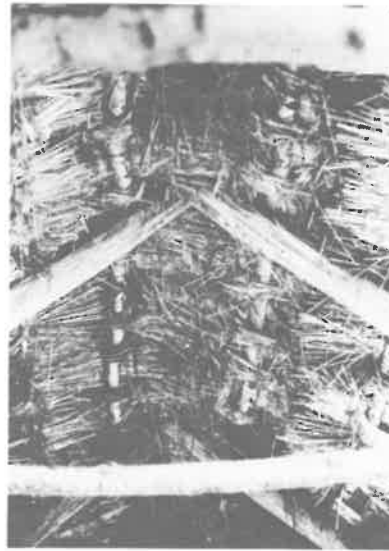
Plate 126. Thatch procedure likely used on the former Arnsey house.

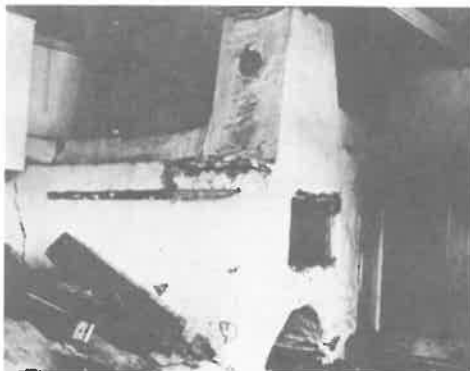
in this structure suggests that there was attention to decorative elements as well. Painting probably enlivened the exterior and religious and family objects likely hung in the "velyka khata". Of course, none of this survives, nor does the "pich" that was replaced with a stove (Plate 127).

Plate 127. A "pich" like this was once in the former Arnsey house.

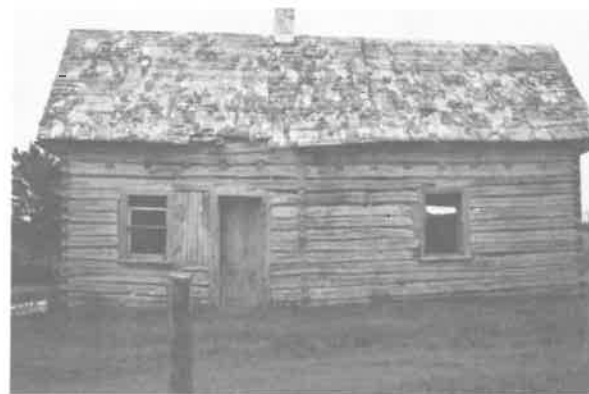
Plate 128. Ukrainian house at NW33-16-4E.

Both of the other Galician houses exhibit the traditional plan with a gable roof and a pent extension (Plates 128 and 129). The Yakabowski

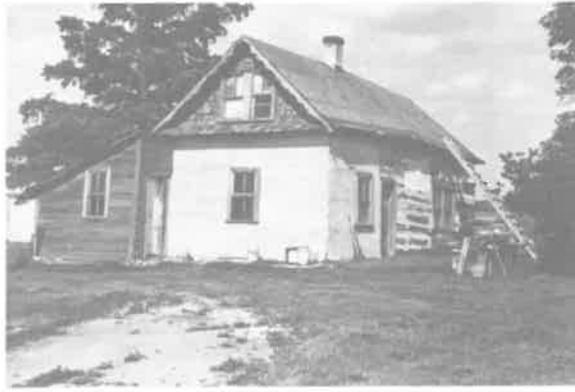
Plate 129. Yakobowski house at NW12-17-3E.

house, the more interesting of the two, features decorative shingling in the gable end and rippling bargeboards -- traditional features -- that enhance the building's charm.

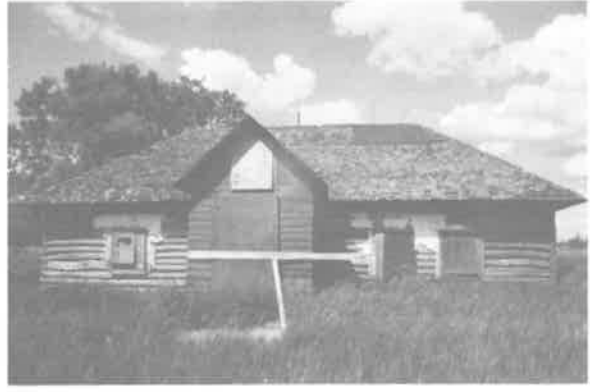
Plate 130. Ukrainian house, clearly of Bukovynian tradition.

The sole Bukovynian house left in the planning area was built around 1925 (Plate 130). The three room plan, the projecting "siny" and the hipped roof are all descriptive of its architectural origins (Plate 131). The house was once plastered -- and likely

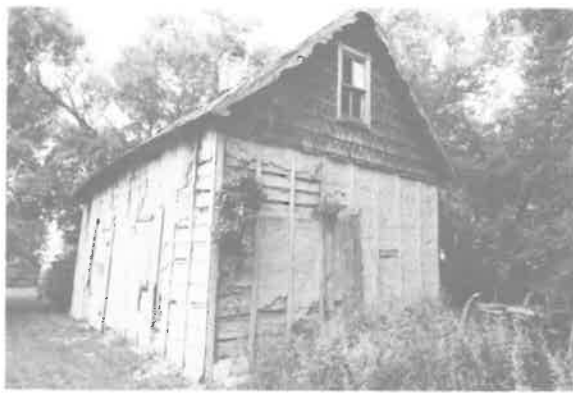
Plate 132. Bilan house at SW27-16-4E.

Many other farm houses built by Ukrainian settlers were hybrids of styles, materials and construction techniques. Perhaps closest in traditional planning to Galician examples, the few hybrid buildings left in the planning area can only suggest some of the variations. A house at SW27-16-4E has taller proportions than its more traditional Ukrainian neighbours (Plate 132); another features the entrance in the gable end (Plate 133); while another has incorporated a lean-to (Plate 134). In general these buildings suggest the waning of a tradition, the acceptance of alternate planning and the incorporation of different functions. It was only the reliance on log as a construction material and some consequent detailing that preserved the link with their architectural past. And when milled lumber and other technological advances gained acceptance among Ukrainian pioneers, their houses quickly lost even those traditional characteristics (Plate 135).

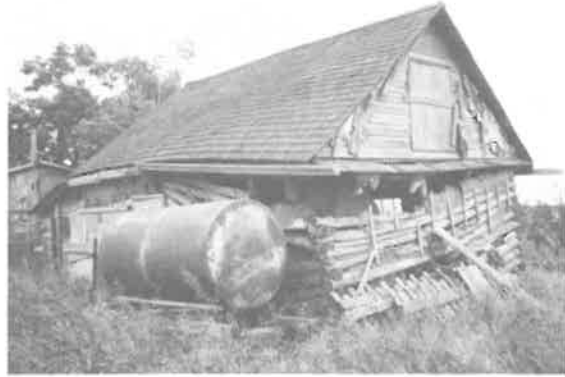
Plate 137. Ukrainian barn at SE24-13-3E.

Only three log barns, and these not of especially traditional form, are present today. All three are small, plain and in poor condition (Plates 137, 138 and 139). The barn at SE24-13-3E is constructed of roughly hewn logs joined by saddlenotches at the corners.

The walls of the building, enclosing space for only a few cattle or horses, were covered with mud and clay and then plastered. A small pent extension offered this covering some protection but neglect and a poor foundation have allowed the northwest corner to collapse. The plan of the barn featured a central entrance on the long side, lit by a small window aligned with the door, and flanking stalls. The other two barns, while built of logs, betray no hint of the heritage of their Ukrainian builders. The barn, or stable, near Lockport differs in no significant way

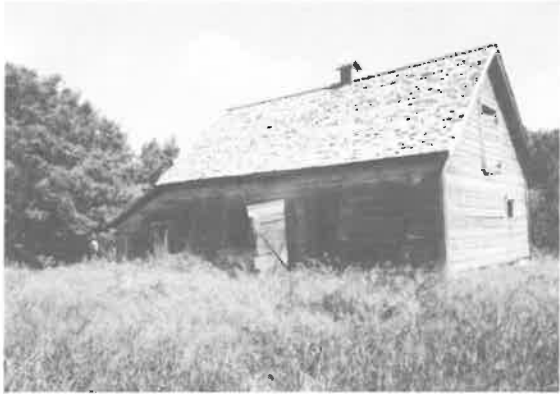
Plate 139. Ukrainian barn, northeast of Lockport.

from other local barns, except that underneath its horizontal sheathing are roughly hewn logs.

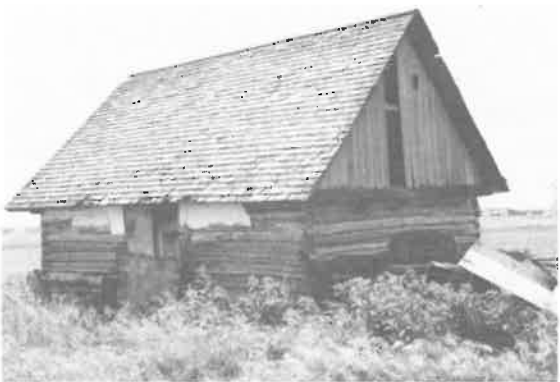
Plate 140. Ukrainian granary, near the junction of Highways 44 and 59.

Of the once common Ukrainian farm buildings, small granaries and tool sheds are especially well represented. Moreover, in comparison with the barns these little storage buildings often more clearly expressed distinct Ukrainian architectural features. The four granaries ("spitlairs") and eight tool sheds ("komoras") are all of logs and have distinctive shapes and details. One of the granaries is especially interesting (Plate 140). It is a neat little building constructed of poplar logs, roughly hewn and dovetail notched, with a covering of plaster. In order to create a straight secure wall, long slender pegs were driven through successive layers of the horizontal logs (Plate 141). The distinctive pent extension on the gable ends was emphasized by projecting and supporting logs, the ends of each cut at a 45 degree angle, and by four extra timbers set into the wall and braced against the pent.
