ARCHITECTURAL HERITAGE

The Selkirk and District

Planning Area

David
Butterfield

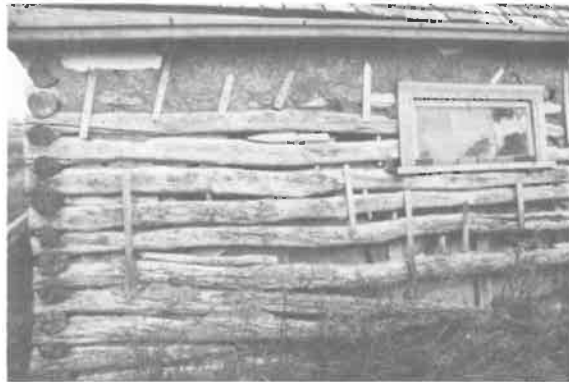
Plate 141. This detail of a granary shows the long pegs used to secure the walls against lateral spread.

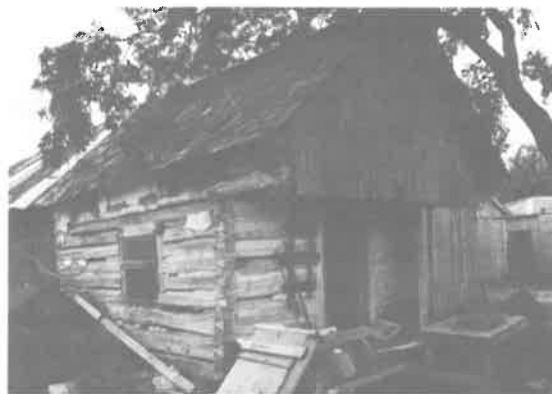
Plate 142. Former Polanski "komora", near the junction of Highways 44 and 59.

The "komoras" are perhaps more interesting than the granaries, for nearly all of them are expressive of Ukrainian skills at log construction. A "komora" in the Gonor area is indicative of those remaining in the planning area (Plate 142). The building is not in the best of condition, but exhibits some fine features. The hewn poplar logs of the walls are joined by dovetail notches and the whole is surmounted by a gabled roof. The distinguishing feature of the "komora", its roof extension, created a covered work space (Plate 143). Tools were kept inside these little buildings but yokes, wire bundles and other hardy articles were occasionally hung on the exterior (Plate 144).

The specific construction of the "komora" porch could vary. In this case, and typically, the top logs from the walls were extended past the front wall and connected, by dovetails, with a few smaller logs across the front. In other cases the procedure and the joinery were more sophisticated. For example, a "komora" west of Little Britain, built around 1910, extended only the top sill log, in this case carefully squared (Plate 145). This log was notched to receive the under brace and the rafter (Plate 146).

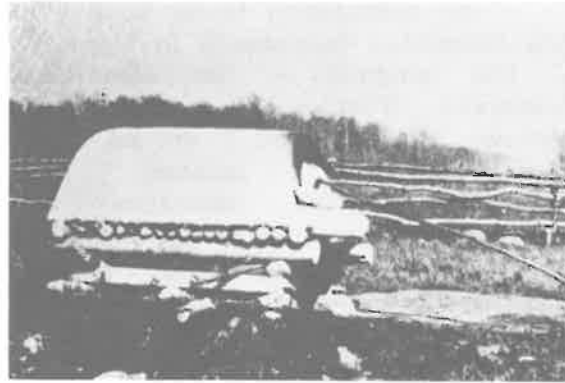
Plate 147. Bake oven, now preserved at the Winnipeg Beach Ukrainian Homestead Museum.

expression. More unfortunate is the loss of a once common site on early Ukrainian farms, the traditional bake oven, where bread and other pastries were prepared. Just one of these clay ovens is known to exist, preserved at the Ukrainian Homestead Museum at Winnipeg Beach (Plate 147). The distinctive sweep wells, usually replaced by the typical pit well, have also been lost, except again for one at the same museum (Plate 148).

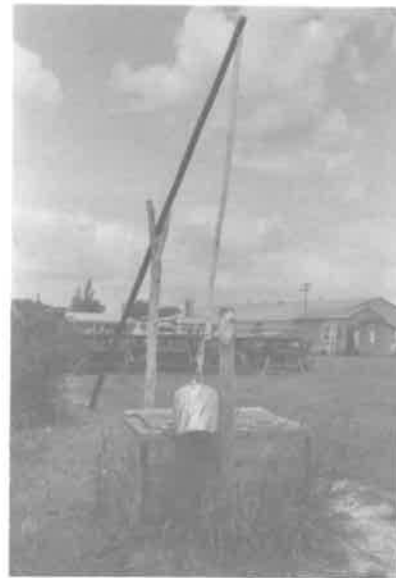
Plate 148. A sweep well, like this one preserved at the Winnipeg Beach Ukrainian Homestead Museum, was common on Ukrainian farmsteads.

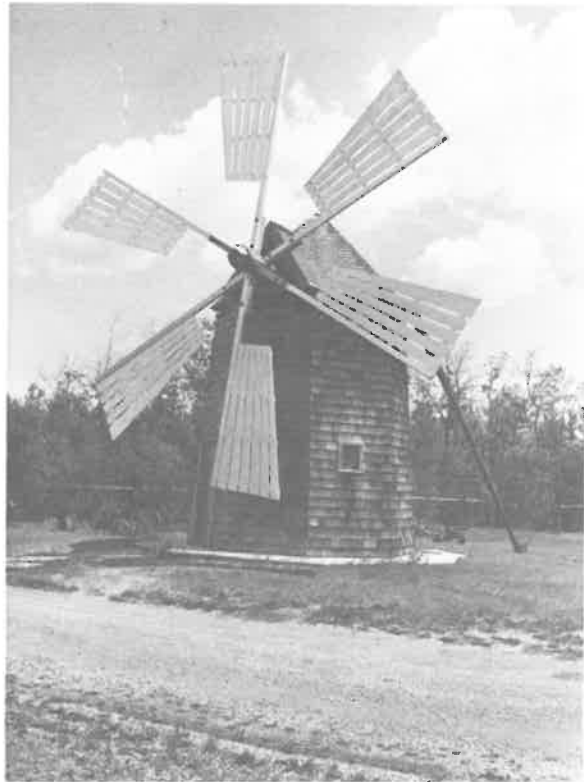
Plate 149. The former Hykawy windmill, now at the Winnipeg Beach Ukrainian Homestead Museum.

An outbuilding found on a very few Ukrainian farmsteads in Manitoba -- the windmill -- has also been preserved (Plate 149). The John Hykawy windmill, built around 1910, was originally located near Fraserwood. The structure was dismantled and moved to the Winnipeg Beach museum site, where it was reconstructed (Plate 150). An early description of the building noted that it was "an eight sided frame structure on a stone foundation. The six sails, windshaft and roof assembly could be turned into the wind by means of long poles hinged to the edge of the roof, and held in position by sticking the poles into the ground. Power from the windshaft was transferred through wooden gears, a vertical shaft, a belt and pulleys, to the spindle that drove the granite upper or "runner" stone. Farmers would make journeys of up to two days to reach this cap mill."⁴⁰ The mill has been restored, the sails replaced and the great spindle needs only to be engaged to grind grain.

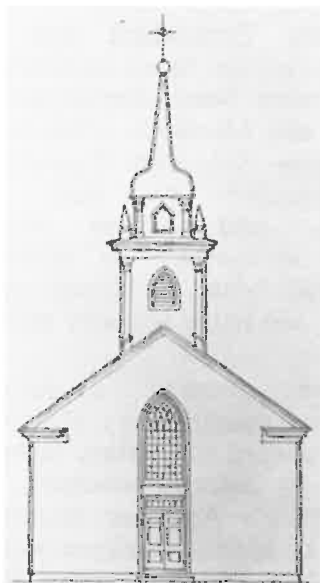
Plate 152. A Roman Catholic church in Ontario, St. Alexander's Lochiel. (From: Hallowed Walls, p. 128.) Other Roman Catholic churches eschewed the Gothic influences common in Protestant churches and drew on classical motifs, often employing round headed windows instead.

In Ontario the diversity of religions -- Anglican, Methodist, Presbyterian, Roman Catholic, Congregationalist, Baptist -- ensured an uncommon wealth of approaches to church design. In the smaller towns and in the countryside, however, where money and time were premiums, small church buildings tended to be simple structures, with the Catholic churches slightly more elaborate than the Protestant (Plates 151 and 152).

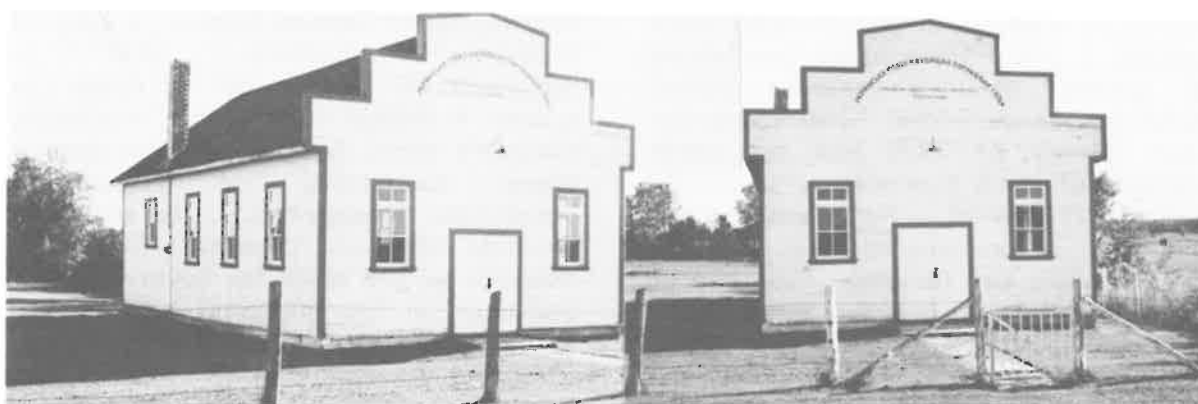
Plate 172. These two views of the Ukrainian Greek Catholic Parish Hall at Poplar Park illustrate the principle of the boom town front: a captivating facade disguises the simple gabled hall behind.

In some cases the local church was deemed inappropriate or simply too small to contain the various social events, vital to a growing community. Consequently, to accomodate everything from dances and dramatic events to political rallies and other large gatherings a community hall would be constructed. In the Ukrainian community, a National Home, usually associated with a church, was the specific name for a hall. An interesting National Home, located near Libau and associated with Holy Trinity Ukrainian Greek Catholic Church, was built in 1923 (Plate 172). The building is faced with a boomtown front of playful outline. The name of the hall is inscribed to form a semi-circle above the door.

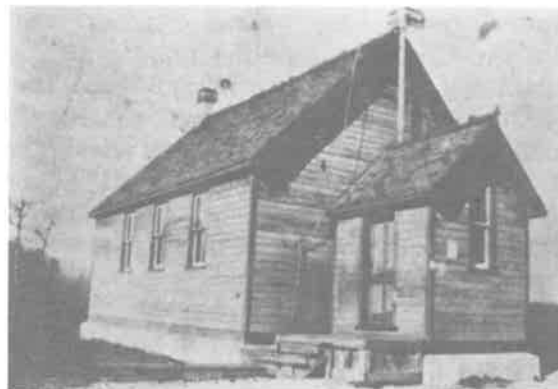
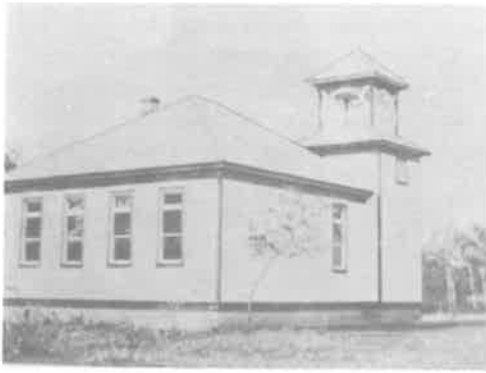
Plate 176. The former Mapleton School had the distinctive offset, detailed tower, square plan and fenestration treatment typical of Hooper's Design No. 3. (From: Beyond the Gates of Lower Fort Garry, p. 78.)

By 1900, however, the intervention of provincial authorities, through regular inspections, had greatly improved school designs and construction. Inspectors had early recognized the limits of ad hoc building ideas but it was not until 1903, when the Department of Education commissioned Samuel Hooper, a notable Winnipeg architect, that a standardized, quality set of plans for school buildings was made available. Hooper's three designs corresponded to three budgetary, or population, conditions. Design No. 1, the simplest, smallest and most popular, was readily adopted as the basis for several school buildings in the planning area (Plate 175). No.'s 2 and 3 were less commonly used, but the old Mapleton School was certainly derived from the latter (Plates 176 and 177).

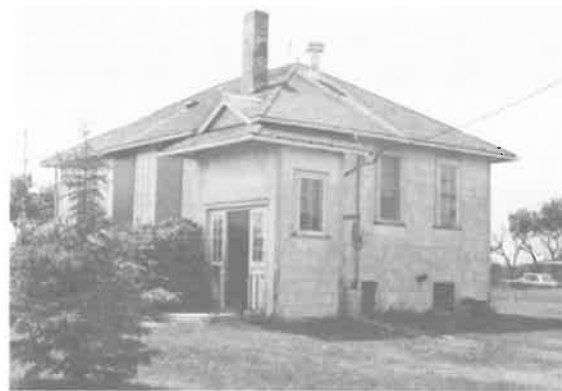
Plate 178. An interesting alternative to Hooper's designs which appeared occasionally in the planning area (here at NE14-15-3E), shifted the entrance to one side and drew it out into a sort of corner tower.

Hooper's designs, in common with other building proposals for rural schools made between 1900 and 1920, relied on a boxy massing with a formal entrance condition (Plate 178). The typical fenestration pattern placed a virtual wall of windows on the west

side, admitting generous amounts of indirect light during the morning and early afternoon, while classes were held, and eliminating the direct light that would otherwise cast dark shadows in the classroom. Great attention was paid in these designs to ventilation and heating although these specific efforts were often undermined by local economic and physical limitations. Nevertheless, suggestions for foundations and general construction procedures were usually followed by local school boards. If Hooper's designs were not always replicated, they were influential and, along with the promulgation of simple plan catalogues and other sample books for rural school designs, helped to create in the construction of schools a uniformity of size, appearance, interior appointments and construction standards.

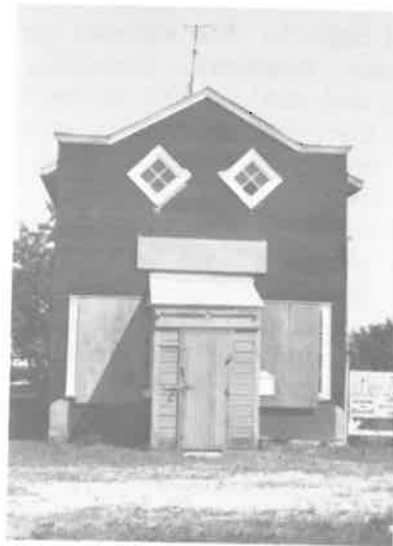
Plate 183. The old Netley Airport Store on Highway No. 9.

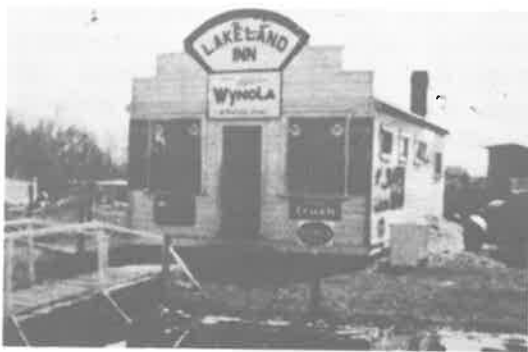
Plate 184. The former Lakeland General Store at Beaconsia. (From: East Side of the Red, p. 344.)

have differed markedly from early settlement houses: they were small, unpretentious log structures (Plate 182). Quickly, however, the proximity of lumber milling facilities and the models presented by urban commercial facilities began to bring about the replacement of the first rudimentary buildings. By the turn of the century nearly all commercial establishments throughout the planning area, though still small, were of light wood frame construction and, more significantly, faced with boom town fronts (Plate 183). This architectural feature not only created an impressive entrance condition but also provided space atop for signage or large advertisements. Subtle changes to the outline of such a facade resulted in a distinctive store front (Plate 184).

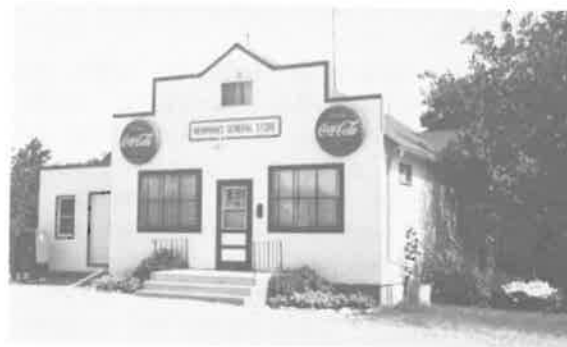
Plate 185. Newman's General Store is cast in stucco, giving it a sleek appearance.

As the need for convenient commercial activity was increasingly met after 1930 by the automobile and the improvement of roads leading to small urban centres, rural business was largely relegated to servicing the automobile. The gas station, while possibly generating some other minor commercial activity, became the predominant rural store. Many of the buildings dating from this period -- several of which exist in the planning area -- present the same boomtown face of the earlier structures although differing slightly in architectural expression. In comparison they, like the automobiles they serviced, are often sleek, influenced by Art Deco styling (Plate 185).

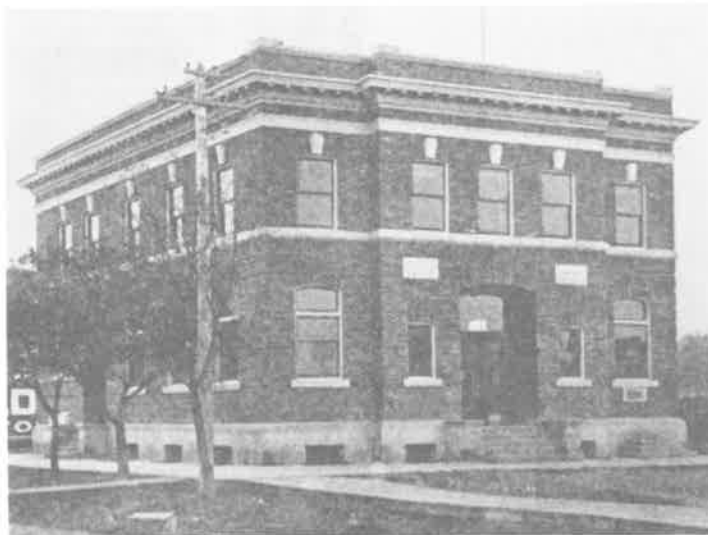
Plate 195. The federal government finally constructed a post office in the community in 1905. The building is an unpretentious structure constructed of red bricks and highlighted and organized by bands and keystones of limestone. (From: Selkirk, The First Hundred Years, p. 91.)

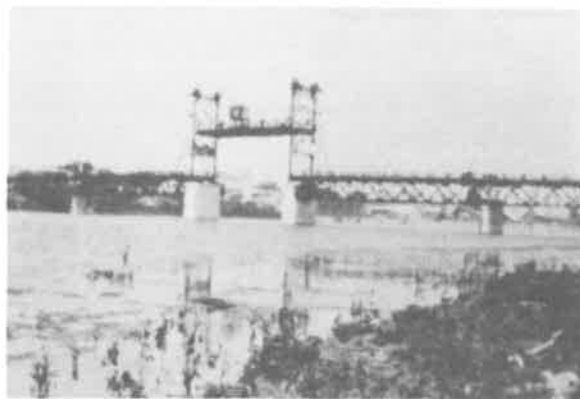
Plate 201. The Selkirk Bridge shortly after completion, with its span up. (From: East Side of the Red, p. 162.)

While the Depression inevitably did wreak havoc with the town's economy, Selkirk was still more fortunate than many other western communities, for it had a major relief project. The construction of the Selkirk Bridge, a bridge with a lift span that permitted river traffic to pass beneath it, was carried out between 1934 and 1936. This finally provided Selkirk with the connection to the east side of the Red and the markets it had always wanted (Plate 201).

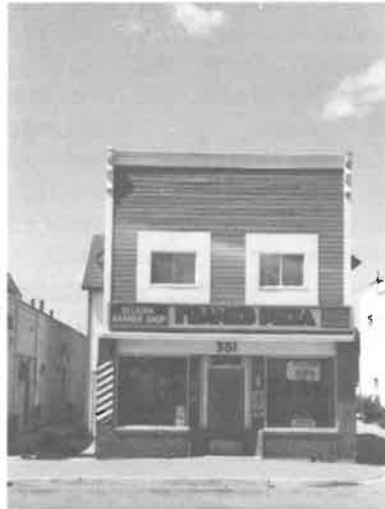
Plate 202. Now Frank's Pizza, this old store features a plain tall boom town front, tipped at the edges of the cornice by decorative little scrolls.

Today the commercial core of Selkirk reveals only hints of its former character and these hints are generally of a humbler nature (Plate 202).

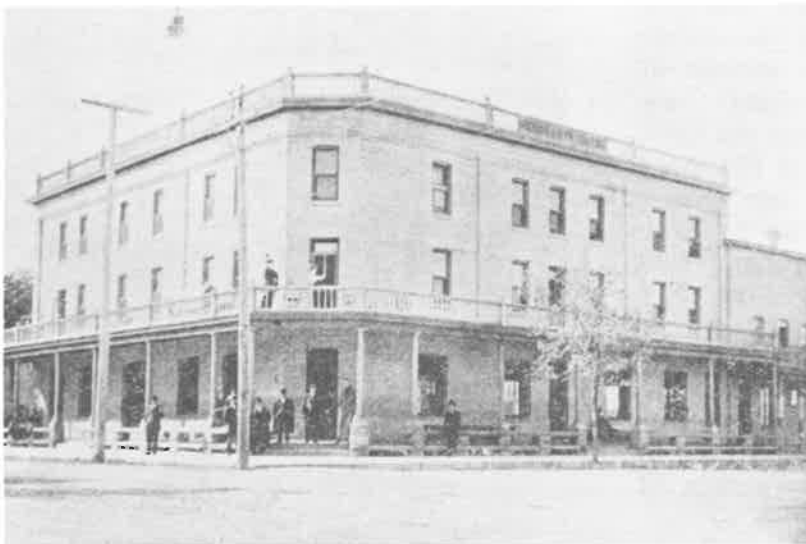
Plate 203. The Merchant's Hotel has been covered with stucco about the main floor, eliminating many of the building's original and interesting features. (PAM)

Exceptions include the old Merchant's Hotel (Plate 203), the former Dominion Bank (Plate 204) and the old Post Office. While buildings like these are of some interest in their own right, they were fairly common in prairie towns and can only assume a greater importance in the particular context of Selkirk, with its current dearth of historic buildings.

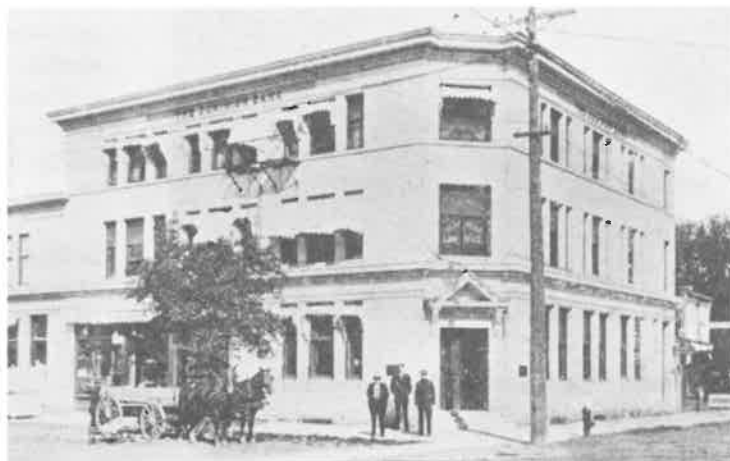
Plate 204. The old Dominion Bank has seen various functions throughout the years, but is remarkably intact, at least on the exterior. Orientation to the corner provides the building with a distinctive entrance bay. This caprice results in interesting details that range across the whole. (PAM)

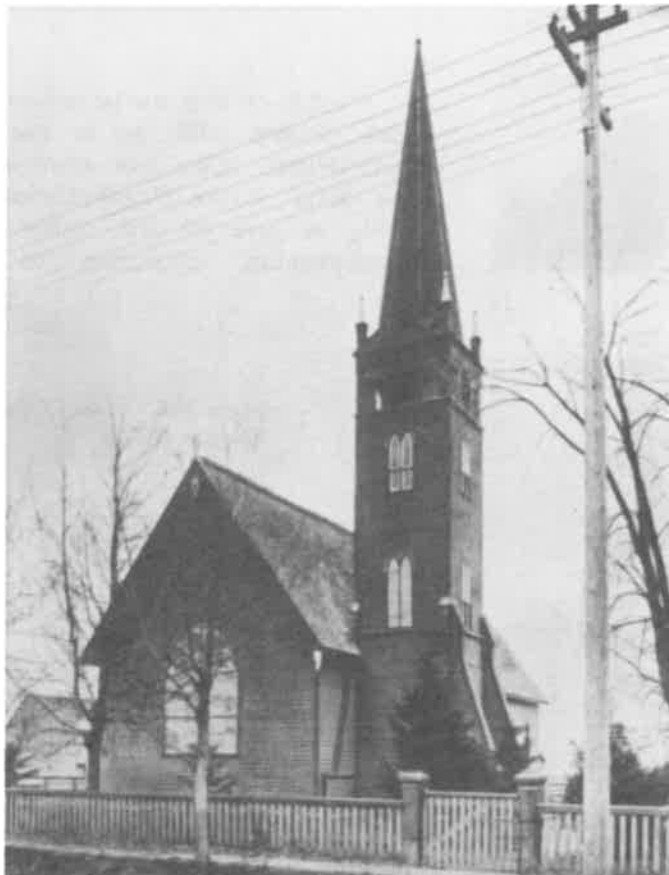
Plate 209. The present Christ Church, designed and built by Walter Sellick.

(Plate 207). The original designs for Christ Church Anglican, on McLean Avenue were prepared by the renowned Winnipeg architect, C. Osborne Wickendon, but Walter Sellick, a local contractor, won the bid and constructed a much simpler and less costly building (Plates 208 and 209). Church services had commenced as early as 1889 to serve the Icelandic population in Selkirk, but it was not until 1924 that the large Evangelical Lutheran Church was built (Plate 210). The Ukrainian population in Selkirk met in various structures before 1955 when Father Philip Ruh was commissioned to design a large Ukrainian Catholic church. The Ukrainian Catholic Church of the Holy Eucharist is one of Father Ruh's finest, distinguished by a large, slightly flattened, central dome, a divergence from the taller domes of his other churches (Plate 211).

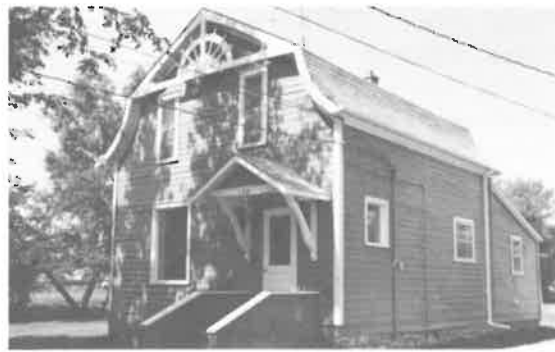
Plate 215. It is perhaps no coincidence that this house, with its maritime themes, lies close to the river on Eveline Street.

There are several other houses of modest size in Selkirk that have a more playful nature. One, on the east side of Main Street, is a side hall plan whose immediate expression is formed more by its gambrel roof shape and the boat wheel detailing in its gable end than its planning (Plate 215). A second house, west of Main on McLean, is likewise a side hall house, but in this case animated by a shallow mansard roof, projecting dormers and a mansard-topped boxed bay window (Plate 216).

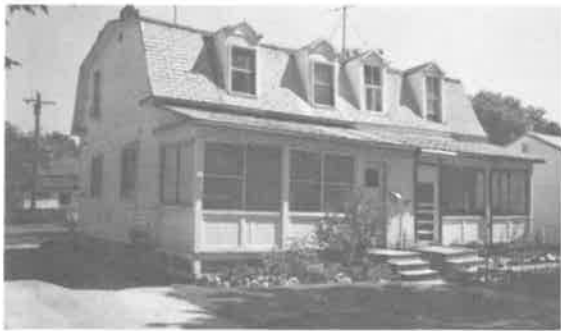
Plate 217. While the old duplex on Rosser Avenue has seen many internal changes, the exterior, including the long verandah, is largely intact.

Selkirk's urban nature required a somewhat increased density of housing. Apartment buildings did not arise in the community until the 1940s but a few duplexes were built here before that date. Constructed ca. 1890, a duplex on Rosser Avenue is a long one-and-a-half storey building, capped by a gambrel roof and gabled dormers (Plate 217).

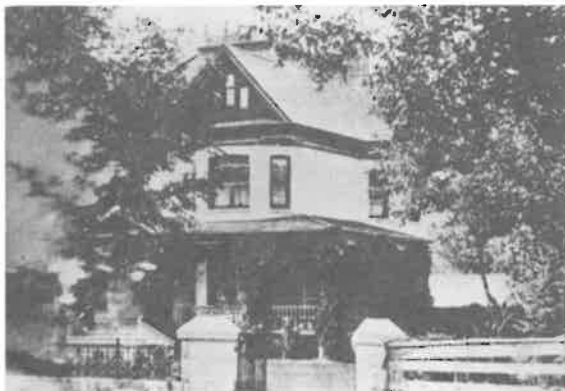
Plate 221. McLeod house, of brick, on Eveline Street.

The fine brick house at the northern extent of Eveline is perhaps the best preserved of these (Plate 221). Two-and-a-half storeys, the building is a testament to its builder. The brickwork is first-rate, with plain and dogtoothed string courses outlining the separation between floors. Where such bands encounter a window opening a broad segmental arch was created. The original porch on the house is intact and boasts fine workmanship in the turned posts, spindles and decorative trim.

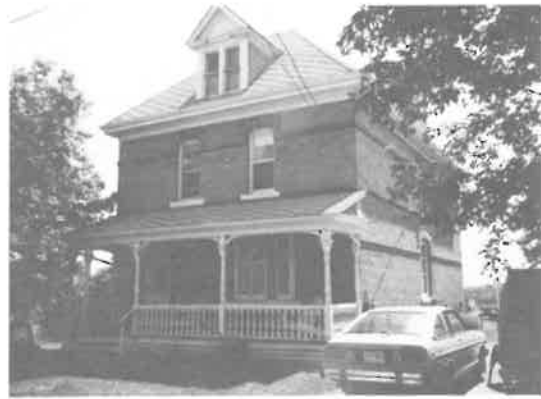
Plate 222. Purvis house, Taylor Avenue. (From: XMas Number of the Selkirk, St. Clement's, Brokenhead and Beausejour Magazine, p. 13.)

The old Purvis house on Taylor Avenue has had its integrity somewhat compromised by the addition of an enclosed wooden porch at the front (Plate 222). The house, of buff brick construction, has a fine intact widow's walk atop the roof, enclosed by filigreed iron cresting. The dormers are highlighted by Palladian-inspired windows which have curved sun burst motifs on either side.

- 21) 2 1/2 Storey Square Plan House
 Construction Date: 1904-05
 Location: 210 Taylor Avenue, Selkirk
 Present Owner: Mr. Roy Purvis
 Present Use: Occupied
 Construction:
 walls - buff brick on milled wood frame
 roof - asphalt shingles on milled wooden rafters
 Integrity: Largely unaltered
 Condition: Good
 Notes: This building is also discussed on page 120.

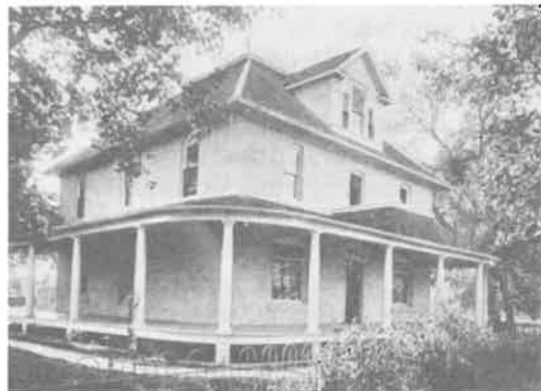
Plate 223. Former Comber house, Eveline Street. (From: XMas Number of the Selkirk, St. Clement's, Brokenhead and Beausejour Magazine, p. 35.)

The former Comber house, now Gilbert's Funeral Home, is the last of the three or more mansions that once graced Eveline Street (Plate 223). The addition of a chapel of modern architectural inspiration along the front greatly inhibits this building, which contains many of the finest architectural details in the community. The complex roof shape, filigreed cresting and numerous turned wooden details nevertheless give this house unrivalled character in Selkirk.

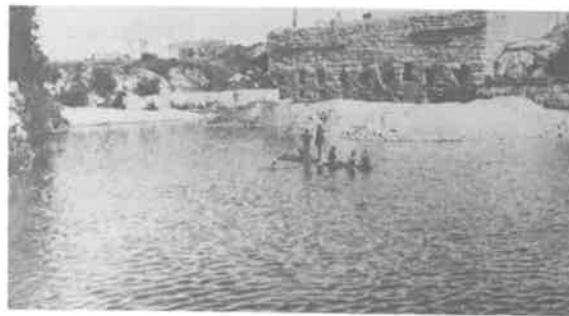
Plate 233. One of the many limestone fireboxes that dotted the quarry landscape around Garson before 1920. (From: They Stopped at a Good Place, p. 86.)

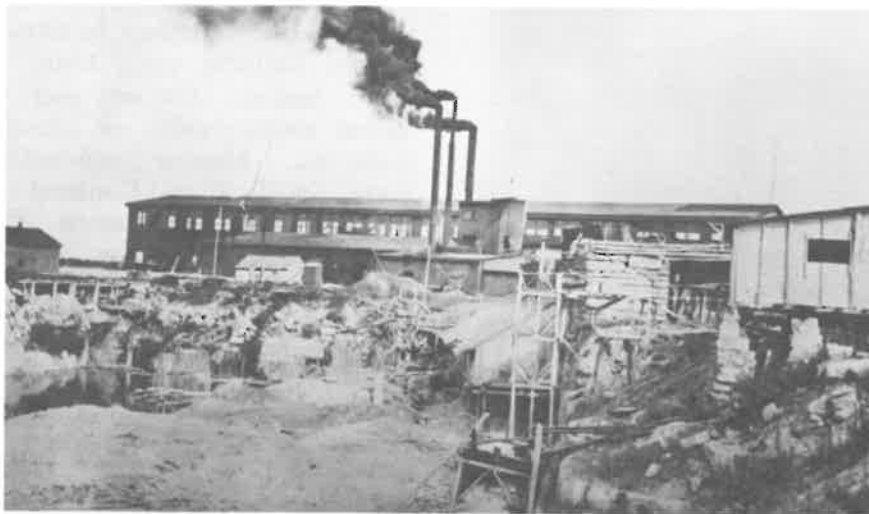
Plate 231. The great stone cutting mill at Garson. (PAM)

Around 1895 an area at the southeastern edge of the planning area was discovered to contain deep beds of limestone, and within five years this area, known as the "Big Hill", was spotted with quarries. The village of Garson, at the western edge of the "Big Hill" was formed shortly after the turn of the century and was named for William Garson (father of S.S. Garson, the Premier of Manitoba from 1943-48) whose quarry near the fledgling community was one of the largest in operation. While the village contained the requisite houses, stores and shops, the significant structures were associated with the quarries: a huge mill where the stones were dressed; a large office next door; and, north of the village, the workers' huts (Plate 231 and 232). Limestone kilns near the pits were also present (Plate 233).

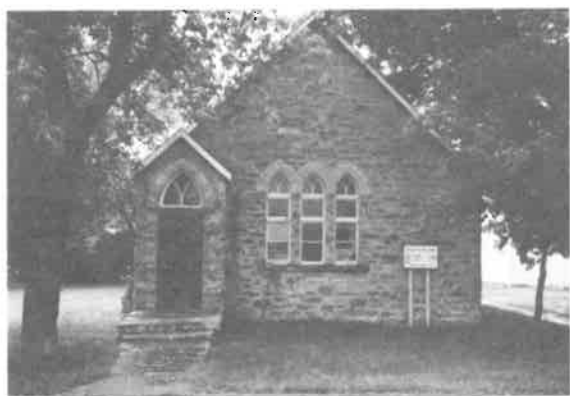
Plate 237. Former Presbyterian Church, Garson.

Although the former activity at Garson is best described today by the quarries themselves, there is one pre-1930 building remaining that conveys the special source of its existence. This one building is the former Presbyterian Church, built in 1919 of the local limestone (Plate 237). It features an offset side entrance that frees the front face of the building for three lancet windows. That Gothic styling is carried throughout by the windows along the nave and by the two small windows above the sanctuary.

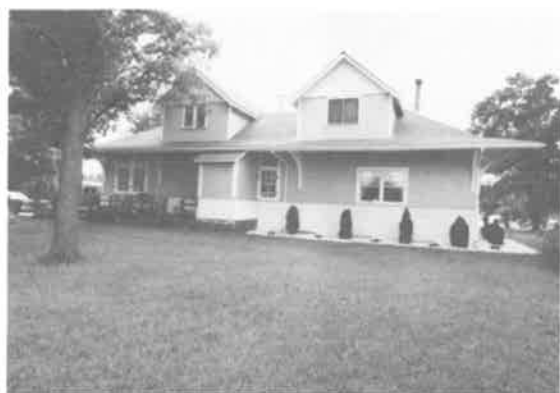
Plate 242. The former Petersfield station was drawn from one of many standardized designs used by the CPR throughout the West.

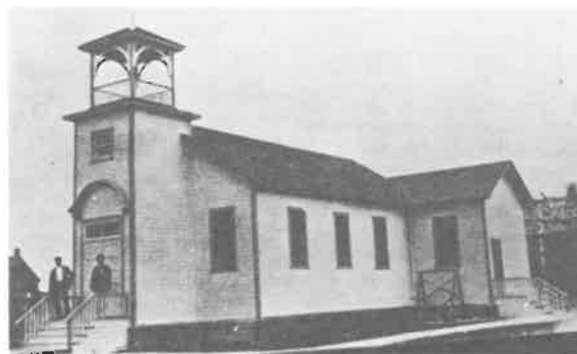
Plate 255. Old Municipal Hall, Winnipeg Beach. (From: The Western Municipal News, Vol. 6, No. 8, p. 260.)

Today the first Winnipeg Beach Town Hall is used as a storage facility (Plate 255). A few of the original commercial structures remain along Railway Street but have been drastically altered by the addition of stucco (Plate 256). Two churches, the Anglican and the United, are still standing (Plates 257 and 258) and many of the cottages built by the prolific Mr. Ritchie remain, despite frequent alterations through the years by different owners (Plate 259).

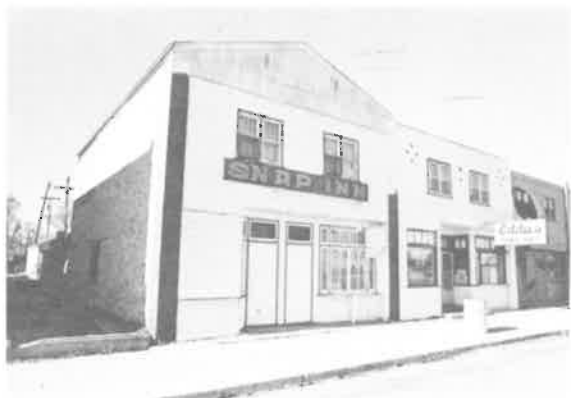
Plate 256. Commercial structures in Winnipeg Beach.

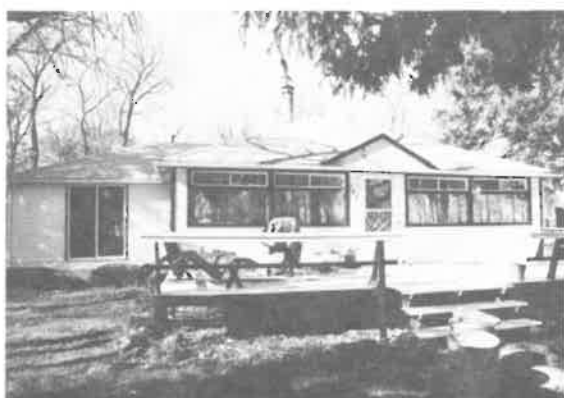
Plate 259. A cottage at Winnipeg Beach altered by external additions, including a deck, and internal winterization.

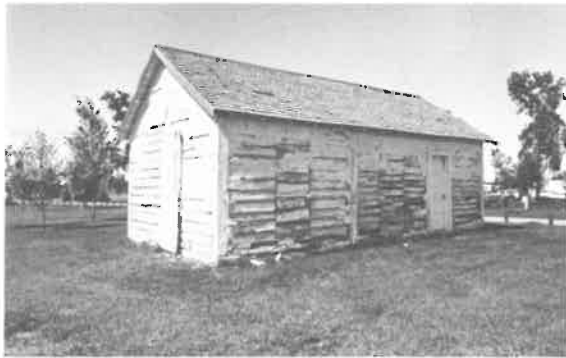
- 1) **Red River Frame House**
 Construction Date: ca. 1860
 Location: Selkirk Park
 Present Owner: Town of Selkirk
 Present Use: Storage
 Construction:
 walls - Red River frame logs
 roof - wooden shingles on milled wooden rafters
 Integrity: The house originally stood on Eveline and was altered when it was moved.
 Condition: Fair
 Notes: This building is also discussed on pages 21-22.

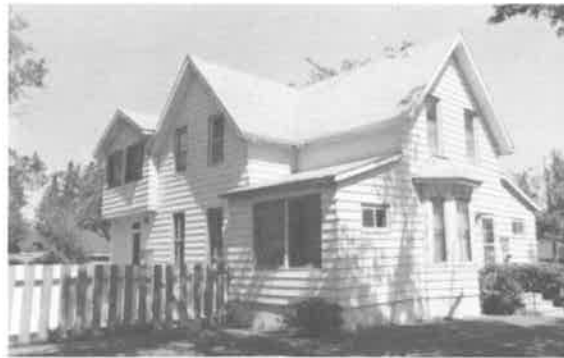
- 2) **1 1/2 Storey House**
 Construction Date: ca. 1870-1875
 Location: 283 Eveline Street, Selkirk
 Present Owner: Mr. Henrikson
 Present Use: Occupied
 Construction:
 walls - original section: logs/additions: horizontal siding on milled wooden frame
 roof - asphalt shingles on milled wooden rafters
 Integrity: The original log house has been added to over the years and the same building now bears little semblance of its original humble state.
 Condition: Good
 Notes: The original log section of this house is one of the oldest remaining buildings in the community.

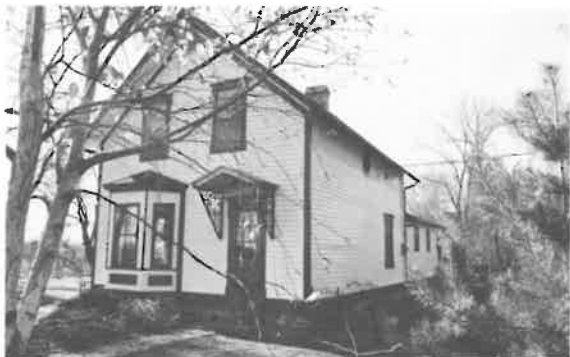
- 3) **1 1/2 Storey Side Hall House**
 Construction Date: 1872-74
 Location: 102 Pacific Avenue, Selkirk
 Present Owner: Mr. H. van der Putten
 Present Use: Occupied
 Construction:
 walls - horizontal siding on milled wooden frame
 roof - asphalt shingles on milled wooden rafters
 Integrity: The house is undergoing renovations to bring it very close to its original appearance.
 Conditions: Excellent
 Notes: This building is also discussed on page 118.

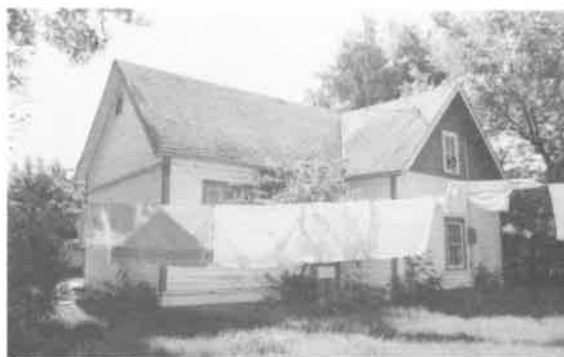
- 4) **L-Shaped Log House**
 Construction Date: ca. 1875
 Location: 103 Toronto Avenue, Selkirk
 Present Owner: A. Bannish
 Present Use: Occupied
 Construction:
 walls - squared dovetailed logs with horizontal siding
 roof - wood shingles on milled wooden rafters
 Integrity: The house appears to have had at least one addition and it is likely that the interior has been altered.
 Condition: Fair

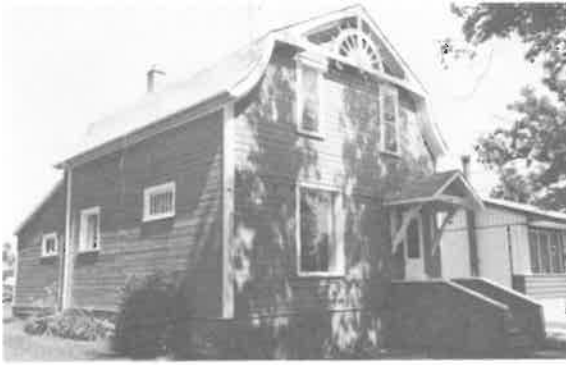
- 9) 1 1/2 Storey Side Hall House with Gambrel Roof
 Construction Date: ca. 1900
 Location: 475 Eveline Street, Selkirk
 Present Owner: Mr. Hawes
 Present Use: Occupied
 Construction:
 walls - horizontal siding on milled wooden frame
 roof - asphalt shingles on milled wooden rafters
 Integrity: Largely unaltered
 Condition: Good
 Notes: This building is also discussed on page 118.

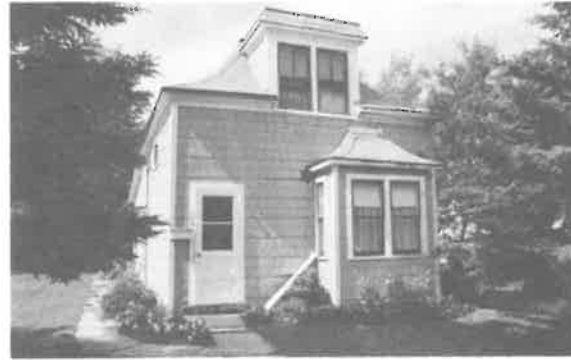
- 10) 1 1/2 Storey Side Hall House with Hipped Bellcast Roof
 Construction Date: ca. 1900
 Location: 520 McLean Avenue, Selkirk
 Present Owner: Mr. Russell Hendry
 Present Use: Occupied
 Construction:
 walls - wooden shingles on milled wooden frame
 roof - asphalt shingles on milled wooden rafters
 Integrity: Largely unaltered
 Condition: Fair
 Notes: This building is also discussed on page 118.

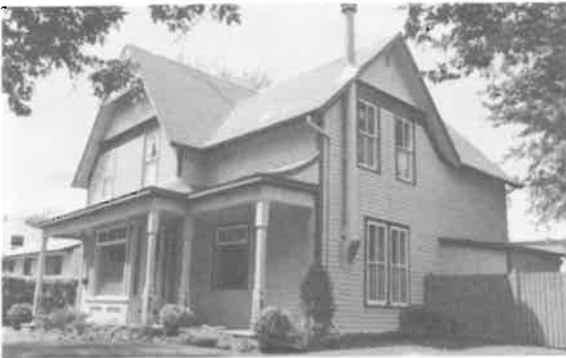
- 11) 1 1/2 Storey L-Shaped House
 Construction Date: 1893
 Location: 323 Eveline Street, Selkirk
 Present Owner: Mr. B. Souter
 Present Use: Occupied
 Construction:
 walls - horizontal siding on milled wooden frame
 roof - asphalt shingles on milled wooden rafters
 Integrity: The interior has been altered considerably, but still retains its period appearance. The exterior is largely unaltered.
 Condition: Good
 Notes: This building is also discussed on pages 60-61.

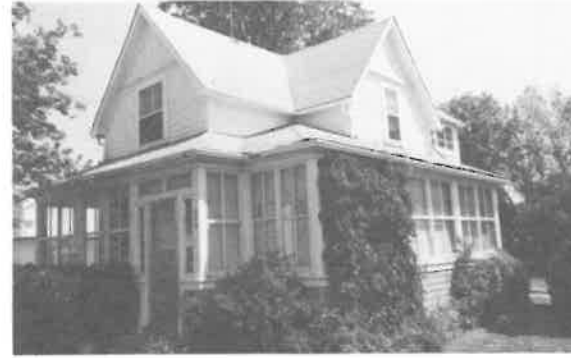
- 12) 1 1/2 Storey T-Shaped House
 Construction Date: ca. 1900
 Location: 470 Main Street, Selkirk
 Present Owner: Mr. H. Little
 Present Use: Occupied
 Construction:
 walls - horizontal siding on milled wooden frame
 roof - asphalt shingles on milled wooden rafters
 Integrity: Largely unaltered
 Condition: Good

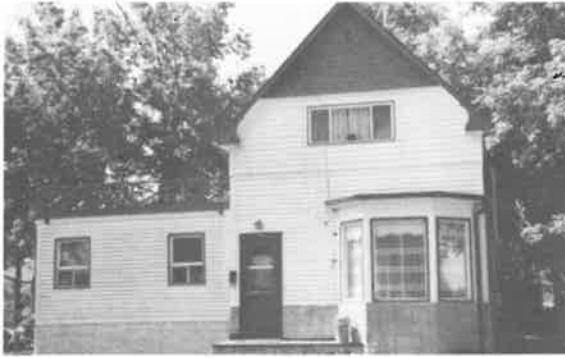
- 13) 1 1/2 Storey Side Hall House
 Construction Date: ca. 1900
 Location: 206 Taylor Avenue, Selkirk
 Present Owner: Mr. R.A. Luining
 Present Use: Occupied
 Construction:
 walls - horizontal siding on milled wooden frame
 roof - asphalt shingles on milled wooden rafters
 Integrity: The main portion of the house is unaltered, but additions have been made to increase the floor size.
 Condition: Good

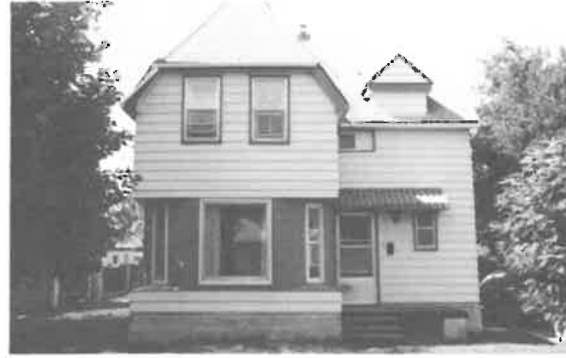
- 14) 1 1/2 Store L-Shaped House
 Construction Date: ca. 1895
 Location: 204 Taylor Avenue, Selkirk
 Present Owner: G. E. Still
 Present Use: Occupied
 Construction:
 walls - aluminum siding on milled wooden frame
 roof - asphalt shingles on milled wooden rafters
 Integrity: Both interior and exterior have been significantly altered.
 Condition: Good

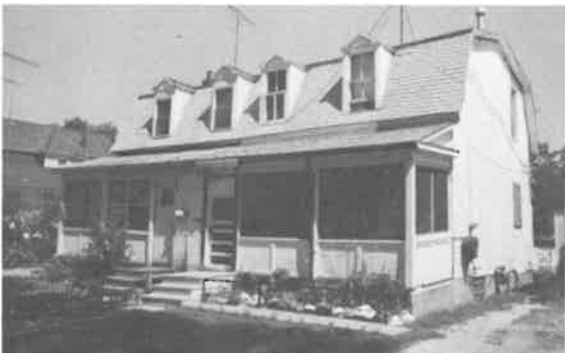
- 15) 1 1/2 Storey Gambrel-Roofed House
 Construction Date: ca. 1890
 Location: 207 & 209 Rosser Avenue, Selkirk
 Present Owner: Mr. Randy Wilson
 Present Use: Occupied Duplex
 Construction:
 walls - horizontal siding on milled wooden frame
 roof - asphalt shingles on milled wooden rafters
 Integrity: The interior has been altered
 Condition: Fair
 Notes: This building is also discussed on pages 118-119.

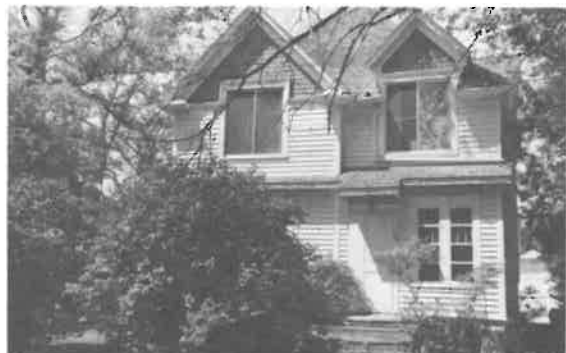
- 16) 1 1/2 Storey L-Shaped House
 Construction Date: 1900
 Location: 149 Eveline Street, Selkirk
 Present Owner: Mrs. Lulashuyk
 Present Use: Occupied
 Construction:
 walls - horizontal siding on milled wooden frame
 roof - wood shingles on milled wooden rafters
 Integrity: The interior is currently being renovated. The exterior is in good unaltered condition.
 Condition: Fair

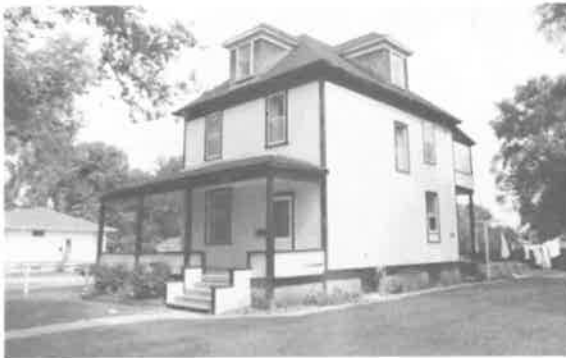
- 17) 2 1/2 Storey Square Plan House
 Construction Date: 1916
 Location: 260 Eveline Street, Selkirk
 Present Owner: Mrs. E. Smith
 Present Use: Occupied
 Construction:
 walls - horizontal siding on milled wooden frame
 roof - asphalt shingles on milled wooden rafters
 Integrity: Largely unaltered
 Condition: Good
 Notes: This building is also discussed on page 119.

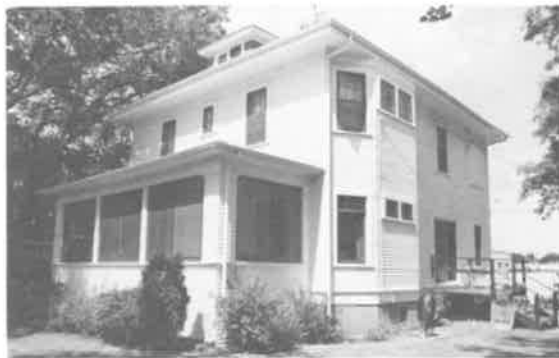
- 18) 2 Storey Square Plan House
 Construction Date: ca. 1900
 Location: 213 Dorchester Avenue, Selkirk
 Present Owner: Mr. Hurley
 Present Use: Occupied
 Construction:
 walls - horizontal siding on milled wooden frame
 roof - asphalt shingles on milled wooden rafters
 Integrity: The interior has been altered.
 Condition: Good

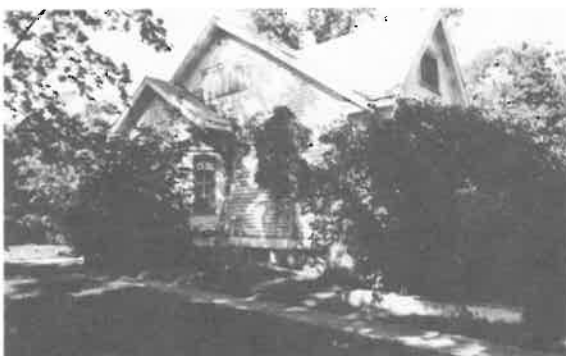
- 19) 1/2 Storey "T" Plan House
 Construction Date: 1896
 Location: 419 Eveline Street, Selkirk
 Present Owner: Mr. R. Hooker
 Present Use: Occupied
 Construction:
 walls - horizontal siding on milled wooden frame
 roof - asphalt shingles on milled wooden rafters
 Integrity: The house was originally 3 1/2 storeys in height. In 1936/37 the middle two storeys were removed.
 Condition: Good

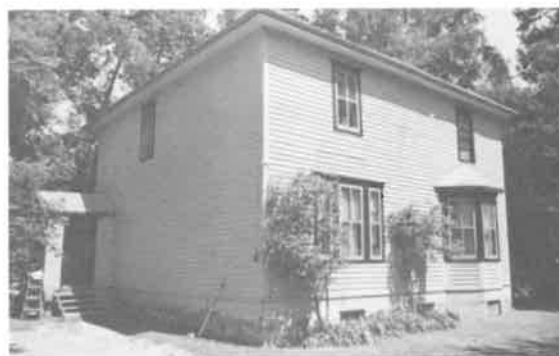
- 20) 2 Storey Square Plan House
 Construction Date: 1903
 Location: 239 Eveline Street, Selkirk
 Present Owner: Mr. Don Lugtig
 Present Use: Occupied
 Construction:
 walls - horizontal siding on milled wooden frame
 roof - asphalt shingles on milled wooden rafters
 Integrity: Largely unaltered
 Condition: Good
 Notes: This building was previously an Anglican manse.

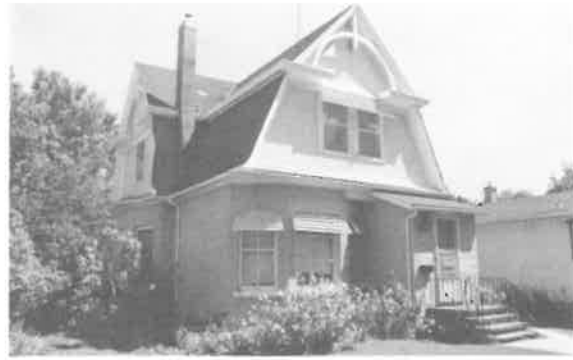
- 22) 1 1/2 Storey Side Hall House with Gambrel Roof
 Construction Date: 1905
 Location: 215 Rosser Avenue, Selkirk
 Present Owner: Mrs. Ellen Howard
 Present Use: Occupied
 Construction:
 walls - horizontal siding on milled wooden frame
 roof - wood shingles on milled wooden rafters
 Integrity: Largely unaltered
 Condition: Good

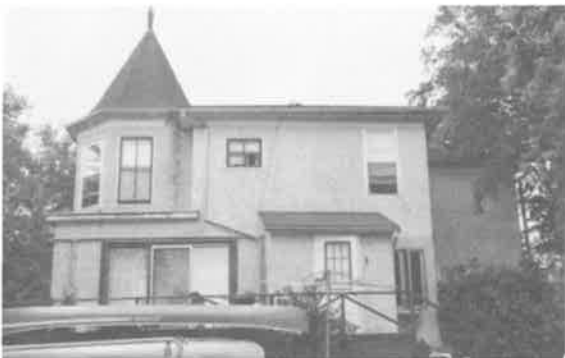
- 23) 2 Storey T-Shaped House
 Construction Date: 1905
 Location: 326 Eveline Street, Selkirk
 Present Owner: Mr. Williams
 Present Use: Occupied
 Construction:
 walls - stucco veneer on milled wooden frame
 roof - asphalt shingles on milled wooden rafters
 Integrity: Largely unaltered
 Condition: Good
 Notes: This house was previously owned by two local physicians, Drs. Grain and Atkinson.

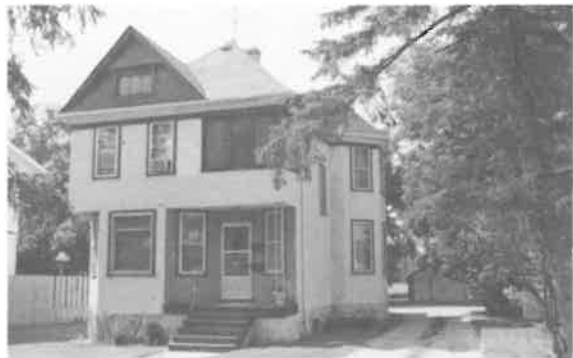
- 24) 2 1/2 Storey T-Shaped House
 Construction Date: ca. 1905
 Location: 243 Eveline Street, Selkirk
 Present Owner: Mrs. Helena Pollock
 Present Use: Occupied
 Construction:
 walls - stucco veneer on milled wooden frame
 roof - asphalt shingles on milled wooden rafters
 Integrity: The interior and exterior have both been altered.
 Condition: Good

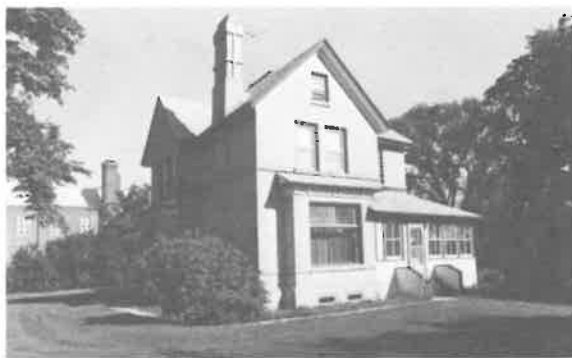
- 25) 1 1/2 Storey Square Plan House
 Construction Date: ca. 1890
 Location: Selkirk Mental Health Centre Grounds
 Present Owner: Selkirk Mental Health Centre
 Present Use: Occupied
 Construction:
 walls - buff brick on milled wooden frame
 roof - asphalt shingles on milled wooden rafters
 Integrity: Largely unaltered
 Condition: Good

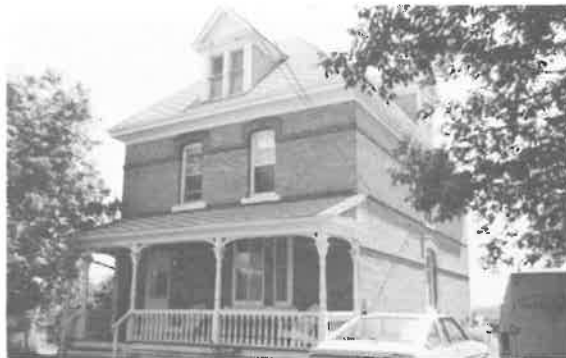
- 26) 2 1/2 Storey Square Plan House
 Construction Date: 1911
 Location: 478 Eveline Street, Selkirk
 Present Owner: Mr. G. McLeod
 Present Use: Occupied
 Construction:
 walls - red brick on milled wooden frame
 roof - asphalt shingles on milled wooden rafters
 Integrity: Largely unaltered
 Condition: Good
 Notes: This building is also discussed on page 120.

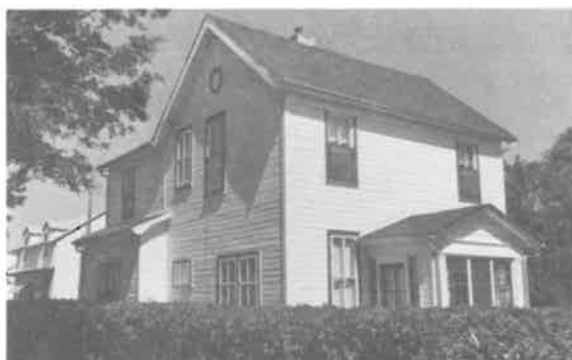
- 27) 1 1/2 Storey L-Shaped House
 Construction Date: ca. 1910
 Location: 285 Eveline Street, Selkirk
 Present Owner: Mr. Edward Lennon
 Present Use: Occupied
 Construction:
 walls - horizontal siding on milled wooden frame
 roof - asphalt shingles on milled wooden rafters
 Integrity: Largely unaltered
 Condition: Good

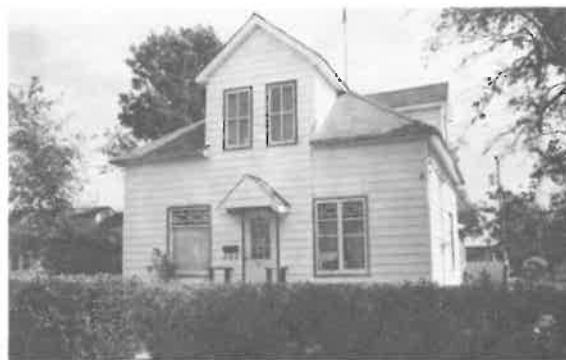
- 28) 1 1/2 Storey Square Plan House
 Construction Date: ca. 1900
 Location: 517 McLean Avenue, Selkirk
 Present Owner: Mrs. Kushliak
 Present Use: Occupied
 Construction:
 walls - horizontal siding on milled wooden frame
 roof - asphalt shingles on milled wooden rafters
 Integrity: Largely unaltered
 Condition: Good

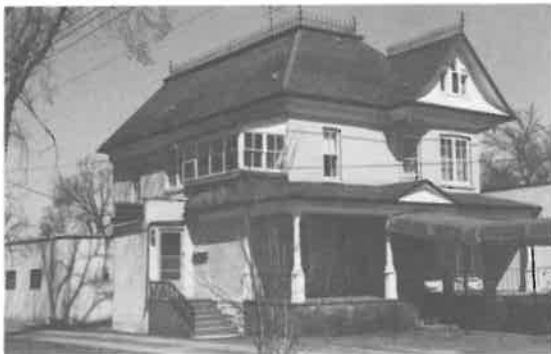
- 29) 2 1/2 Storey Square Plan House
 Construction Date: 1913
 Location: 307 Eveline Street, Selkirk
 Present Owner: Mr. Roy Gilbert
 Present Use: Funeral Parlour
 Construction:
 walls - buff brick on milled wood frame
 roof - wood shingles on milled wooden rafters
 Integrity: The interior has been altered considerably.
 The exterior retains most of its original features.
 Condition: Good
 Notes: This building is also discussed on page 120.

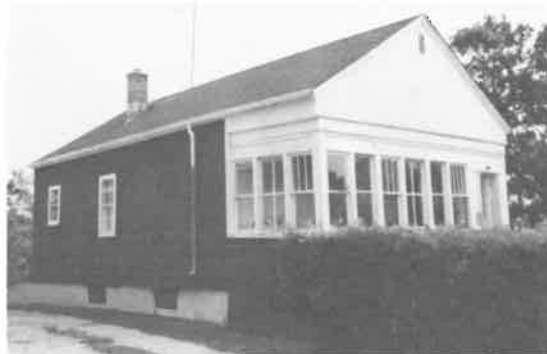
- 30) Single Storey House
 Construction Date: ca. 1880
 Location: 515 Clandeboye Avenue, Selkirk
 Present Owner: Mr. K. Davidson
 Present Use: Occupied
 Construction:
 walls - insulbrick siding on milled wooden frame
 roof - asphalt shingles on milled wooden rafters
 Integrity: Unaltered floorplan
 Condition: Fair

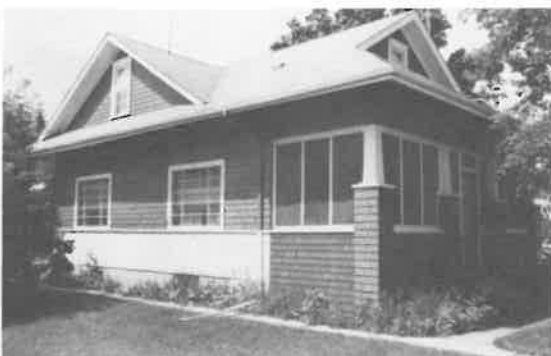
- 31) 1 1/2 Storey House
 Construction Date: ca. 1910
 Location: 218 McLean Avenue, Selkirk
 Present Owner: Mr. C. Reid
 Present Use: Occupied
 Construction:
 walls - wood shingles and horizontal siding on milled wooden frame
 roof - asphalt shingles on milled wooden rafters
 Integrity: Largely unaltered
 Condition: Good
 Notes: This unpretentious house was designed by the architect George Teeter, who designed the Winnipeg Shriner's Hospital.

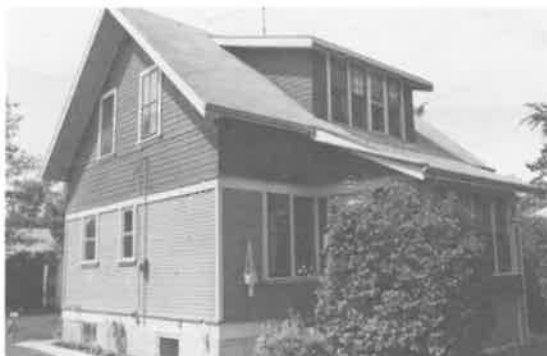
- 32) 1 1/2 Storey House
 Construction Date: 1922
 Location: 212 McLean Avenue, Selkirk
 Present Owner: Mr. Hadfield
 Present Use: Occupied
 Construction:
 walls - horizontal siding on milled wooden frame
 roof - asphalt shingles on milled wooden rafters
 Integrity: Largely unaltered
 Condition: Good
 Notes: This house was constructed by Roy Hooker, once owner of Hooker's Lumber in Selkirk.

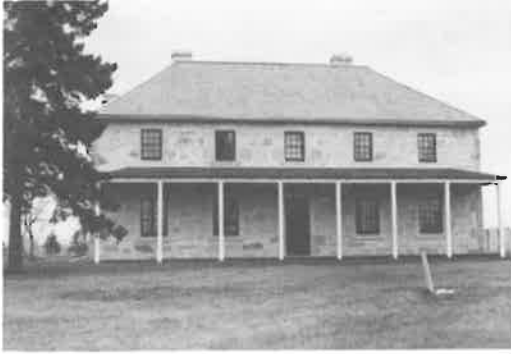
- 33) St. Andrew's Anglican Church Rectory
 Construction Date: 1854
 Location: River Lot #62
 Present Owner: Parks Canada
 Present Use: Museum/Residence
 Construction:
 walls - fieldstone
 roof - wood shingles on square cut timbers
 Integrity: The building was recently restored by Parks Canada to its original state.
 Condition: Excellent
 Notes: This building is also discussed on page 39.

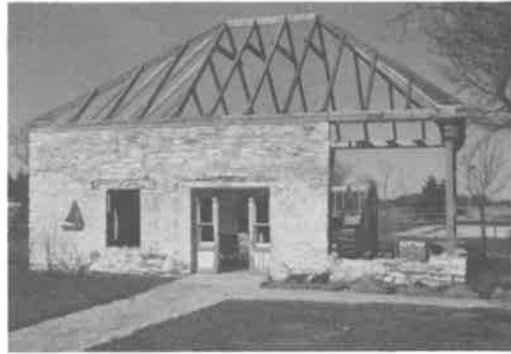
- 34) Scott House
 Construction Date: ca. 1855
 Location: River Lot #47
 Present Owner: Manitoba Parks Branch
 Present Use: Tourist attraction
 Construction:
 walls - fieldstone
 roof - wood shingles on cut timbers
 Integrity: The building has been altered considerably for its current function.
 Condition: Fair
 Notes: This building is also discussed on page 34.

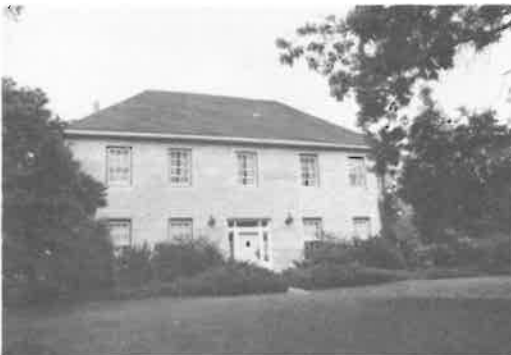
- 35) Twin Oaks, formerly Miss Davis' School
 Construction Date: 1858
 Location: River Lot #51
 Present Owner: Mr. T. Denton
 Present Use: Occupied
 Construction:
 walls - limestone
 roof - asphalt shingles on cut timbers
 Integrity: The interior has been altered.
 Condition: Good
 Notes: This building is also discussed on page 38.

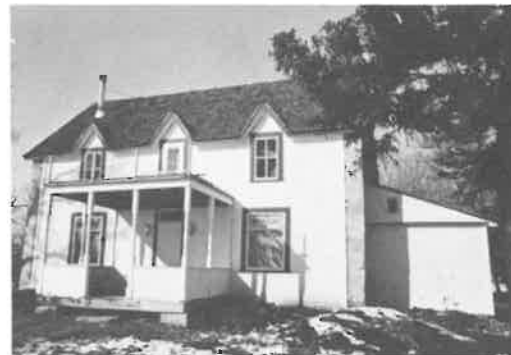
- 36) Hay House
 Construction Date: ca. 1861
 Location: River Lot #86
 Present Owner: Mr. Rudi Isbach
 Present Use: Vacant
 Construction:
 walls - fieldstone and horizontal wood siding on milled wooden frame
 roof - asphalt shingles on cut timbers
 Integrity: The interior has been altered.
 Condition: This building is being greatly upgraded.
 Notes: This building is also discussed on pages 34-36.
