ARCHITECTURAL HERITAGE

The Selkirk and District

Planning Area

David
Butterfield

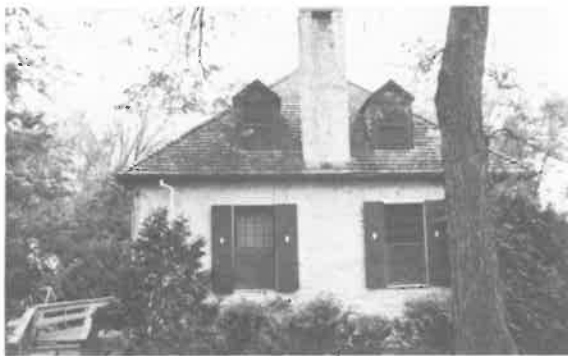
- 37) **Bunn House**
Construction Date: 1861-64
Location: River Lot #97
Present Owner: The Stewart Brothers
Present Use: Summer residence
Construction:
 walls - fieldstone
 roof - wood shingles on cut timbers
Integrity: Unaltered
Condition: Good
Notes: This building is also discussed on pages 36-38.

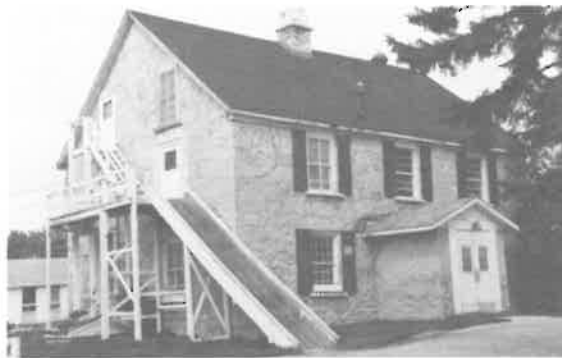
- 38) **St. Peter's Dynevor Indian Hospital**
Construction Date: 1862-65
Location: River Lot #40
Present Owner: St. John's Cathedral Boy's School
Present Use: Administrative Offices
Construction:
 walls - fieldstone
 roof - asphalt shingles on cut timbers
Integrity: The interior has been altered
Condition: Fair
Notes: This building is also discussed on pages 40-42.

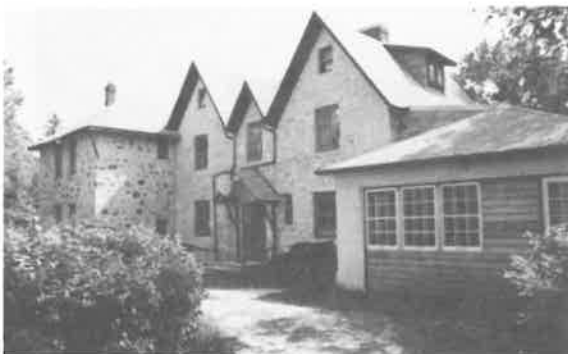
- 39) **Kennedy House**
Construction Date: 1866-70
Location: River Lot #70
Present Owner: Manitoba Parks Branch
Present Use: Tourist Attraction/Tea Room
Construction:
 walls - fieldstone
 roof - wood shingles on cut timbers
Integrity: The interior has been greatly altered and the exterior has been modified.
Condition: Good
Notes: This building is also discussed on pages 42-43.

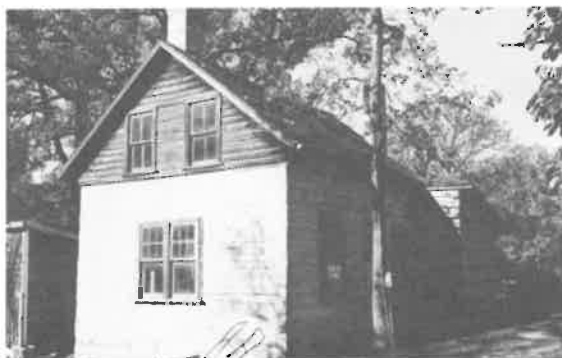
- 40) **Log House**
Construction Date: ca. 1895
Location:
Present Owner: Mrs. West
Present Use: Cottage
Construction:
 walls - squared dovetailed logs
 roof - shingles on milled wooden rafters
Integrity: Largely unaltered
Condition: Good

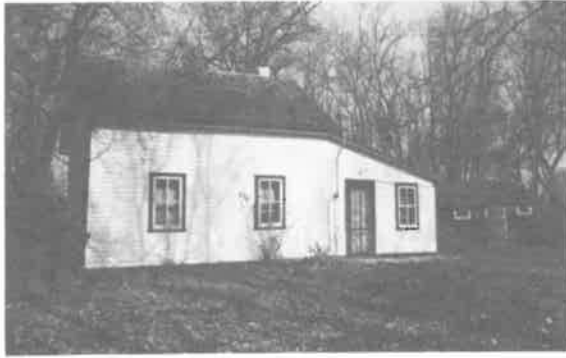
- 41) Log House
 Construction Date: ca. 1875
 Location: St. Peter's Anglican Church Grounds
 Present Owner: Mr. S. Hawchuk
 Present Use: Vacant
 Construction:
 walls - horizontal siding on dovetailed square logs
 roof - wooden shingles on square timber rafters
 Integrity: The building has been moved to its present site.
 Condition: Good
 Notes: This building may be an Indian home from St. Peter's Reserve.

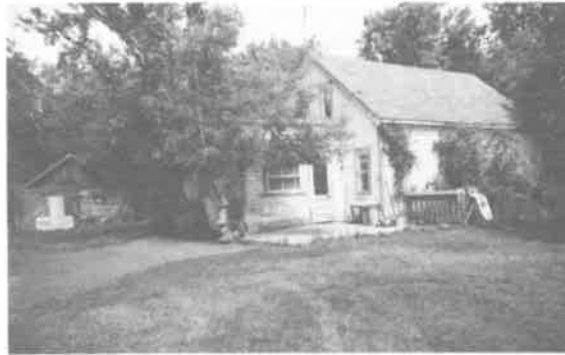
- 42) Log House
 Construction Date: ca. 1900
 Location: River Lot #129
 Present Owner: Mr. P. Kuhn
 Present Use: Occupied
 Construction:
 walls - horizontal siding on squared dovetailed logs
 roof - asphalt shingles on milled wooden rafters
 Integrity: Largely unaltered
 Condition: Fair

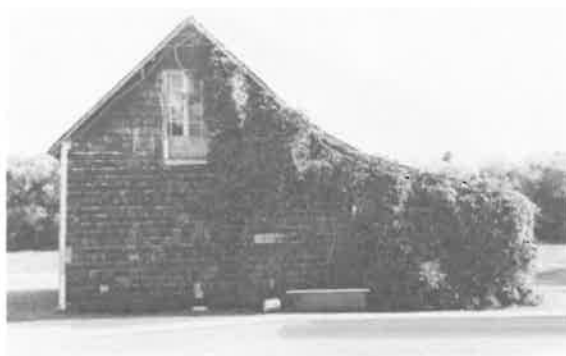
- 43) Log House
 Construction Date: ca. 1900
 Location: SW 2-17-3E
 Present Owner: Mr. Hawkins
 Present Use: Children's Playhouse
 Construction:
 walls - horizontal siding on squared dovetailed logs
 roof - wood shingles on milled wooden rafters
 Integrity: The interior has been completely gutted.
 Condition: Fair
 Notes: This building is also discussed on pages 55-56.

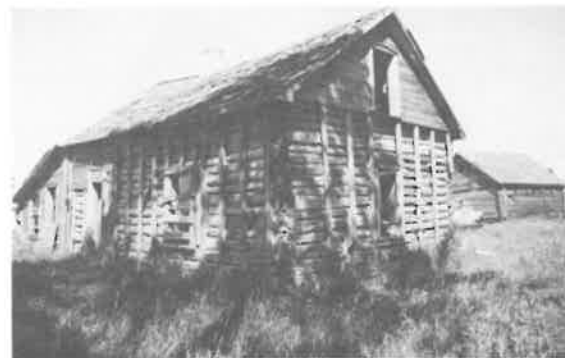
- 44) Log House
 Construction Date: 1906
 Location: NE 32-16-7E
 Present Owner: Mr. Otto
 Present Use: Vacant
 Construction:
 walls - horizontal siding on saddlenotched logs
 roof - wood shingles on milled wooden rafters
 Integrity: Largely unaltered
 Condition: Poor
 Notes: This building served as a post office from 1907-1920.

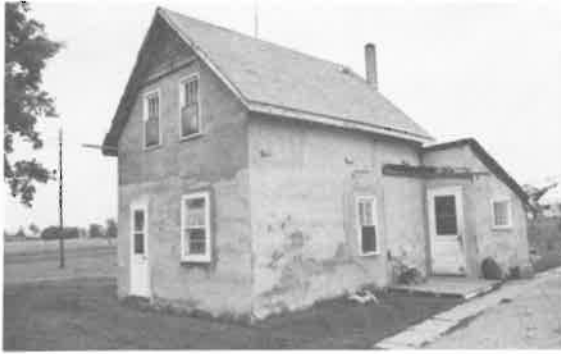
- 45) Log House
 Construction Date: 1910
 Location: River Lot #81
 Present Owner: Mrs. Lillie
 Present Use: Occupied
 Construction:
 walls - stucco veneer on squared dovetailed logs
 roof - asphalt shingles on milled wooden rafters
 Integrity: The interior has been altered.
 Condition: Fair

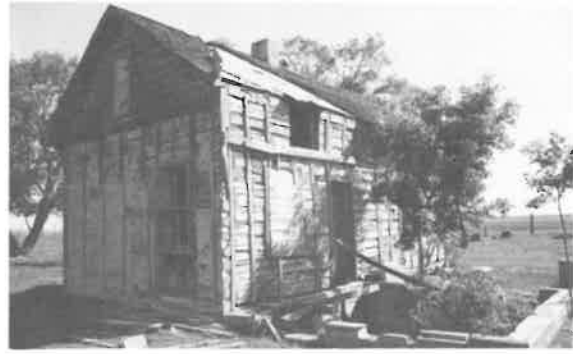
- 46) Log House
 Construction Date: ca. 1910
 Location: SE 12-16-7E
 Present Owner: Mr. V. Parke
 Present Use: Abandoned
 Construction:
 walls - horizontal siding on squared dovetailed logs
 roof - wood shingles on milled wooden rafters
 Integrity: Largely unaltered
 Condition: Poor
 Notes: Henry Parks, who homesteaded this land in 1908, was among the second group of settlers who crossed the Brokenhead River. He was the first school teacher in the area.

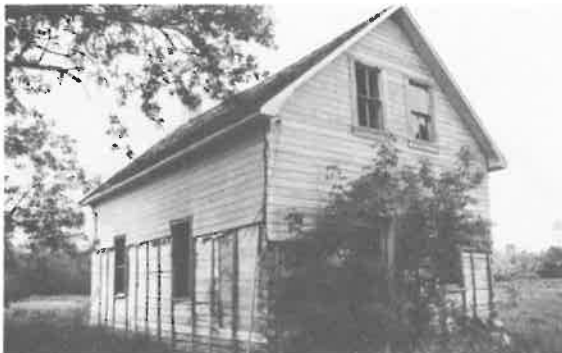
- 47) Log House
 Construction Date: ca. 1910
 Location: NW 3-15-6E
 Present Owner:
 Present Use: Vacant
 Construction:
 walls - horizontal siding on squared dovetailed logs
 roof - wood shingles on milled wooden rafters
 Integrity: Largely unaltered
 Condition: Poor

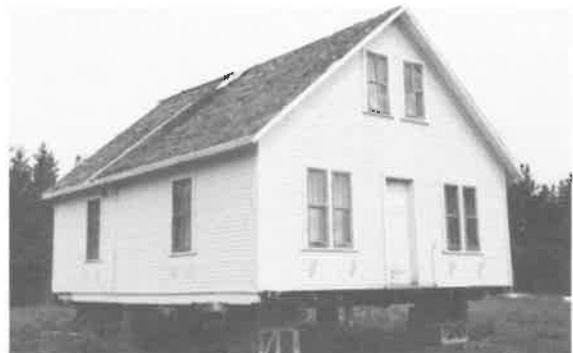
- 48) Log House
 Construction Date: ca. 1910
 Location: SE 32-14-6E
 Present Owner: Mrs. Bowden
 Present Use: Vacant
 Construction:
 walls - horizontal siding on squared dovetailed logs
 roof - wood shingles on milled wooden rafters
 Integrity: Largely unaltered
 Condition: Fair

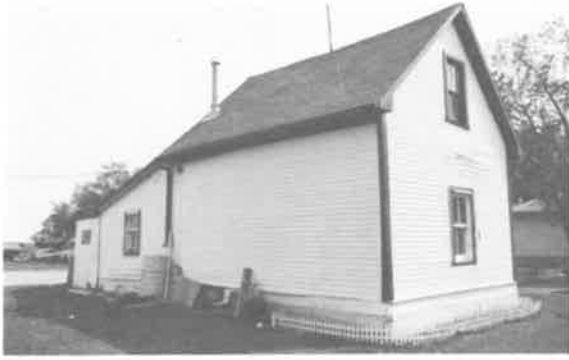
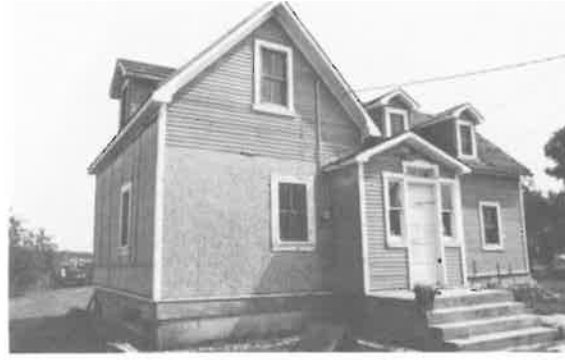
- 49) Log House
 Construction Date: 1911
 Location: River Lot #219
 Present Owner: Mrs. R. Honnie
 Present Use: Occupied
 Construction:
 walls - horizontal siding on squared dovetailed logs
 roof - asphalt shingles on milled wooden rafters
 Integrity: Largely unaltered
 Condition: Fair

- 50) Log House
 Construction date: ca. 1915
 Location: River Lot #242
 Present Owner: Mr. W. Meger
 Present Use: Occupied
 Construction:
 walls - horizontal siding on dovetailed square logs
 roof - wood shingles on milled wooden rafters
 Integrity: Unaltered floorplan
 Condition: Fair
 Notes: The rather complex plan of this house suggests wood frame construction; it is actually of log.

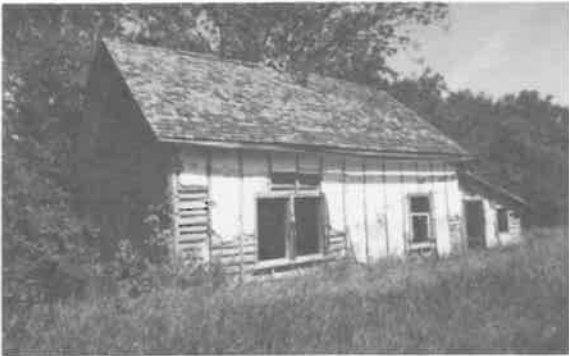
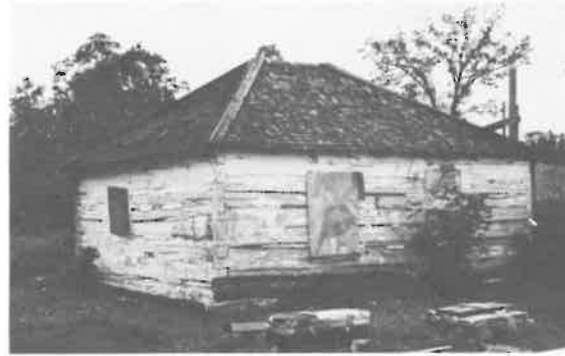
- 51) Log House
 Construction Date: ca. 1920
 Location: River Lot #151
 Present Owner:
 Present Use: Vacant
 Construction:
 walls - plaster veneer on squared dovetailed logs
 roof - wood shingles on cut timbers
 Integrity: Largely unaltered
 Condition: Poor
 Notes: This building is also discussed on page 85.

- 52) Log House
 Construction Date: 1931
 Location: SE 6-17-7E
 Present Owner: Mr. W. Viznagh
 Present Use: Storage
 Construction:
 walls - squared dovetailed logs
 roof - wood shingles on milled wooden rafters
 Integrity: Largely unaltered
 Condition: Fair

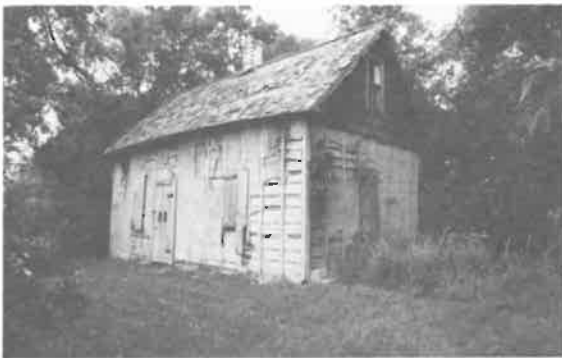
- 55) Galician-Style Log House
 Construction Date:
 Location: SW 6-17-4E
 Present Owner: Mr. W. Bilan
 Present Use: Vacant
 Construction:
 walls - squared dovetailed logs
 roof - wood shingles on cut timbers
 Integrity: Largely unaltered
 Condition: Poor
 Notes: This building is also discussed on page 85.

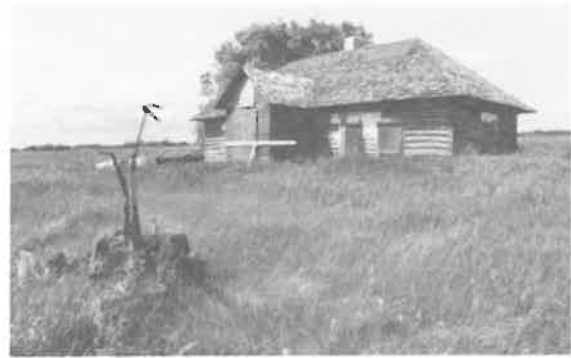
- 56) Bukovynian Log House
 Construction Date: 1913
 Location: River Lot #178
 Present Owner: Mr. Depaulo
 Present Use: Vacant
 Construction:
 walls - horizontal siding on square dovetailed logs
 roof - wood shingles on milled wooden rafters
 Integrity: The interior has been altered
 Condition: Fair
 Notes: This building is also discussed on page 84.
 The structure was demolished in 1987.

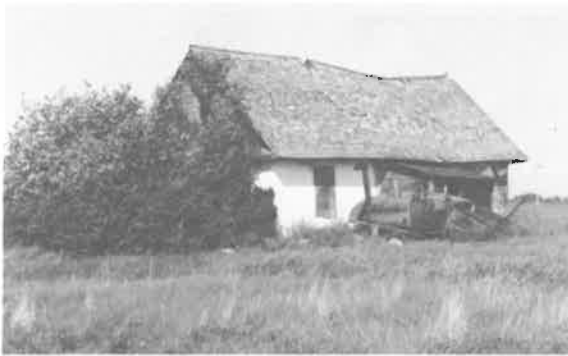
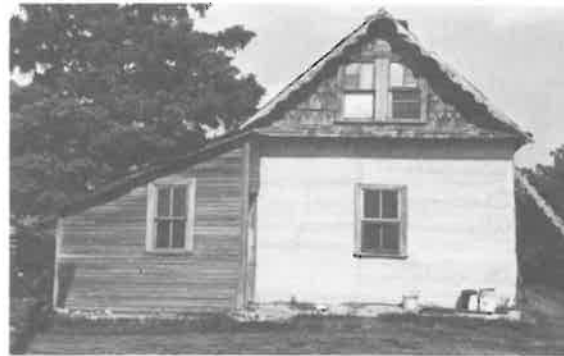
- 57) Galician Log House
 Construction Date: ca. 1920
 Location:
 Present Owner: Mr. Sawchuk
 Present Use: Abandoned
 Construction:
 walls - plaster veneer on square dovetailed logs
 roof - wood shingles on squared logs
 Integrity: Largely unaltered
 Condition: Poor

- 58) Galician Log House
 Construction Date: ca. 1920
 Location: NW 12-17-3E
 Present Owner: Mr. Yakobowski
 Present Use: Occupied
 Construction:
 walls - plaster veneer on squared dovetailed logs
 roof - wood shingles on cut timbers
 Integrity: Largely unaltered
 Condition: Fair
 Notes: This building is also discussed on page 2 83-84.

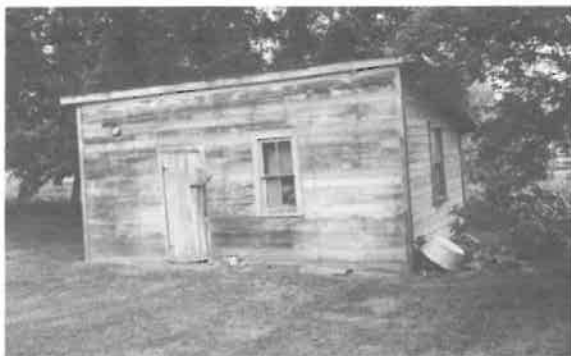
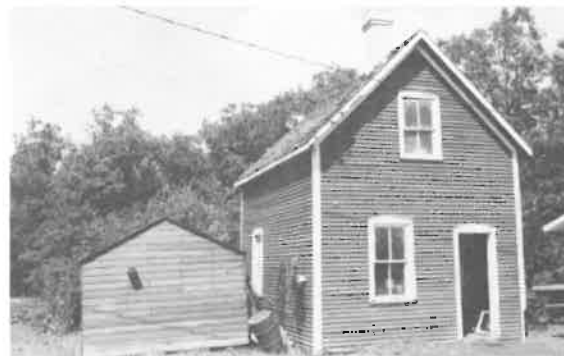
- 59) Single Storey Shanty
 Construction Date: ca. 1890
 Location: River Lot #199
 Present Owner: Mrs. M. Ritchie
 Present Use: Storage
 Construction:
 walls - horizontal siding on milled wooden frame
 roof - wood shingles on milled wooden rafters
 Integrity: Largely unaltered
 Condition: Fair
 Notes: This building is also discussed on page 58.

- 60) 1 1/2 Storey Side Hall House
 Construction Date: ca. 1890
 Location: SW 12-14-3E
 Present Owner: Mr. Dewar
 Present Use: Storage
 Construction:
 walls - horizontal siding on milled wooden frame
 roof - wood shingles on milled wooden rafters
 Integrity: The interior has been altered
 Condition: Fair

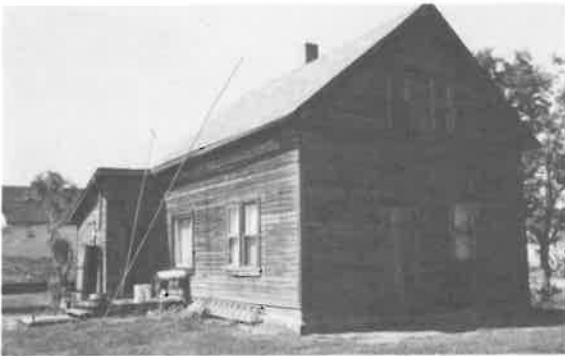
- 63) 1 1/2 Storey Side Hall House
 Construction Date: ca. 1910
 Location: NE 32-16-8E
 Present Owner: L. Turner & R. Dick
 Present Use: Occupied
 Construction:
 walls - horizontal siding on milled wooden frame
 roof - asphalt shingles on milled wooden rafters
 Integrity: Largely unaltered
 Condition: Fair

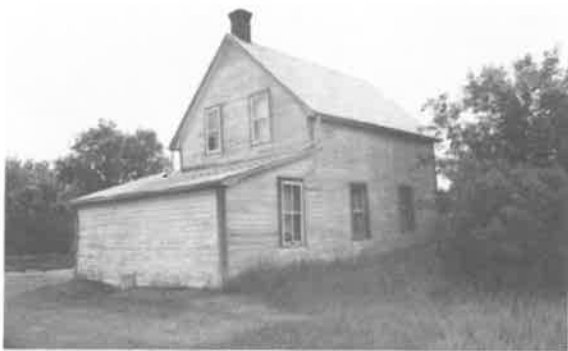
- 65) 1 1/2 Storey Side Hall House
 Construction Date: ca. 1910
 Location: River Lot #121
 Present Owner: A. MacArthur
 Present Use: Summer occupancy
 Construction:
 walls - horizontal siding on milled wooden frame
 roof - asphalt shingles on milled wooden rafters
 Integrity: Unaltered floorplan
 Condition: Good
 Notes: This building is also discussed on pages 56-58.

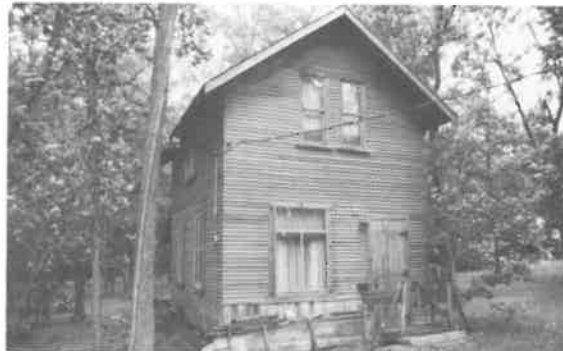
- 66) 1 1/2 Storey Side Hall House
 Construction Date: ca. 1915
 Location: River Lot #117
 Present Owner: Mr. C. Douglas
 Present Use: Vacant
 Construction:
 walls - horizontal siding on milled wooden frame
 roof - asphalt shingles on milled wooden rafters
 Integrity: Largely unaltered
 Condition: Good

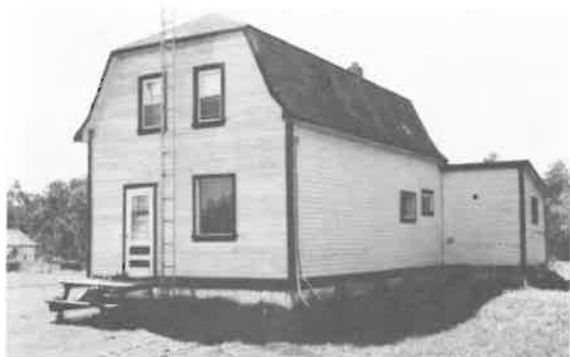
- 67) 1 1/2 Storey Side Hall House with Hipped Gable Roof
 Construction Date: ca. 1915
 Location: NE 18-14-6E
 Present Owner: Manitoba Agricultural Credit Corporation
 Present Use: Occupied
 Construction:
 walls - horizontal siding on milled wooden frame
 roof - asphalt shingles on milled wooden rafters
 Integrity: Unaltered floorplan
 Condition: Good
 Notes: This building is also discussed on pages 58-59.

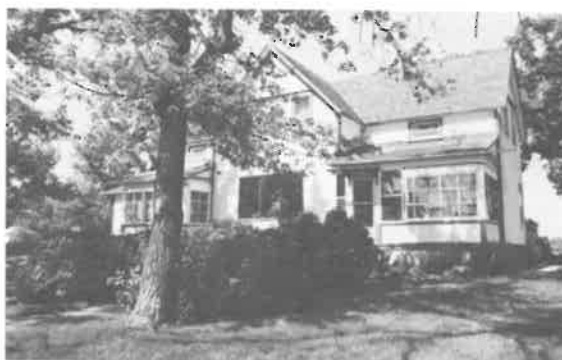
- 68) 1 1/2 Storey T-shaped House
 Construction Date: ca. 1890
 Location: River Lot #18
 Present Owner: Mr. Slyker
 Present Use: Occupied
 Construction:
 walls - horizontal siding on milled wooden frame
 roof - asphalt shingles on milled wooden rafters
 Integrity: Only the original kitchen area has been altered
 Condition: Good

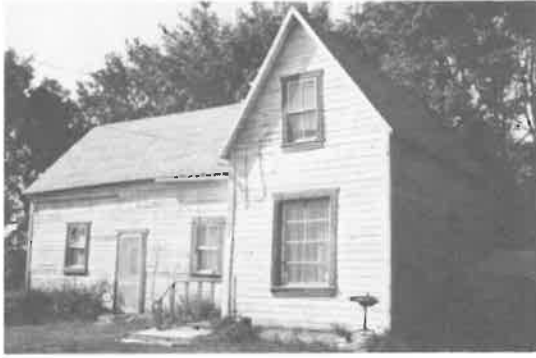
- 69) 1 1/2 Storey L-Shaped House
 Construction Date: ca. 1890
 Location: SW 27-15-6E
 Present Owner: R. Krahn
 Present Use: Vacant
 Construction:
 walls - horizontal siding on squared dovetailed logs
 roof - asphalt shingles on milled wooden rafters
 Integrity: The original log house has been enlarged
 with an addition.
 Condition: Fair

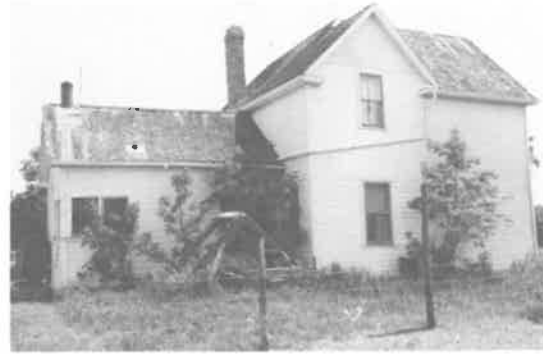
- 70) 1 1/2 Storey L-Shaped House
 Construction Date: 1900
 Location: SW 9-14-4E
 Present Owner: T. Jenkins
 Present Use: Storage
 Construction:
 walls - horizontal siding on milled wooden frame
 roof - wood shingles on milled wooden rafters
 Integrity: Largely unaltered
 Condition: Good

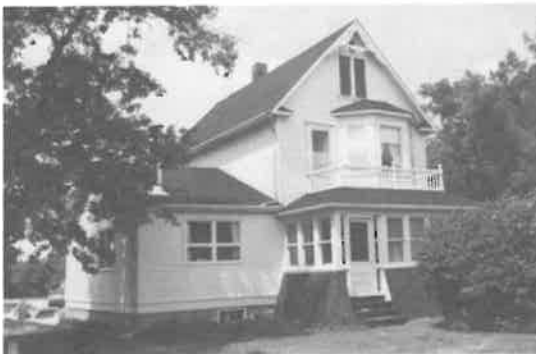
- 71) 1 1/2 Storey L-Shaped House
 Construction Date: ca. 1900
 Location: River Lot #124
 Present Owner: Mr. K.W. Noreus
 Present Use: Occupied
 Construction:
 walls - horizontal siding on milled wooden frame
 roof - asphalt shingles on milled wooden rafters
 Integrity: The interior has been altered.
 Condition: Good
 Notes: This building is also discussed on page 58.

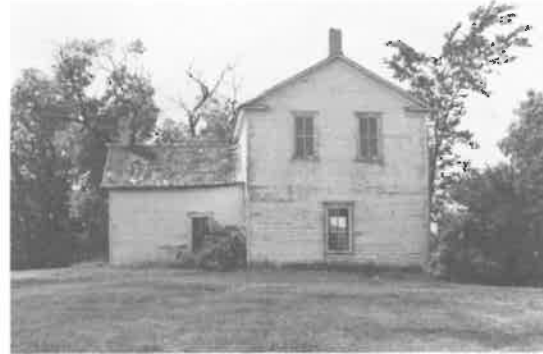
- 72) 1 1/2 Storey L-Shaped House
 Construction Date: ca. 1900
 Location: SE 3-15-4E
 Present Owner: H. Zelyk
 Present Use: Vacant
 Construction:
 walls - horizontal siding on milled wooden frame
 roof - wood shingles on milled wooden rafters
 Integrity: Largely unaltered
 Condition: Poor

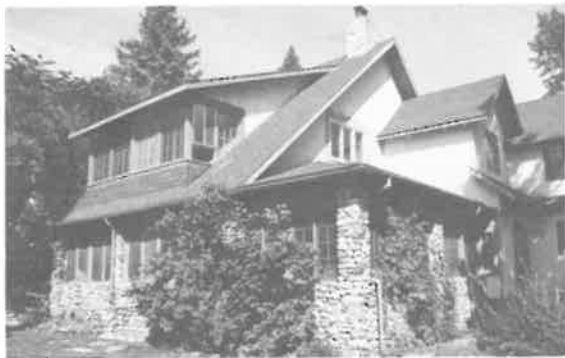
- 73) 1 1/2 Storey House
 Construction Date: 1908-1910
 Location: River Lot #13
 Present Owner: Mrs. Tallin
 Construction:
 walls - fieldstone
 roof - asphalt shingles on milled wooden rafters
 Integrity: The floorplan has been expanded with several additions
 Condition: Good

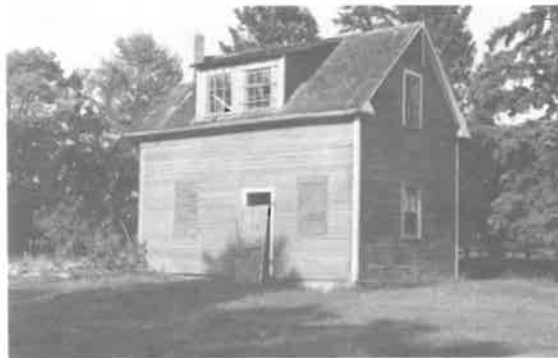
- 74) 1 1/2 Storey House
 Construction Date: ca. 1910
 Location: SW 2-17-3E
 Present Owner: Mr. Hawkins
 Present Use: Vacant
 Construction:
 walls - horizontal siding on saddlenotched logs
 roof - wood shingles on milled wooden rafters
 Integrity: The interior was altered at one time for use as a chicken coop.
 Condition: Poor
 Notes: The building has been destroyed since the survey was done.

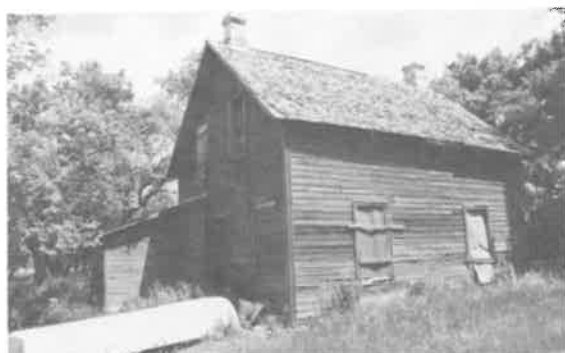
- 75) 1 1/2 Storey House
 Construction Date: ca. 1910
 Location: River Lot #138
 Present Owner: The Klos Brothers
 Present Use: Vacant
 Construction:
 walls - horizontal siding on milled wooden frame
 roof - wood shingles on milled wooden rafters
 Integrity: Largely unaltered
 Condition: Fair

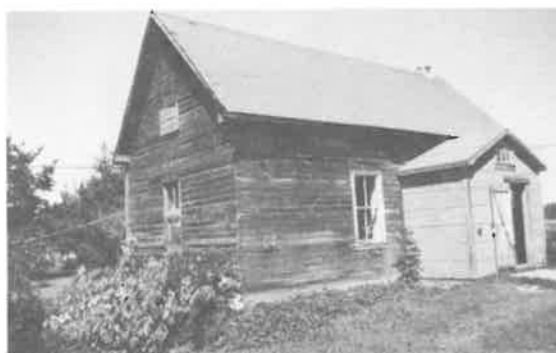
- 76) 1 1/2 Storey House
 Construction Date: 1912
 Location: NW 24-16-7E
 Present Owner: Mr. Monsan
 Present Use: Occupied
 Construction:
 walls - horizontal siding on milled wooden frame
 roof - asphalt shingles on milled wooden rafters
 Integrity: Largely unaltered
 Condition: Fair

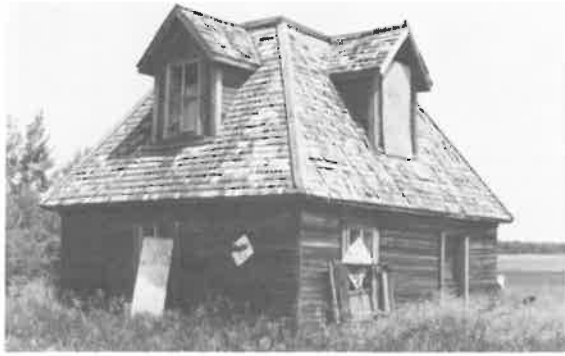
- 77) 1 1/2 Storey Cottage
 Construction Date: ca. 1915
 Location: NW 19-15-4E
 Present Owner: J. Hacking
 Present Use: Vacant
 Construction:
 walls - horizontal siding on milled wooden frame
 roof - wood shingles on milled wooden rafters
 Integrity: Largely unaltered
 Condition: Poor

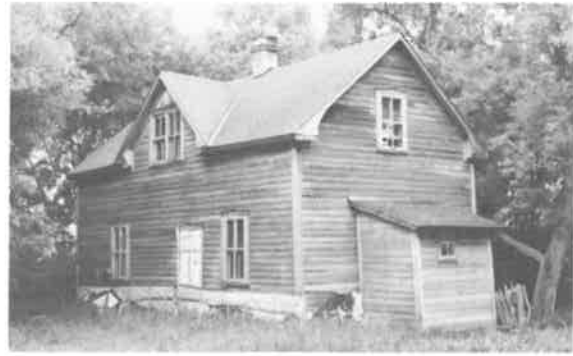
- 78) 1 1/2 Storey Central Gable House
 Construction Date: ca. 1890
 Location: NW 36-17-3E
 Present Owner: Mr. N. Swirski
 Present Use: Occupied
 Construction:
 walls - horizontal siding on milled wooden frame
 roof - asphalt shingles on milled wooden rafters
 Integrity: Largely unaltered
 Condition: Fair

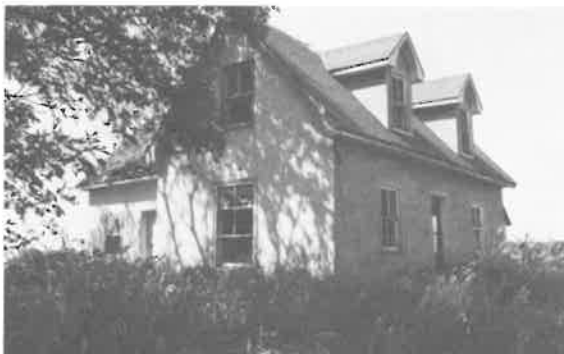
- 79) 1 1/2 Storey Central Plan House
 Construction Date: ca. 1920
 Location: SE 33-15-6E
 Present Owner: S. Myslawchuk
 Present Use: Vacant
 Construction:
 walls - stucco veneer on milled wooden frame
 roof - wood shingles on milled wooden rafters
 Integrity: Largely unaltered
 Condition: Poor

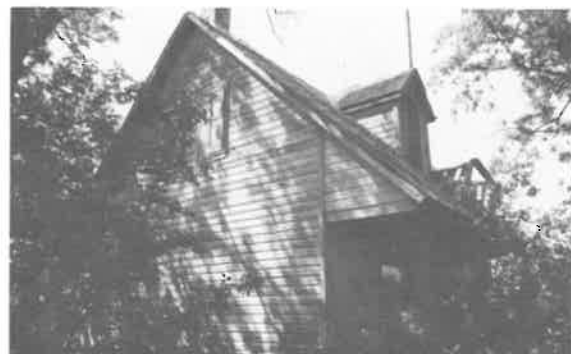
- 80) 1 1/2 Storey House
 Construction Date: ca. 1925
 Location: NE 9-14-4E
 Present Owner: J. Clouston
 Present Use: Vacant
 Construction:
 walls - horizontal siding on milled wooden frame
 roof - wood shingles on milled wooden rafters
 Integrity: Largely unaltered
 Condition: Poor

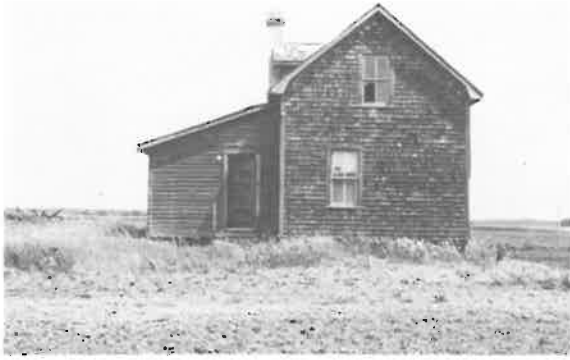
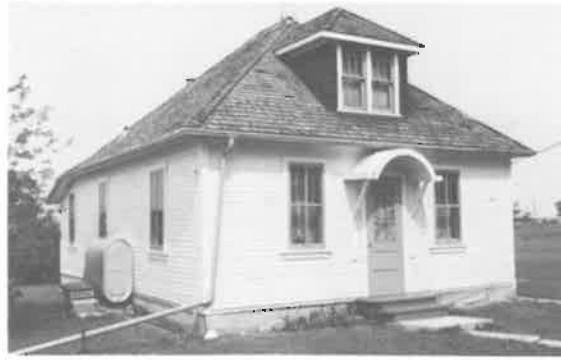
- 81) 1 1/2 Storey House
 Construction Date: ca. 1925
 Location: SW 23-16-3E
 Present Owner: R. Penner
 Present Use: Vacant
 Construction:
 walls - wood shingles on milled wooden frame
 roof - wood shingles on milled wooden rafters
 Integrity: Largely unaltered
 Condition: Fair

- 82) 1 1/2 Storey Cottage
 Construction Date: 1929
 Location: River Lot #242
 Present Owner: Mrs. Zybyluk
 Present Use: Occupied
 Construction:
 walls - horizontal siding on milled wooden frame
 roof - wood shingles on milled wooden rafters
 Integrity: Largely unaltered
 Condition: Good

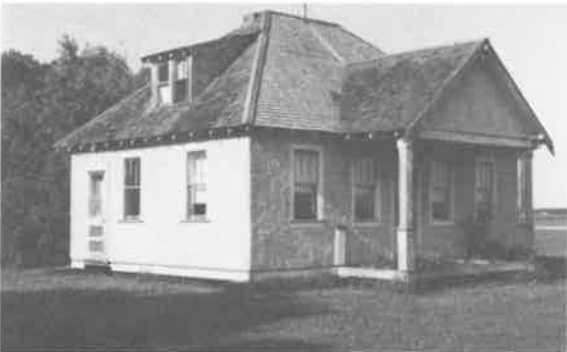
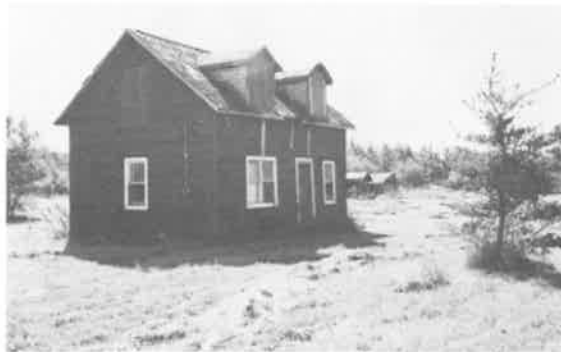
- 83) 1 1/2 Storey Central Plan House
 Construction Date: ca. 1930
 Location: NE 14-17-3E
 Present Owner: Mr. V. Nitchie
 Present Use: Storage
 Construction:
 walls - stucco veneer on milled wooden frame
 roof - wood shingles on milled wooden rafters
 Integrity: Largely unaltered
 Condition: Good

- 84) 1 1/2 Storey Central Plan House
 Construction Date: ca. 1930
 Location: NE 32-16-7E
 Present Owner: Mr. A. Hourie
 Present Use: Vacant
 Construction:
 walls - insulbrick veneer on milled wooden frame
 roof - wood shingles on milled wooden rafters
 Integrity: Largely unaltered
 Condition: Poor

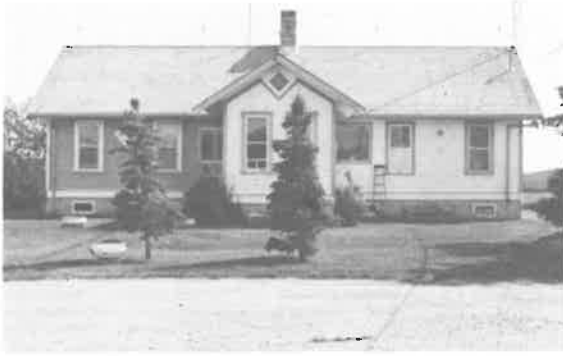
- 85) Single Storey House
 Construction Date: 1928
 Location: NE 2-16-3E
 Present Owner: Mr. C.P. Kollar
 Present Use: Occupied
 Construction:
 walls - horizontal siding on milled wooden frame
 roof - asphalt shingles on milled wooden rafters
 Integrity: Largely unaltered
 Condition: Good

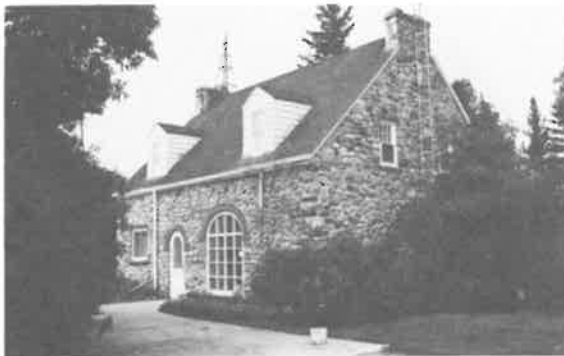
- 87) 1 1/2 Storey Stone House
 Construction Date: 1939-41
 Location: NW 1-14-5E
 Present Owner: Mr. W. Buchanan
 Present Use: Occupied
 Construction:
 walls -
 roof - wood shingles on milled wooden rafters
 Integrity: Largely unaltered
 Condition: Good

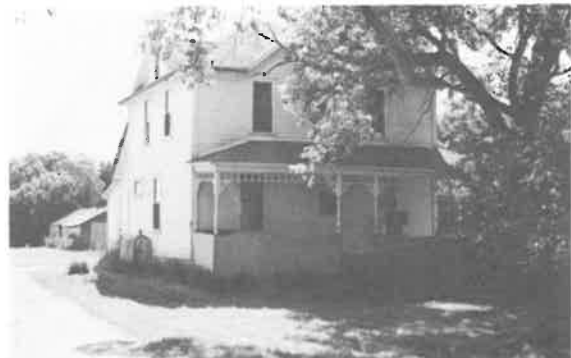
- 88) 2 1/2 Storey Square Plan House
 Construction Date: ca. 1910
 Location: SW 35-14-4E
 Present Owner: E. Bracken
 Present Use: Vacant
 Construction:
 walls - horizontal siding on milled wooden frame
 roof - asphalt shingles on milled wooden rafters
 Integrity: Largely unaltered
 Condition: Good
 Notes: This building is also discussed on page 61.

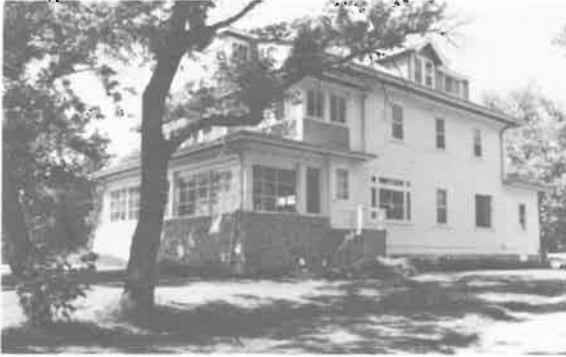
- 89) 2 1/2 Storey Square Plan House
 Construction Date: 1912
 Location: River Lot #17
 Present Owner: Mrs. Fox
 Present Use: Occupied
 Construction:
 walls - horizontal siding on milled wooden frame
 roof - asphalt shingles on milled wooden rafters
 Integrity: Largely unaltered
 Condition: Good
 Notes: This building is also discussed on pages 61-63.

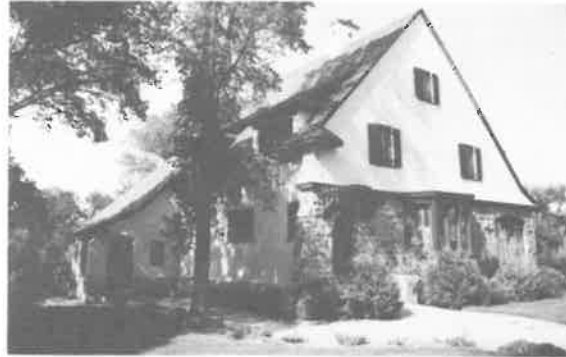
- 90) 2 1/2 Storey House
 Construction Date: 1918
 Location: River Lots #117-119
 Present Owner: Dr. Olafson
 Present Use: Occupied
 Construction:
 walls - stone and stucco veneer on milled wooden frame
 roof - asphalt shingles on milled wooden rafters
 Integrity: Unaltered floorplan
 Condition: Good
 Notes: This building stands on the site of the original Hawthorne Lodge, discussed on page 29.

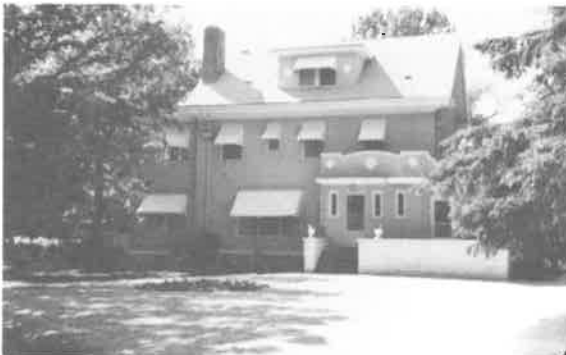
- 91) 2 1/2 Storey House
 Construction Date: 1915
 Location: River Lot #114
 Present Owner: Dr. Robertson
 Present Use: Occupied
 Construction:
 walls - stucco veneer on milled wooden frame
 roof - asphalt shingles on milled wooden rafters
 Integrity: Largely unaltered
 Condition: Good

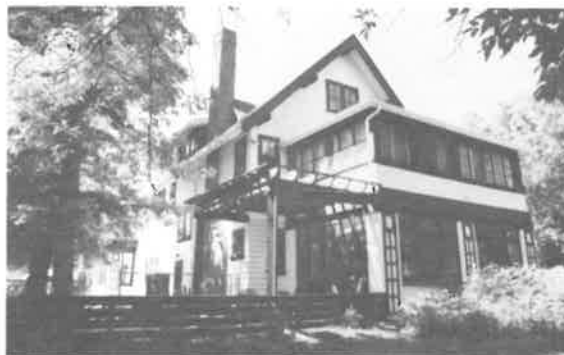
- 92) 2 1/2 Storey House
 Construction Date: 1919
 Location: River Lot #114
 Present Owner: Ms. Schadek
 Present Use: Occupied
 Construction:
 walls - horizontal siding on milled wooden frame
 roof - asphalt shingles on milled wooden rafters
 Integrity: Largely unaltered
 Condition: Good

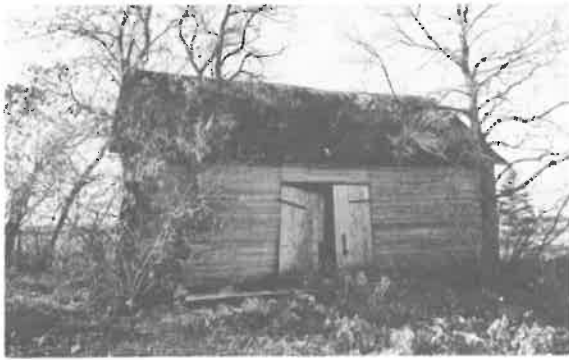
- 93) Red River Frame Barn
 Construction Date: ca. 1870
 Location: SW 10-14-4E
 Present Owner:
 Present Use: Vacant
 Construction:
 walls - Red River frame logs
 roof - wood shingles on hewn log rafters
 Integrity: Largely unaltered
 Condition: Poor
 Notes: This building is one of only three remaining structures in the planning area that used Red River frame construction procedures.

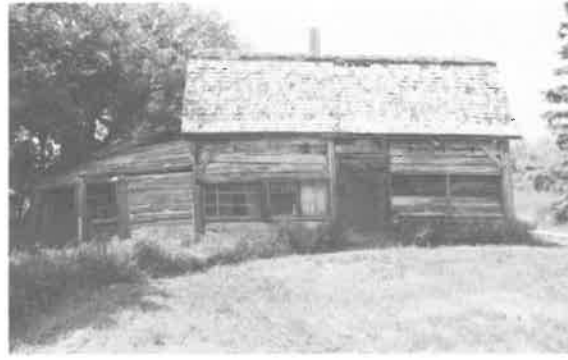
- 94) Log Barn
 Construction Date: 1860 (reconstructed 1922)
 Location: River Lot #129
 Present Owner: Mr. P. Kuhn
 Present Use: Storage
 Construction:
 walls - Red River Frame log construction
 roof - wood shingles on milled wooden rafters
 Integrity: The barn was once much larger and oriented differently. Materials from the 1860 barn were used in this barn.
 Condition: Poor
 Notes: This building is also discussed on pages 23-24.

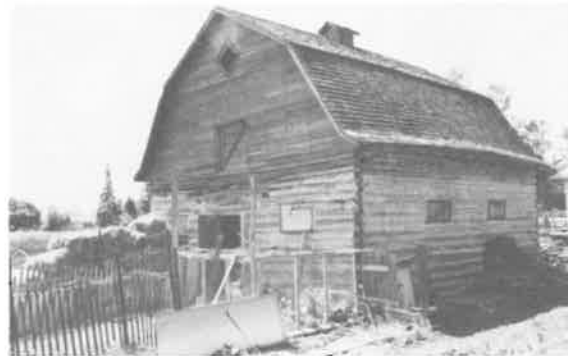
- 96) Log Barn
 Construction Date: ca. 1880
 Location: River Lot #188
 Present Owner: Mr. S. Miller
 Present Use: Storage
 Construction:
 walls - squared dovetailed logs
 roof - wood shingles on milled wooden rafters
 Integrity: The former gable roof was replaced.
 Condition: Fair

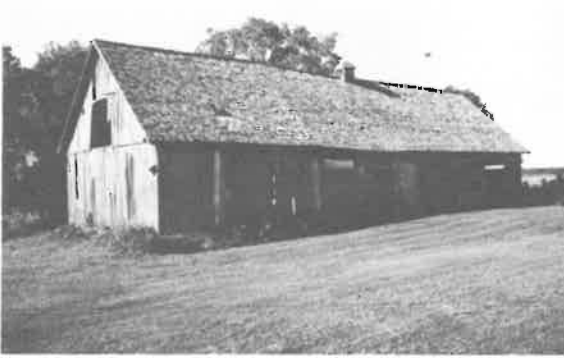
- 97) **Heavy Wood Frame Barn**
Construction Date: ca. 1910
Location: NW 24-15-6E
Present Owner: Mr. C. Horbady
Present Use: Storage
Construction:
 walls - horizontal and vertical siding on heavy wood frame
 roof - wood shingles on milled wooden rafters
Integrity: Unaltered
Condition: Fair

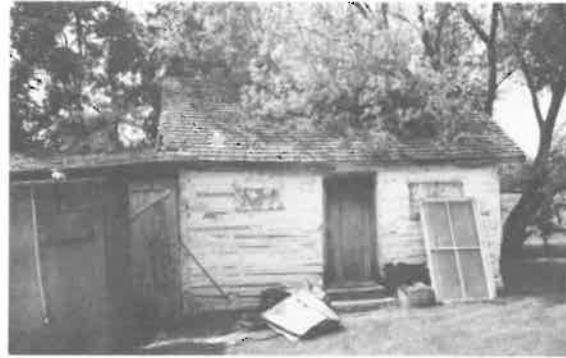
- 98) **Log Barn**
Construction Date: ca. 1910
Location: River Lot #264
Present Owner: Henry Semenchuk
Present Use: Storage
Construction:
 walls - dovetailed squared logs
 roof - wood shingles on hewn wooden rafters
Integrity: Largely unaltered
Condition: Fair
Notes: This building is also discussed on page 64.

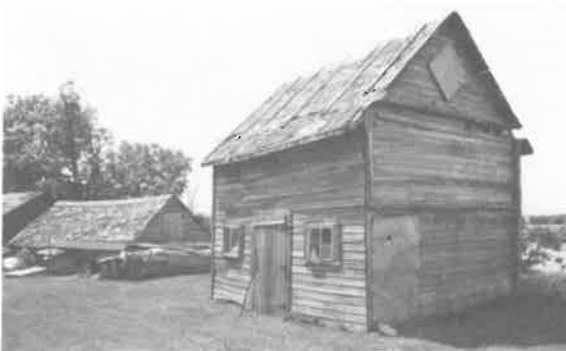
- 99) **Light Wood Frame Stable**
Construction Date: ca. 1910
Location: River Lot #255
Present Owner: Mr. M. Nebozonko
Present Use: Storage
Construction:
 walls - horizontal siding on milled wooden frame
 roof - wood shingles on milled wooden rafters
Integrity: Unaltered
Condition: Good

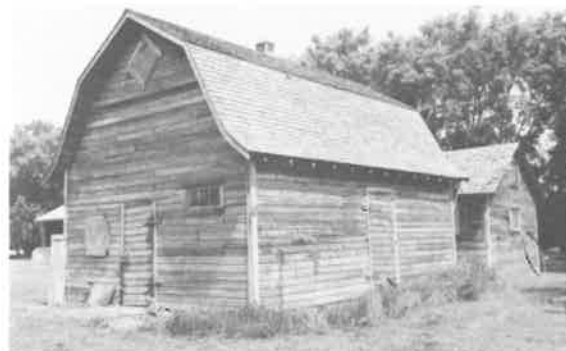
- 100) **Light Wood Frame Barn**
Construction Date: 1912
Location: River Lot #261
Present Owner: Mr. Henry Semenchuk
Present Use: Storage
Construction:
 walls - horizontal siding on milled wooden frame
 roof - wood shingles on milled wooden rafters
Integrity: Unaltered
Condition: Good

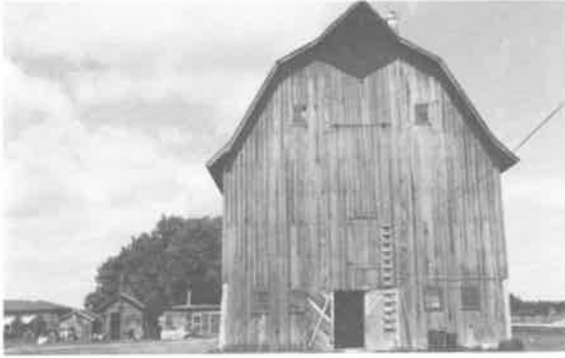
- 101) Large Light Wood Frame Barn
 Construction Date: 1912
 Location: River Lot #20
 Present Owner: Mr. Overwater
 Present Use: Storage
 Construction:
 walls - concrete stable and light frame loft
 roof - wood shingles on built-up wooden rafters
 Integrity: Unaltered
 Condition: Good
 Notes: This building is also discussed on pages 65-66.

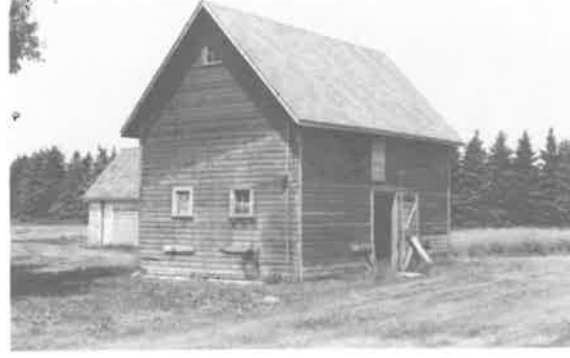
- 102) Light Wood Frame Stable
 Construction Date: 1913
 Location: NE 15-15-3E
 Present Owner: Mrs. C.S. Pruden
 Present Use: Storage
 Construction:
 walls - horizontal siding on milled wooden frame
 roof - wood shingles on milled wooden rafters
 Integrity: Unaltered
 Condition: Good
 Notes: This building is also discussed on pages 65 and 67.

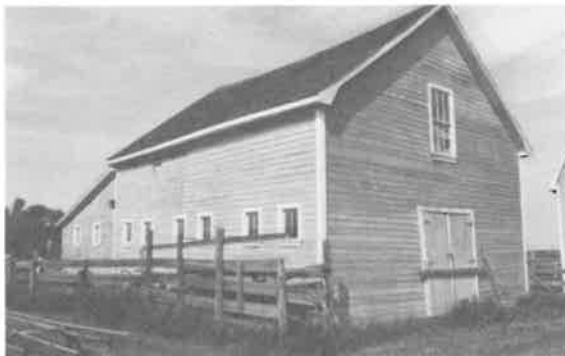
- 103) Large Light Wood Frame Barn
 Construction Date: 1915
 Location: SE 1-15-4E
 Present Owner: Mr. Macklin
 Present Use: Functioning Barn
 Construction:
 walls - horizontal siding on milled wooden frame
 roof - wood shingles on milled wooden rafters
 Integrity: Unaltered
 Condition: Good

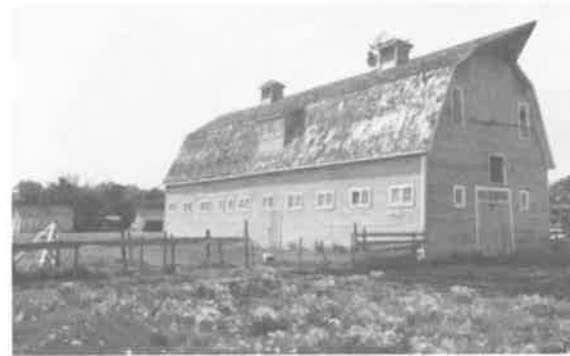
- 104) Large Light Wood Frame Barn
 Construction Date: 1915
 Location: SE 1-15-4E
 Present Owner: Mr. Macklin
 Present Use: Functioning Barn
 Construction:
 walls - horizontal siding on milled wooden frame
 roof - wood shingles on built-up wooden rafters
 Integrity: Unaltered
 Condition: Good

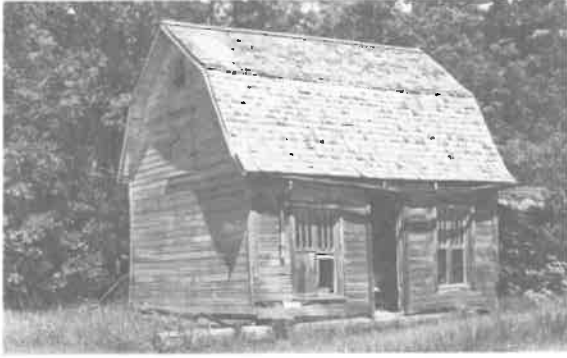
- 105) **Small Light Wood Frame Barn**
Construction Date: ca. 1915
Location: River Lots 89 and 90
Present Owner: Mr. Kartzmark
Present Use: Storage
Construction:
 walls - horizontal siding on milled wooden frame
 roof - wood shingles on milled wooden rafters
Integrity: The interior has been altered for its later function as a residence
Condition: Fair

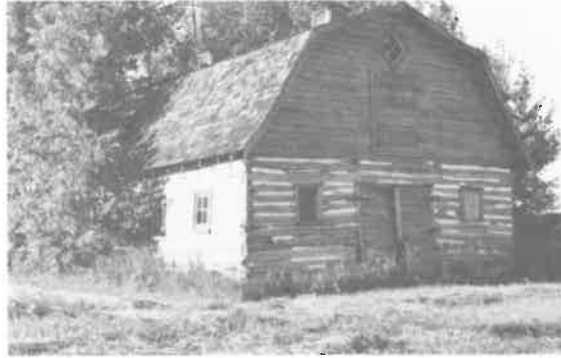
- 106) **Log Barn**
Construction Date: ca. 1920
Location: SW 34-17-3E
Present Owner: Mr. Huminicki
Present Use: Storage
Construction:
 walls - dovetailed logs
 roof - wood shingles on milled wooden rafters
Integrity: Unaltered
Condition: Fair

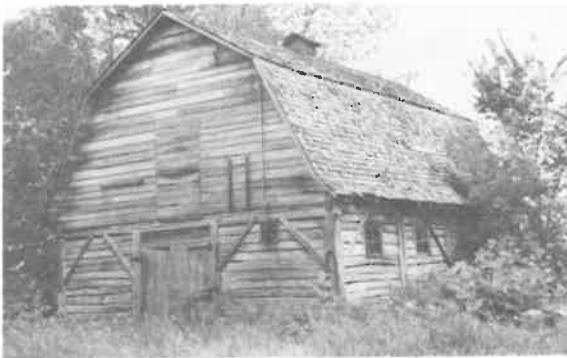
- 107) **Log Barn**
Construction Date: ca. 1920
Location: NW 35-17-3E
Present Owner: Mr. C. Stutsky
Present Use: Vacant
Construction:
 walls - Post-and-Sill Logs
 roof - wood shingles on milled wooden rafters
Integrity: Unaltered
Condition: Good
Notes: Like earlier Ukrainian barns in other areas of the province, this log structure was supported at its corners with diagonal braces.

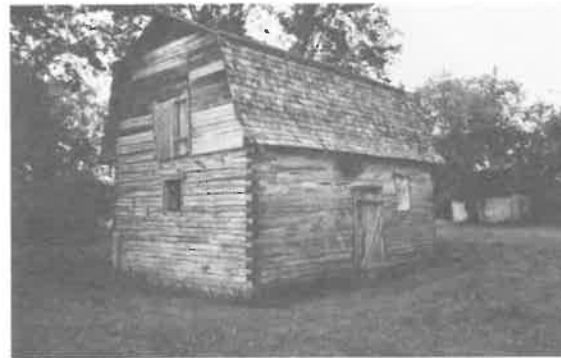
- 108) **Log Barn**
Construction Date: ca. 1920
Location: Libau
Present Owner:
Present Use: Storage
Construction:
 walls - squared dovetailed logs
 roof - wood shingles on milled wooden rafters
Integrity: Unaltered
Condition: Fair

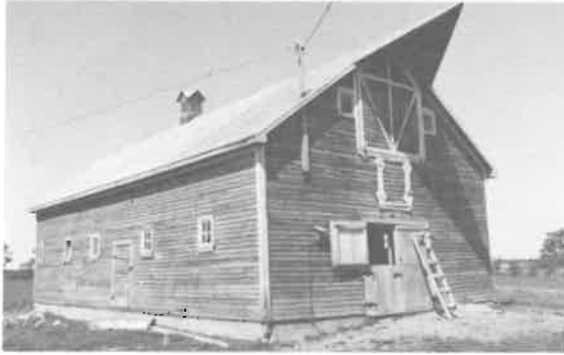
- 109) Large Light Wood Frame Barn
 Construction Date: ca. 1920
 Location: NE 18-16-8E
 Present Owner: G. Lloyd
 Present Use: Functioning Barn
 Construction:
 walls - horizontal siding on milled wooden frame
 roof - metal sheeting on milled wooden rafters
 Integrity: Unaltered
 Condition: Good

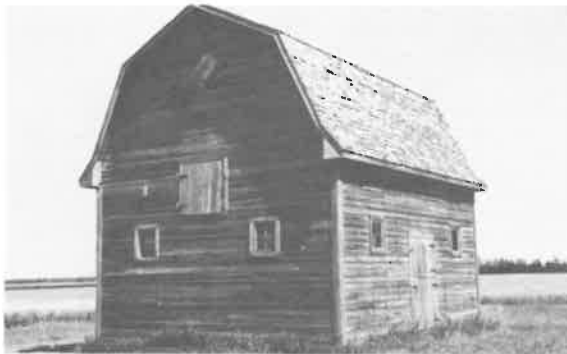
- 111) Small Light Wood Frame Barn
 Construction Date: ca. 1925
 Location: SW 21-15-6E
 Present Owner:
 Present Use: Storage
 Construction:
 walls - horizontal siding on milled wooden frame
 roof - wood shingles on milled wooden rafters
 Integrity: Unaltered
 Condition: Good

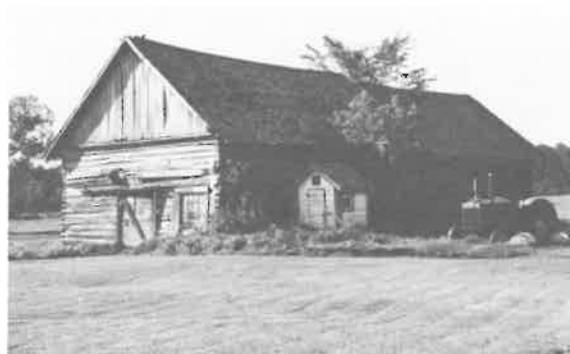
- 112) Log Barn
 Construction Date: ca. 1925
 Location: SW 13-15-6E
 Present Owner: Mr. R. Ozol
 Present Use: Storage
 Construction:
 walls - squared dovetailed logs
 roof - wood shingles on squared logs
 Integrity: Unaltered
 Condition: Fair

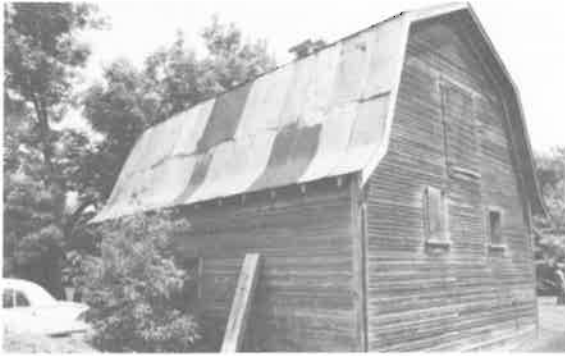
- 113) Small Light Wood Frame Barn
 Construction Date: ca. 1930
 Location: River Lot #236
 Present Owner: Mr. A. Wachel
 Present Use: Storage
 Construction:
 walls - horizontal siding on milled wooden frame
 roof - metal sheeting on milled wooden rafters
 Integrity: Unaltered
 Condition: Good

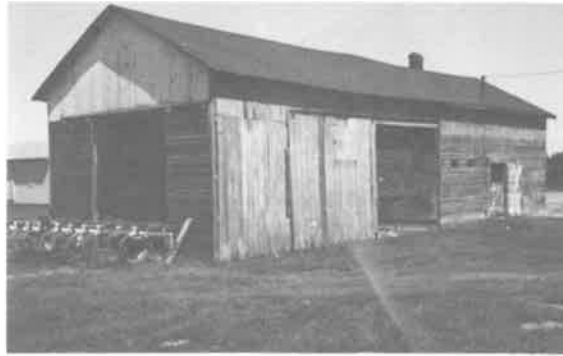
- 114) Light Wood Frame Barn
 Construction Date: ca. 1930
 Location: NE 30-16-8E
 Present Owner: Mr. F. Klann
 Present Use: Storage/Granary
 Construction:
 walls - horizontal siding on milled wooden frame
 roof - asphalt shingles on milled wooden rafters
 Integrity: Unaltered
 Condition: Fair
 Notes: This building is also discussed on page 74.

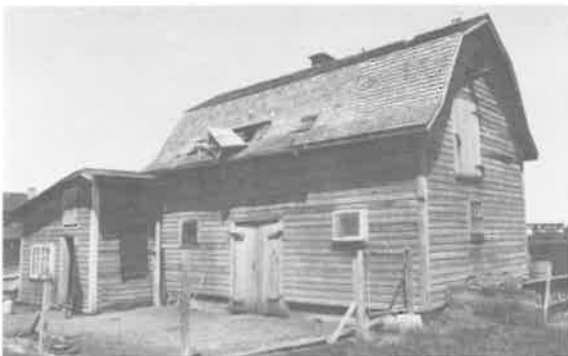
- 115) Small Light Wood Frame Barn
 Construction Date: 1936
 Location: River Lots #21 and 22
 Present Owner: Mr. Art Neltner
 Present Use: Pigeon Coop
 Construction:
 walls - horizontal siding on milled wooden frame
 roof - wood shingles on milled wooden rafters
 Integrity: The interior has been altered for its present function
 Condition: Fair

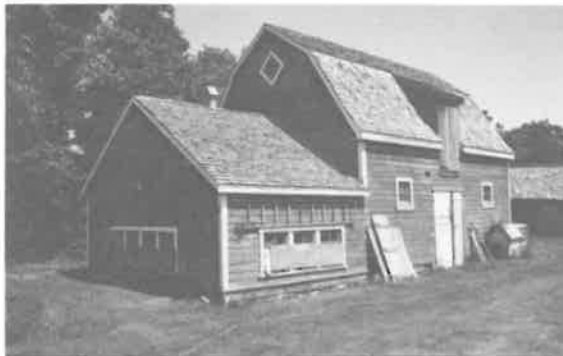
- 116) Market Barn
 Construction Date: ca. 1930
 Location: River Lot #69
 Present Owner: P. Charaton
 Present Use: Storage
 Construction:
 walls - horizontal siding on milled wooden frame
 roof - asphalt shingles on built-up wooden rafters
 Integrity: The interior has been altered with the extension of the building to incorporate a chicken coop.
 Condition: Good
 Notes: This building is also discussed on pages 68-69.

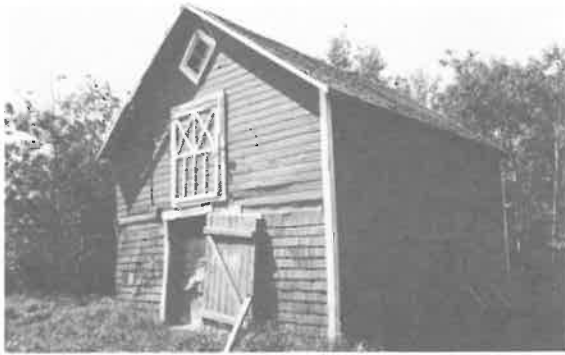
- 117) Small Light Wood Frame Barn
 Construction Date: 1938
 Location: SE 7-14-6E
 Present Owner: Mr. M. Chorney
 Present Use: Storage
 Construction:
 walls - horizontal siding on milled wooden frame
 roof - wood shingles on milled wooden rafters
 Integrity: Stable has been altered
 Condition: Fair

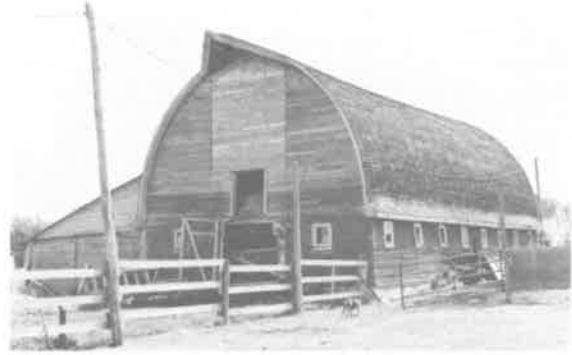
- 118) Large Light Wood Frame Barn with Vaulted Roof
 Construction Date: ca. 1940
 Location: SW 9-14-4E
 Present Owner: Mr. T. Jenkins
 Present Use: Functioning Barn
 Construction:
 walls - horizontal siding on milled wooden frame
 roof - wood shingles on built up rafters
 Integrity: The stable has been altered to produce a more open space
 Condition: Fair
 Notes: This building is also discussed on pages 69-70.

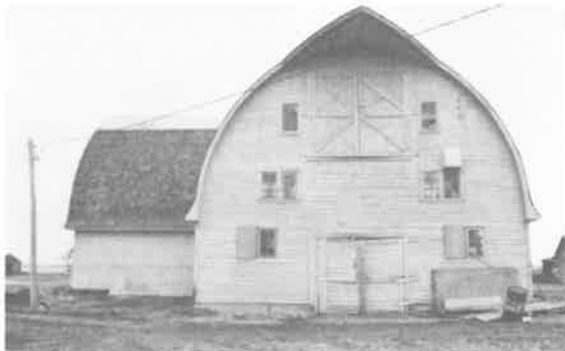
- 119) Large Light Wood Frame Barn with Vaulted Roof
 Construction Date: ca. 1940
 Location: SE 20-15-8E
 Present Owner: Mr. K. Goritz
 Present Use: Functioning Barn
 Construction:
 walls - horizontal siding on milled wooden frame
 roof - wood shingles on built-up rafters
 Integrity: Unaltered
 Condition: Good

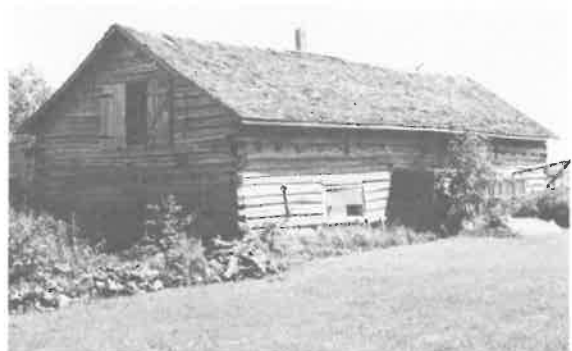
- 120) Log Barn
 Construction Date: 1943
 Location: NW 10-17-7E
 Present Owner: Mr. K. Klatt
 Present Use: Vacant
 Construction:
 walls - squared dovetailed logs
 roof - wood shingles on milled wooden rafters
 Integrity: Unaltered
 Condition: Fair

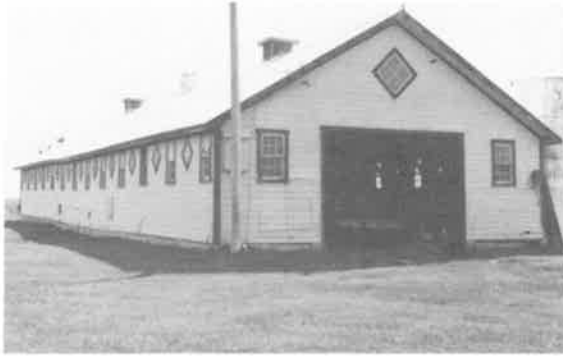
- 121) Light Wood Frame Cattle Feeder
 Construction Date: ca. 1925
 Location: NE 2-16-3E
 Present Owner: Mr. C.P. Kollar
 Present Use: Machine Storage
 Construction:
 walls - horizontal siding on milled wooden frame
 roof - metal sheeting on milled wooden rafters
 Integrity: The interior has been altered to accommodate machinery
 Condition: Good
