ARCHITECTURAL HERITAGE

The Selkirk and District

Planning Area

David
Butterfield

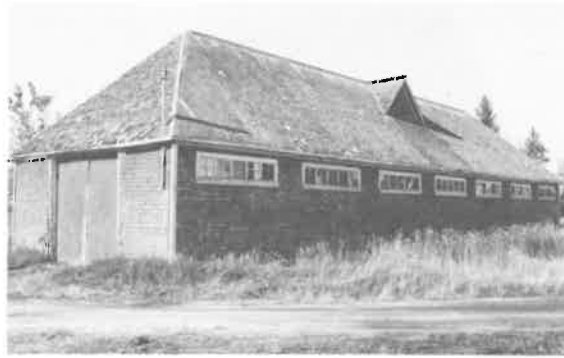
- 122) Horse Barn
 Construction Date: ca. 1910
 Location:
 Present Owner: Mr. Buus
 Present Use: Summer Theatre for Interlake Theatre Troupe
 Construction:
 walls - wood shingles on milled wooden frame
 roof - wood shingles on milled wooden rafters
 Integrity: Unaltered
 Condition: Good

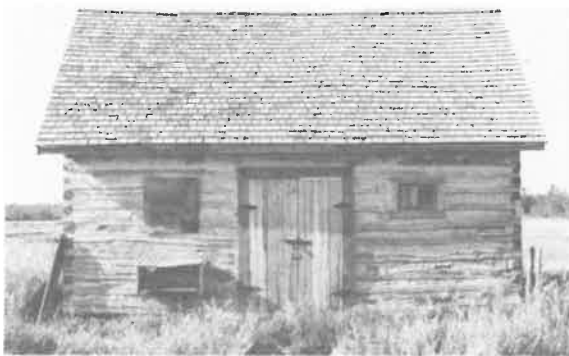
- 123) Log Granary
 Construction Date: ca. 1930
 Location:
 Present Owner: Arnold Husluk
 Present Use: Storage
 Construction:
 walls - dovetailed squared logs
 roof - wood shingles on hewn log rafters
 Integrity: Unaltered
 Condition: Good
 Notes: This building is also discussed on page 71.

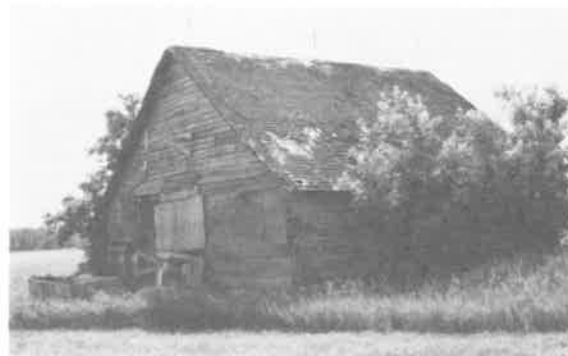
- 124) Granary
 Construction Date: ca. 1880
 Location: NE 12-17-3E
 Present Owner: Mrs. M. Allison
 Present Use: Storage
 Construction:
 walls - horizontal siding on milled wooden frame
 roof - wood shingles on milled wooden rafters
 Integrity: The interior posts and beams have gradually been replaced so that none of the originals exist today
 Condition: Fair
 Notes: This building is also discussed on pages 71-72.

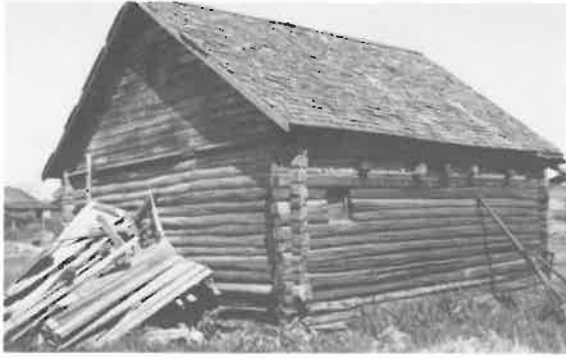
- 125) Log Granary
 Construction Date: 1906
 Location: SW 18-16-8E
 Present Owner: Mr. Otto
 Present Use: Storage
 Construction:
 walls - round lap-notched logs
 roof - wood shingles on milled wood rafters
 Integrity: Unaltered
 Condition: Fair

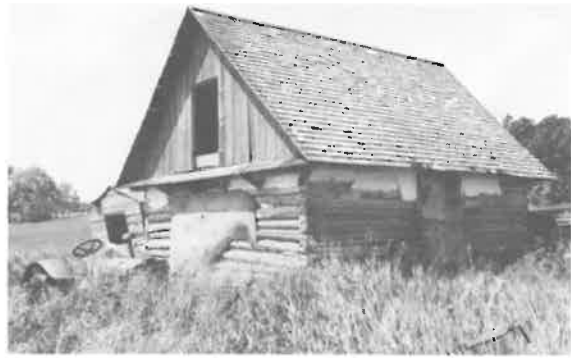
- 126) Log Granary
 Construction Date: ca. 1910
 Location:
 Present Owner:
 Present Use: Vacant
 Construction:
 walls - dovetailed logs with plaster cover
 roof - wood shingles on milled wooden rafters
 Integrity: Unaltered, but plaster is disintegrating
 Condition: Fair

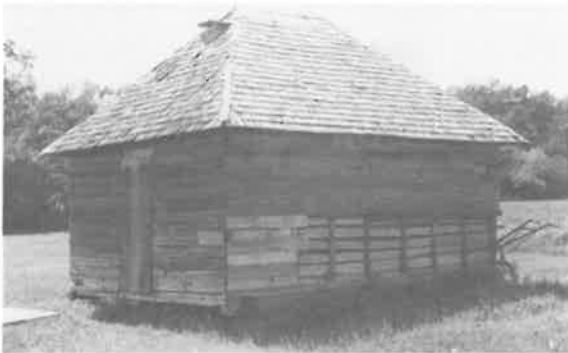
- 127) Log Granary
 Construction Date: ca. 1915
 Location: River Lot #156
 Present Owner: N. Schafer
 Present Use: Storage
 Construction:
 walls - horizontal siding on dovetailed logs
 roof - wood shingles on milled wooden rafters
 Integrity: Unaltered
 Condition: Good
 Notes: The hipped roof on this structure is unusual in the local context, where farmers preferred the simple gable roof.

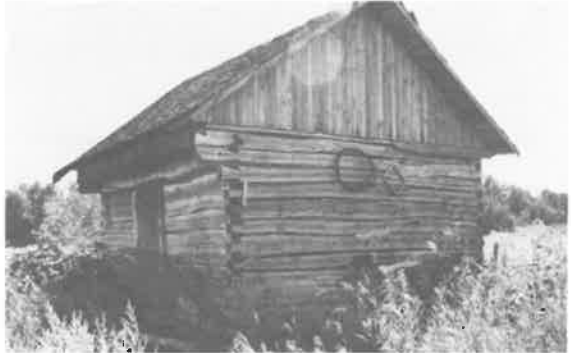
- 128) Log Granary
 Construction Date: ca. 1915
 Location: SE 19-14-6E
 Present Owner: Mr. A. Caravan
 Present Use: Storage
 Construction:
 walls - dovetailed logs
 roof - wooden shingles on milled wooden rafters
 Integrity: Unaltered
 Condition: Good

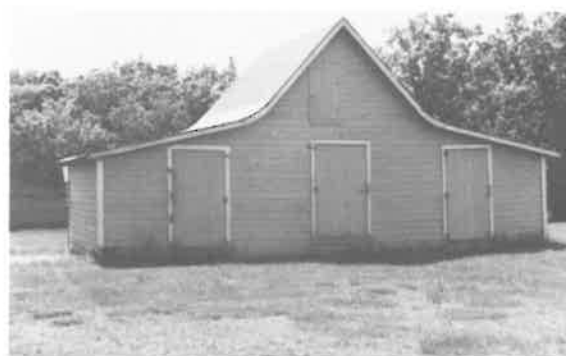
- 132) Granary
 Construction Date: ca. 1920
 Location: River Lot #71
 Present Owner:
 Present Use:
 walls - horizontal siding on milled wooden frame
 roof - wood shingles on milled wooden rafters
 Integrity: Unaltered
 Condition: Good
 Notes: The central section of the building is for grain storage; the projecting wings house crushing equipment and related machinery

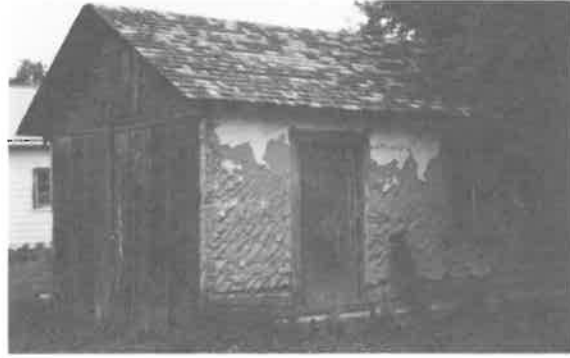
- 134) Machine Shed
 Construction Date: ca. 1930
 Location:
 Present Owner: Peter Romanic
 Present Use: Storage
 Construction:
 walls - plaster and willow lath on dovetailed logs
 roof - wood shingles on milled wooden rafters
 Integrity: Largely unaltered
 Condition: Fair
 Notes: This building is also discussed on page 74.

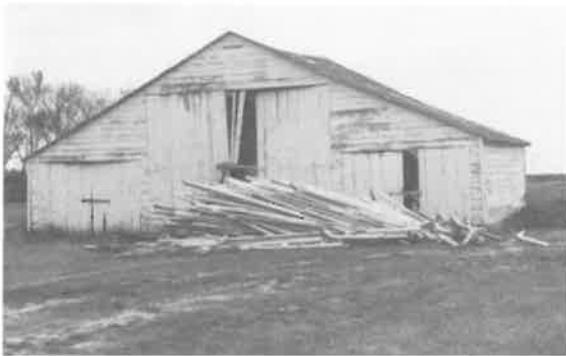
- 135) Machine Shed
 Construction Date: ca. 1910
 Location: River Lot #120
 Present Owner: Province of Manitoba
 Present Use: Vacant
 Construction:
 walls - horizontal siding with milled wooden frame
 roof - wood shingles on milled wooden rafters
 Integrity: Unaltered
 Condition: Poor
 Notes: The large central doors accommodated a threshing machine

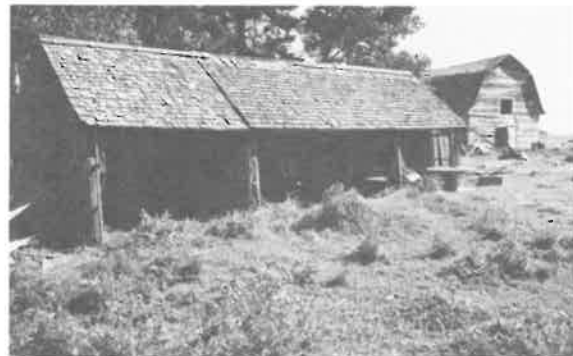
- 136) Machine Shed
 Construction Date: ca. 1920
 Location: SE 12-16-7E
 Present Owner: V. Parke
 Present Use: Abandoned
 Construction:
 walls - vertical logs
 roof - wood shingles on hewn wooden rafters
 Integrity: Unaltered
 Condition: Poor

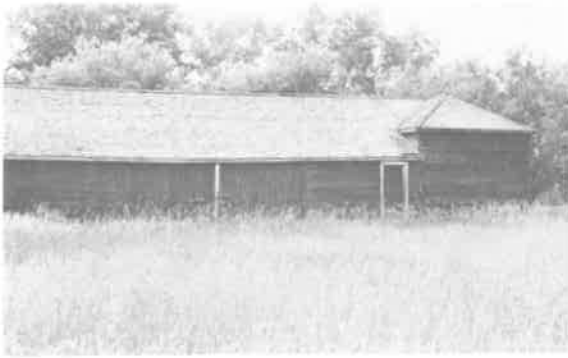
- 137) Machine Shed
 Construction Date: ca. 1910
 Location: SE 22-16-3E
 Present Owner: A. Dalman
 Present Use: Abandoned
 Construction:
 walls - horizontal siding on milled wooden frame
 roof - wood shingles on milled wooden rafters
 Integrity: Unaltered
 Condition: Poor

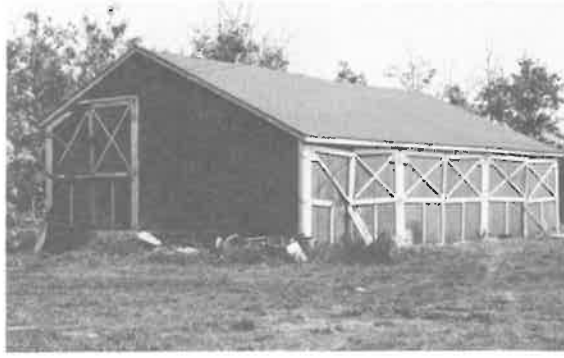
- 138) Machine Shed
 Construction Date: 1938
 Location: SE 22-16-3E
 Present Owner: M. Chorney
 Present Use: Functioning machine shed
 Construction:
 walls - horizontal siding on milled wooden frame
 roof - asphalt shingles on milled wooden rafters
 Integrity: Unaltered
 Condition: Good

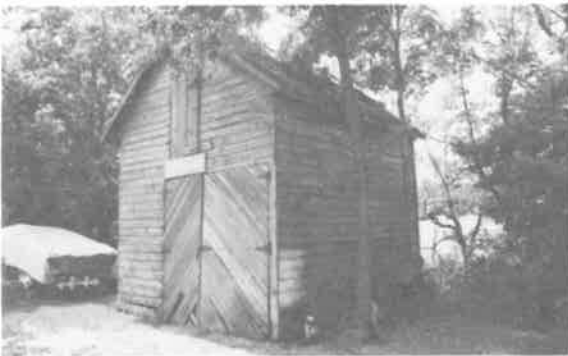
- 139) Garage
 Construction Date: ca. 1910
 Location: River Lot #255
 Present Owner: M. Nebozenko
 Present Use: Storage
 Construction:
 walls - horizontal siding on milled wooden frame
 roof - wood shingles on milled wooden rafters
 Integrity: Unaltered
 Condition: Good
 Notes: The upper level was used for miscellaneous storage.

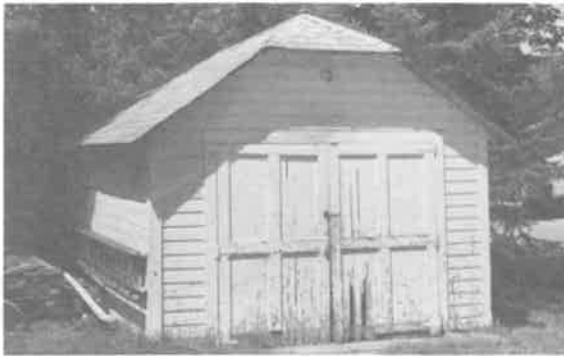
- 140) Garage
 Construction Date: 1900
 Location: 149 Eveline Street, Selkirk
 Present Owner: Mrs. Lulashyk
 Present Use: Functioning garage
 Construction:
 walls - horizontal siding on milled wooden frame
 roof - asphalt shingles on milled wooden rafters
 Integrity: Unaltered
 Condition: Fair

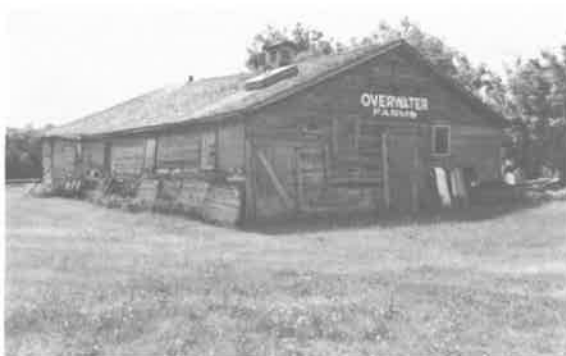
- 141) Shed
 Construction Date: 1912
 Location: River Lot #20
 Present Owner: Mr. Overwater
 Present Use: Storage
 Construction:
 walls - horizontal siding on milled wooden frame
 roof - wood shingles on milled wooden rafters
 Integrity: Parts of the building are now used for grain storage.
 Conditions: Poor - The roof has a swayback and the walls have buckled in places.

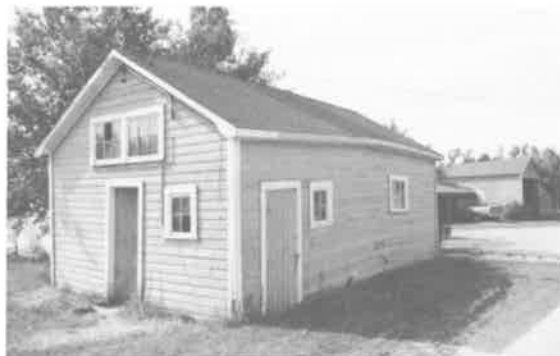
- 142) Shed
 Construction Date: 1915
 Location: SE 1-15-4E
 Present Owner: Mr. Macklin
 Present Use: Storage
 Construction:
 walls - horizontal siding on milled wooden frame
 roof - asphalt shingles on milled wooden rafters
 Integrity: Unaltered
 Condition: Good

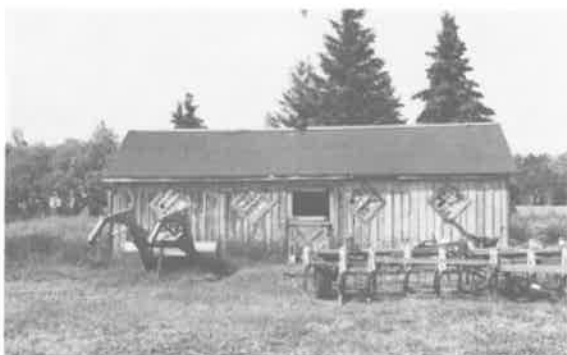
- 143) Shed
 Construction Date: ca. 1925
 Location: NE 2-16-3E
 Present Owner: C.P. Kollar
 Present Use: Storage
 Construction:
 walls - vertical board-and-batten on milled wooden frame
 roof - asphalt shingles on milled wooden rafters
 Integrity: Unaltered
 Condition: Good

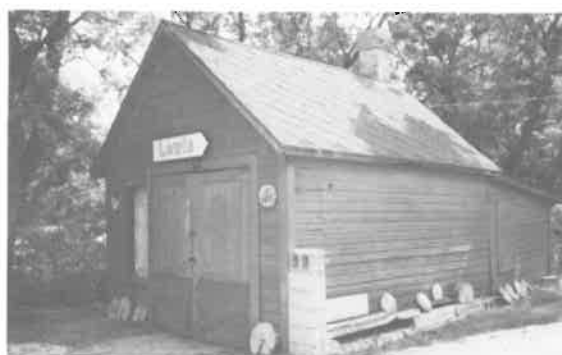
- 144) Blacksmith Shop
 Construction Date: ca. 1910
 Location: River Lot #120
 Present Owner: Mr. Lewis
 Present Use: Storage
 Construction:
 walls - horizontal siding on milled wooden frame
 roof - wood shingles on milled wooden rafters
 Integrity: Unaltered
 Condition: Good
 Notes: The chimney, large front doors and single window belie this building's function.

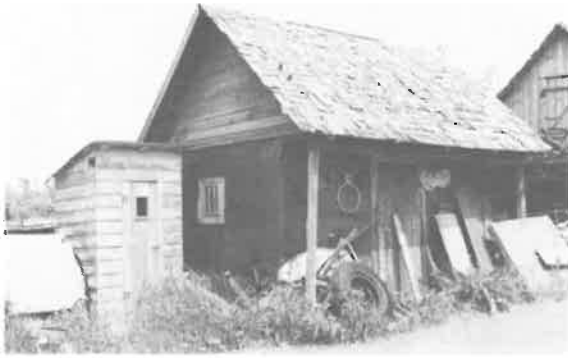
- 145) Workshop
 Construction Date: 1932
 Location: River Lot #226
 Present Owner: W.R. Kozak
 Present Use: Storage
 Construction:
 walls - dovetailed logs
 roof - wood shingles on milled wooden rafters
 Integrity: Unaltered
 Condition: Fair

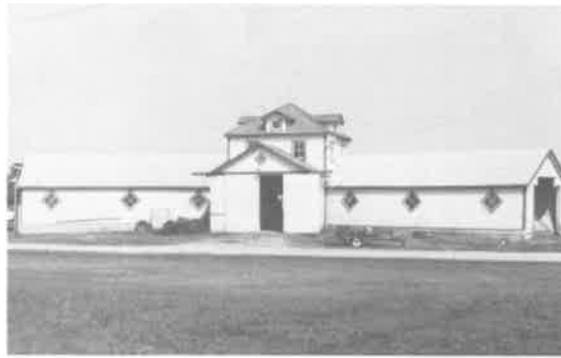
- 146) Bunkhouse/Machine Shed
 Construction Date: ca. 1925
 Location: NE 2-16-3E
 Present Owner: C.P. Kollar
 Present Use: Storage
 Construction:
 walls - horizontal siding on milled wooden frame
 roof - wood shingles on milled wooden rafters
 Integrity: The attached wings have been altered to accommodate larger machinery
 Condition: Good
 Notes: This building is also discussed on page 74.

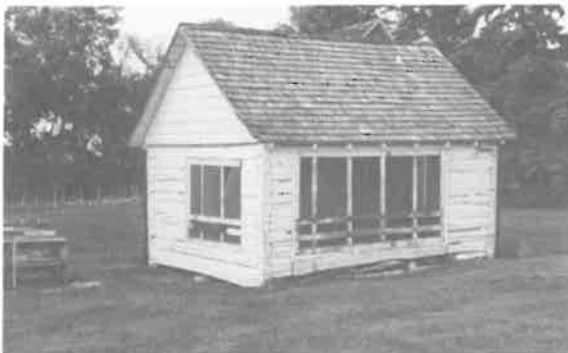
- 147) Chicken Coop
 Construction Date: ca. 1920
 Location: SW 2-17-3E
 Present Owner: Mr. Hawkins
 Present Use: Storage
 Construction:
 walls - dovetailed logs
 roof - wood shingles on milled wooden rafters
 Integrity: Interior has been gutted
 Condition: Fair

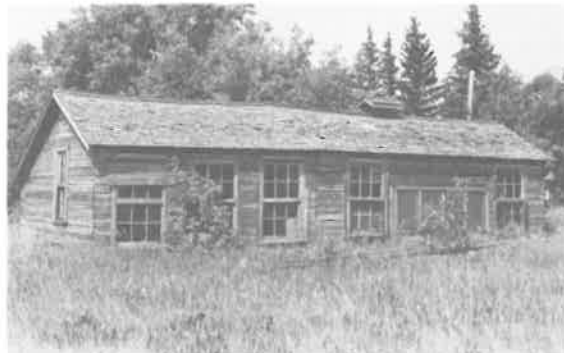
- 148) Chicken Coop
 Construction Date: ca. 1920
 Location: SE 22-16-3E
 Present Owner: A. Dalman
 Present Use: Abandoned
 Construction:
 walls - horizontal siding on milled wooden frame
 roof - wood shingles on milled wooden rafters
 Integrity: Unaltered
 Condition: Poor
 Notes: This building is also discussed on page 75.

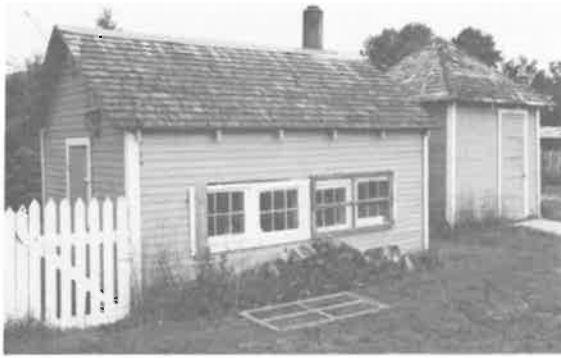
- 149) Chicken Coop
 Construction Date: ca. 1915
 Location: River Lot #82
 Present Owner: Mr. Goltz
 Present Use: Storage
 Construction:
 walls - horizontal siding on milled wooden frame
 roof - wood shingles on milled wooden rafters
 Integrity: Unaltered
 Condition: Good

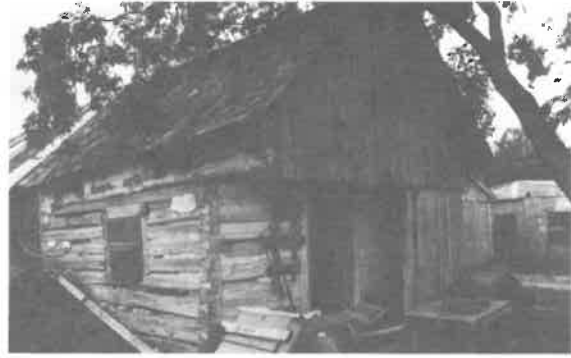
- 150) Komora
 Construction Date: ca. 1925
 Location:
 Present Owner: Joan Polanski
 Present Use: Vacant
 Construction:
 walls - squared dovetailed logs
 roof - wood shingles on hewn timber rafters
 Integrity: Largely unaltered
 Condition: Poor
 Notes: This building is also discussed on page 88.

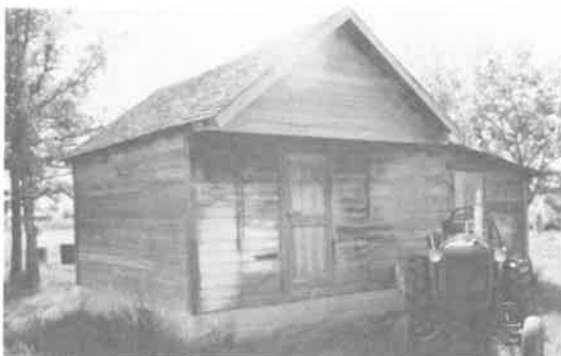
- 151) Komora
 Construction Date: ca. 1915
 Location: River Lot #109
 Present owner: Joseph Pronyk
 Present Use: Storage
 Construction:
 walls - squared dovetailed logs
 roof - wood shingles on hewn timber rafters
 Integrity: Largely unaltered
 Condition: Fair
 Notes: This building is also discussed on pages 88-89.

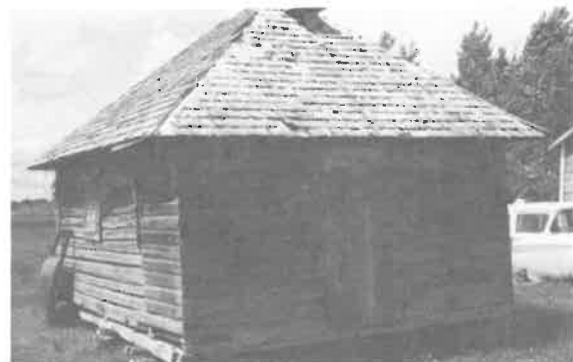
- 152) Komora
 Construction Date: ca. 1920
 Location:
 Present Owner: Nick Shafer
 Present Use: Storage
 Construction:
 walls - squared dovetailed logs
 roof - wood shingles on hewn timber rafters
 Integrity: Largely unaltered
 Condition: Fair

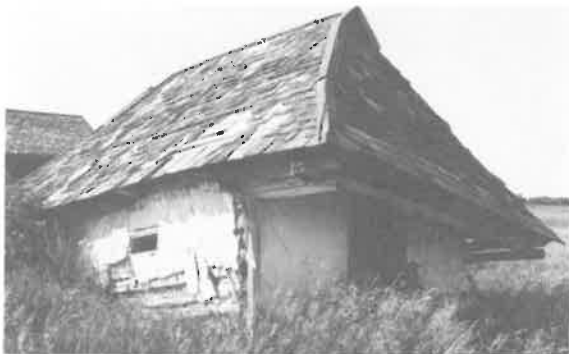
- 153) Summer Kitchen
 Construction Date: ca.1900
 Location: River Lot #90
 Present Owner:
 Present Use: Abandoned
 Construction:
 walls - Plaster cover on dovetailed logs
 roof - wood shingles on milled wooden rafters
 Integrity: Unaltered
 Condition: Poor - the structure is collapsing on the north side

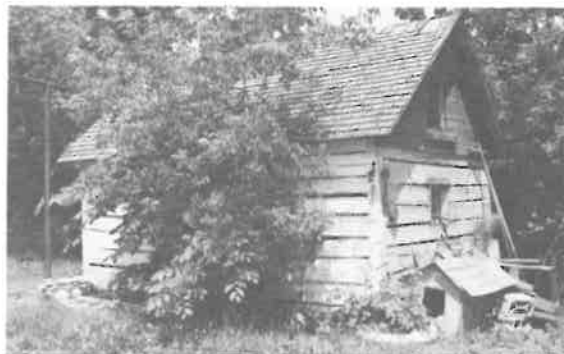
- 154) Summer Kitchen
 Construction Date: 1926
 Location: River Lot #240
 Present Owner: E. Huzarski
 Present Use: Storage
 Construction:
 walls - dovetailed logs
 roof - wood shingles on milled wooden rafters
 Integrity: Interior has been gutted
 Condition: Fair

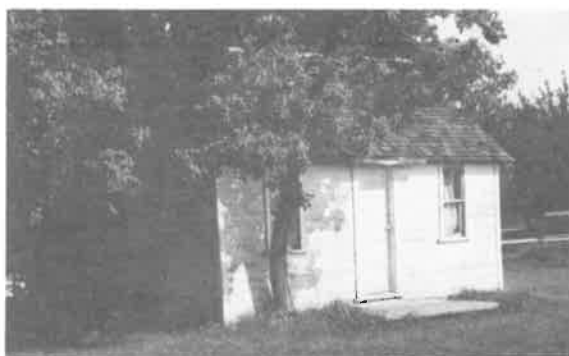
- 155) Summer Kitchen
 Construction Date: ca. 1910
 Location: SE 27-15-6E
 Present Owner: R. Krahn
 Present Use: Storage
 Construction:
 walls - horizontal siding on milled wooden frame
 roof - wood shingles on milled wooden rafters
 Integrity: Unaltered
 Condition: Good

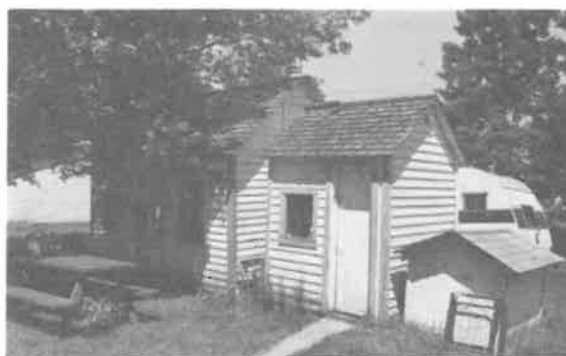
- 156) Summer Kitchen
 Construction Date: ca.1915
 Location: 423 Sinclair Avenue, Selkirk
 Present Owner: Mrs. L. Morrisseau
 Present Use: Storage
 Construction:
 walls - horizontal siding on milled wooden frame
 roof - wood shingles on milled wooden rafters
 Integrity: Unaltered
 Condition: Good

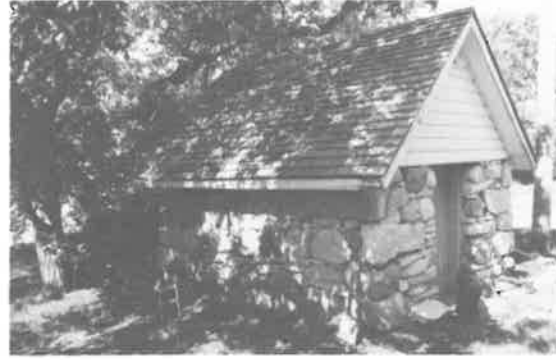
- 158) Milk House
 Construction Date: Ca. 1880
 Location: River Lot #10
 Present Owner: Mrs. Larter
 Present Use: Storage
 Construction:
 walls - solid fieldstone
 roof - wood shingles on milled wooden rafters
 Integrity: Unaltered
 Condition: Good
 Notes: This building is also discussed on page 76.

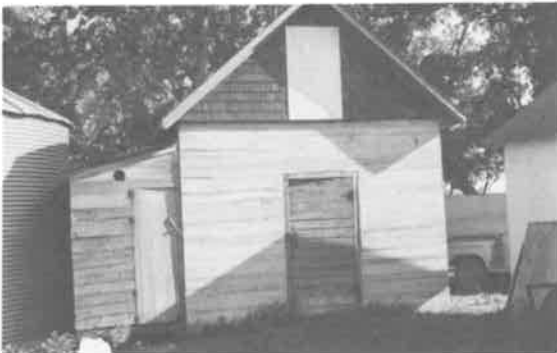
- 159) Ice House
 Construction Date: ca. 1910
 Location: NW 24-15-6E
 Present Owner: C. Horbady
 Present Use: Storage
 Construction:
 walls - solid poured concrete
 roof - asphalt shingles on milled wooden rafters
 Integrity: Unaltered
 Condition: Good

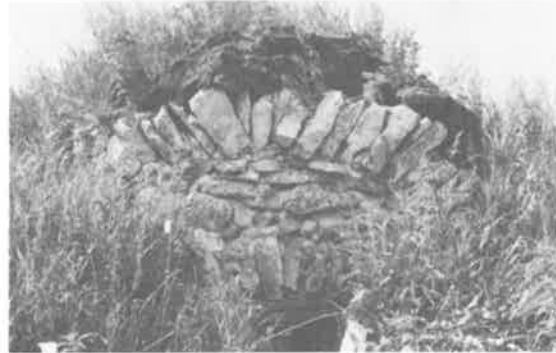
- 160) Root Cellar
 Construction Date: ca. 1920
 Location: SE 2-13-5E
 Present Owner:
 Present Use: Abandoned
 Construction:
 walls - fieldstone barrel vault
 roof - fieldstone, covered with sod
 Integrity: Unaltered
 Condition: Poor

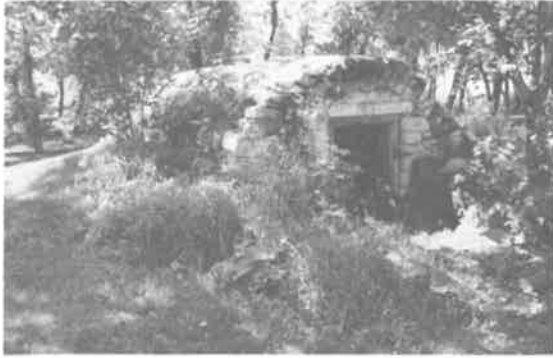
- 161) Root Cellar
 Construction Date: ca. 1920
 Location: SE 2-13-5E
 Present Owner: J. Letecki
 Present Use: Storage
 Construction:
 walls - fieldstone barrel vault
 roof - fieldstone, covered with sod
 Integrity: Unaltered
 Condition: Good
 Notes: This building is also discussed on page 75.

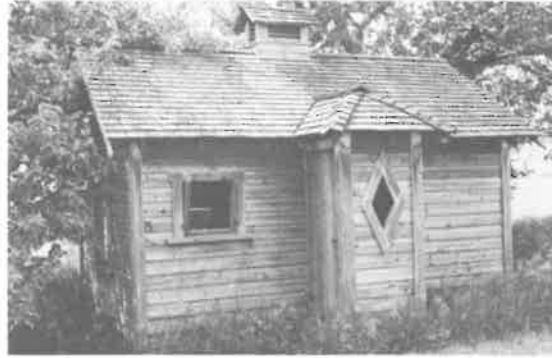
- 162) Outhouse
 Construction Date: ca. 1920
 Location:
 Present Owner:
 Present Use: Vacant
 Construction:
 walls - horizontal siding on milled wooden frame
 roof - wood shingles on milled wooden rafters
 Integrity: Unaltered
 Condition: Good

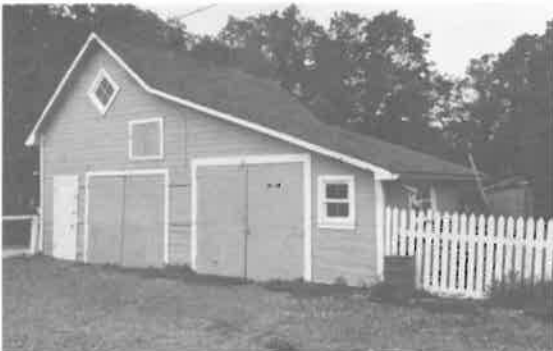
- 163) Pump House
 Construction Date: ca. 1915
 Location: River Lot #82
 Present Owner:
 Present Use: Storage
 Construction:
 walls - horizontal siding on milled wooden frame
 roof - wood shingles on milled wooden rafters
 Integrity: Unaltered
 Condition: Fair

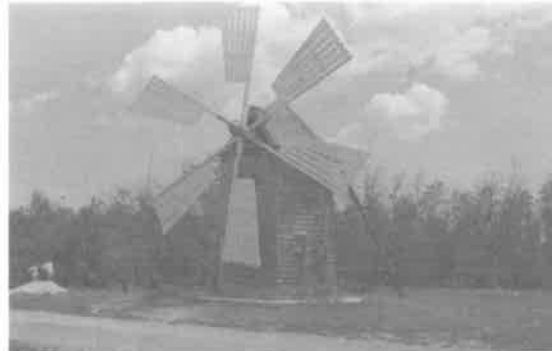
- 164) Windmill
 Construction Date: ca. 1910
 Location: Winnipeg Beach Ukrainian Heritage Museum
 Present Owner: Winnipeg Beach Ukrainian Heritage Museum
 Present Use: Display
 Construction: Wood shingles on wooden frame on roughly hewn logs
 Integrity: The building has been moved to its present site and numerous changes have been made to the interior. The sails are of recent construction.
 Condition: Good
 Notes: This building is also discussed on pages 90-91.

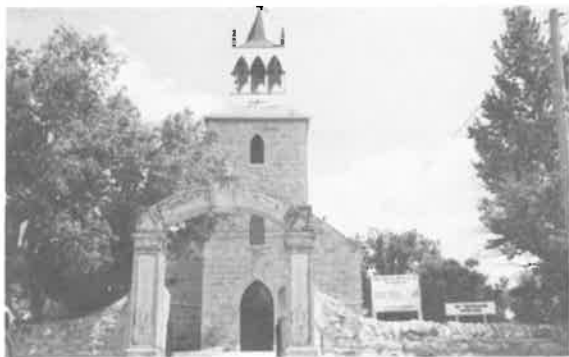
- 165) St. Andrew's Anglican Church
 Construction Date: 1844-49
 Location: River Lot #63
 Present Owner: Anglican Church of Canada
 Present Use: Active Congregation
 Construction:
 walls - fieldstone
 roof - wood shingles on milled wooden rafters
 Integrity: Unaltered
 Condition: Good
 Notes: This building is also discussed on pages 44-45.

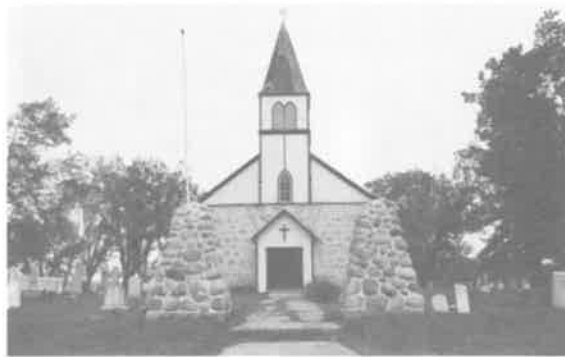
- 166) St. Peter's Dynevor Anglican Church
 Construction Date: 1853
 Location: River Lot #212
 Present Owner: Anglican Church of Canada
 Present Use:
 Construction:
 walls - fieldstone
 roof - wood shingles on milled wooden rafters
 Integrity: Unaltered
 Condition: Fair
 Notes: This building is also discussed on pages 45-46.

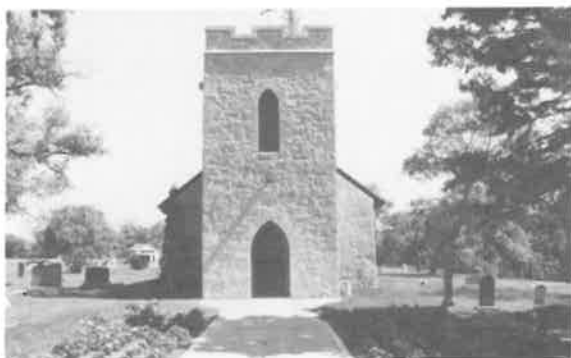
- 167) St. Clement's Mapleton Anglican Church
 Construction Date: 1860-61
 Location: River Lots 21 and 22
 Present Owner: Anglican Church of Canada
 Present Use: Active Congregation
 Construction:
 walls - fieldstone
 roof - wood shingles on milled wooden rafters
 Integrity: Unaltered
 Condition: Good
 Notes: This building is also discussed on page 47.

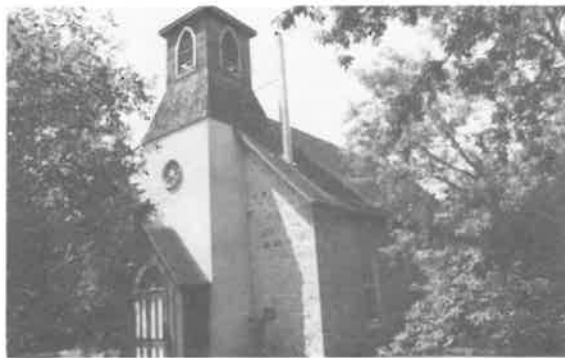
- 168) Little Britain United Church
 Construction Date: 1874
 Location: River Lots 123 and 124
 Present Owner: United Church of Canada
 Present Use: Active Congregation
 Construction:
 walls - fieldstone
 roof - wood shingles on timbers
 Integrity: Unaltered floorplan
 Condition: Good
 Notes: This building is also discussed on page 48.

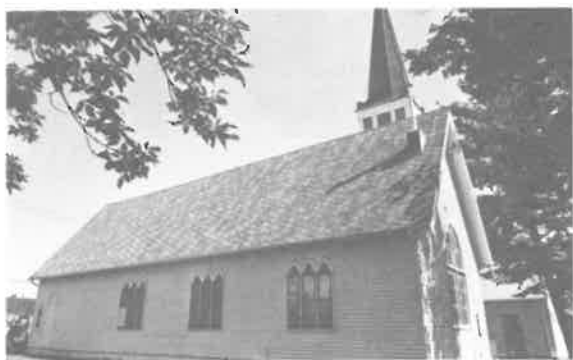
- 169) Christ Church, Anglican
 Construction Date: 1887-94
 Location: McLean Avenue, Selkirk
 Present Owner: Anglican Church of Canada
 Present Use: Active Congregation
 Construction:
 walls - horizontal siding on milled wooden frame
 roof - asphalt shingles on milled wooden rafters
 Integrity: The exterior has recently been covered with aluminum siding.
 Condition: Good
 Notes: This building is also discussed on pages 116-117.

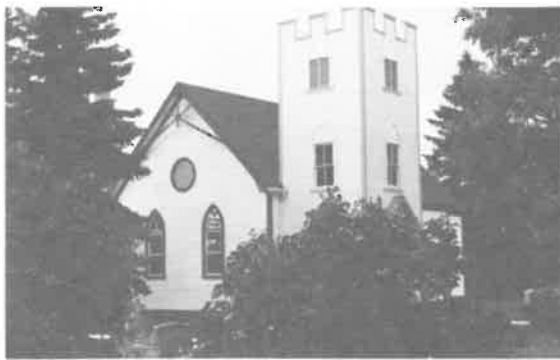
- 170) St. George's Anglican Church, Wakefield
 Construction Date: 1904
 Location: SE 16-15-4E
 Present Owner: Anglican Church of Canada
 Present Use: Active Congregation
 Construction:
 walls - horizontal siding on milled wooden frame
 roof - asphalt shingles on milled wooden rafters
 Integrity: The old Parkdale School has been attached to the west end of the church in 1967.
 Condition: Good
 Notes: This building is also discussed on pages 94-95.

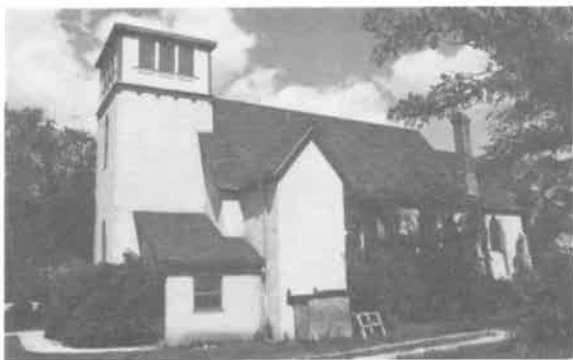
- 171) St. Thomas Anglican
 Construction Date: 1905
 Location: Lockport
 Present Owner: Anglican Church of Canada
 Present Use: Active Congregation
 Construction:
 walls - stucco veneer on milled wooden frame
 roof - asphalt shingles on milled wooden rafters
 Integrity: Largely unaltered
 Condition: Good

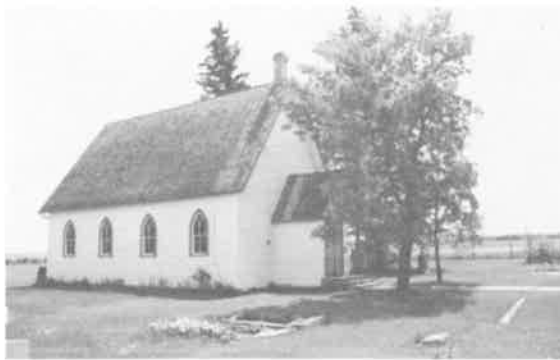
- 172) St. Matthew's Anglican Church
 Construction Date: 1906
 Location: SW 33-13-4E
 Present Owner: Anglican Church of Canada
 Present Use: Active Congregation
 Construction:
 walls - horizontal siding on milled wooden frame
 roof - wood shingles on milled wooden rafters
 Integrity: Largely unaltered
 Condition: Good
 Notes: This building is also discussed on pages 94-95.

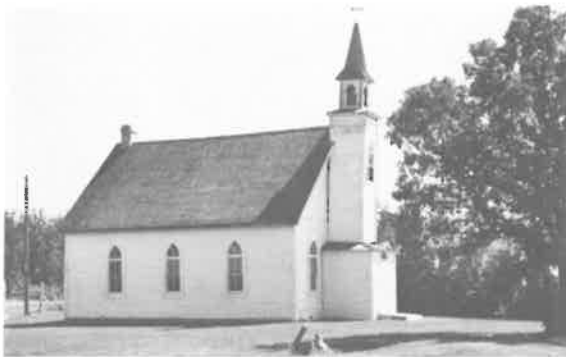
- 173) St. James Anglican Church
 Construction Date: 1912
 Location: NE 32-15-6E
 Present Owner: Anglican Church of Canada
 Present Use: Active Congregation
 Construction:
 walls - horizontal siding on milled wooden frame
 roof - asphalt shingles on milled wooden rafters
 Integrity: Largely unaltered floorplan
 Condition: Good
 Notes: This building is also discussed on pages 93-94.

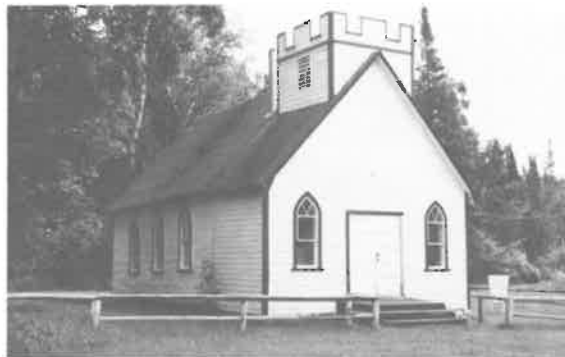
- 174) St. Luke's Anglican Church, Balsam Bay
 Construction Date: ca. 1920
 Location: SW 28-17-7E
 Present Owner: Anglican Church of Canada
 Present Use: Active Congregation
 Construction:
 walls - squared dovetailed logs
 roof - asphalt shingles on milled wooden rafters
 Integrity: Largely unaltered
 Condition: Good

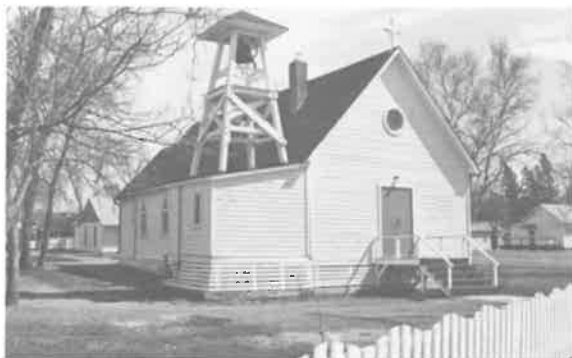
- 175) St. Bartholomew's Anglican Church
 Construction Date: 1909
 Location: Winnipeg Beach
 Present Owner: Anglican Church of Canada
 Present Use: Active Congregation
 Construction:
 walls - horizontal siding on milled wooden frame
 roof - asphalt shingles on milled wooden rafters
 Integrity: Largely unaltered.
 Condition: Good
 Notes: This building is also discussed on pages 133.

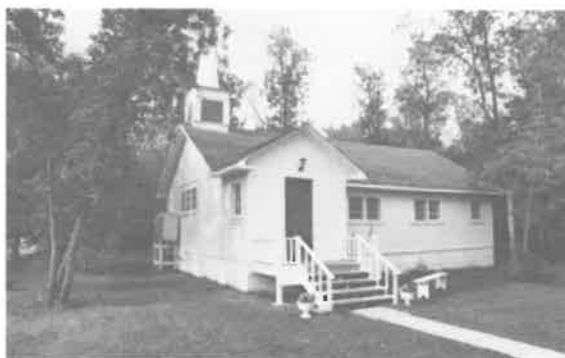
- 176) All Saints Anglican Church
 Construction Date: 1922
 Location: Whytewold
 Present Owner: Anglican Church of Canada
 Present Use: Active Congregation
 Construction:
 walls - horizontal siding on milled wooden frame
 roof - asphalt shingles on milled wooden rafters
 Integrity: Largely unaltered
 Condition: Good

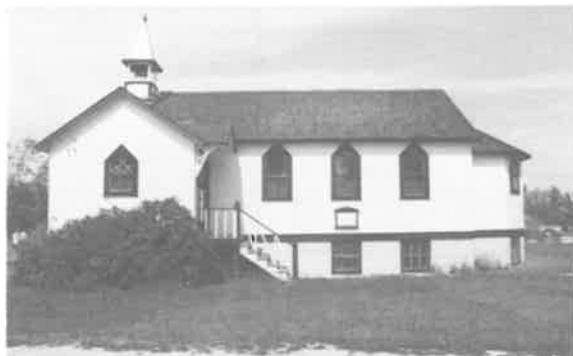
177) St. Peter's-Dynevor Church
 Construction Date: ca. 1925
 Location: River Lot #34
 Present Owner: Anglican Church of Canada
 Present Use: Active Congregation
 Construction:
 walls - horizontal siding on milled wooden frame
 roof - asphalt shingles on milled wooden rafters
 Integrity: Largely unaltered
 Condition: Good

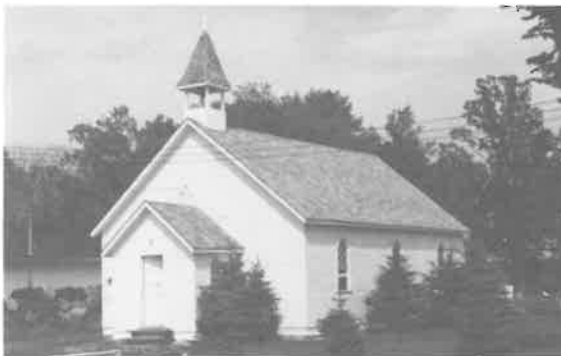
178) St. George's Anglican Church
 Construction Date: 1938
 Location: St. John's Boy's School/River Lot #41
 Present Owner: St. John's Cathedral Boy's School
 Present Use: School Use
 Construction:
 walls - horizontal siding on milled wooden frame
 roof - asphalt shingles on milled wooden rafters
 Integrity: The church has been moved onto its present site.
 Condition: Good

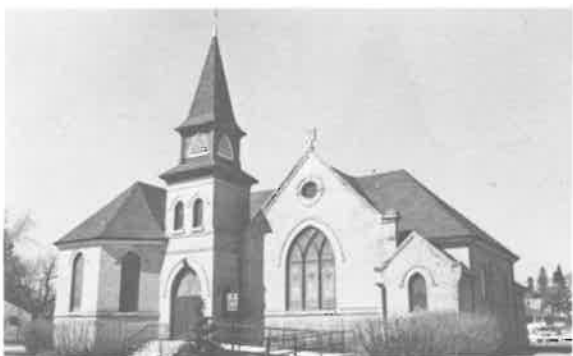
179) Knox Presbyterian Church
 Construction Date: 1904
 Location: Eveline Street, Selkirk
 Present Owner: Presbyterian Church of Canada
 Present Use: Active Congregation
 Construction:
 walls - buff brick on wood frame
 roof - asphalt shingles on milled wooden rafters
 Integrity: Largely unaltered
 Condition: Good
 Notes: This building is also discussed on pages 115 and 117.

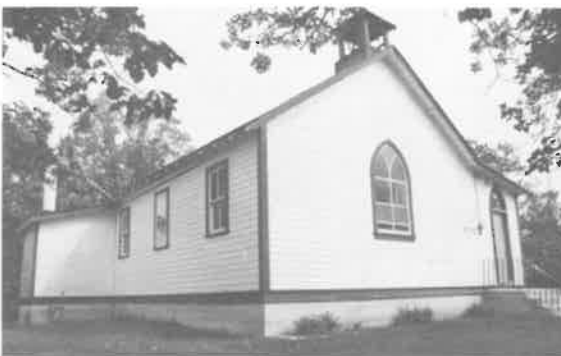
180) MacKenzie Presbyterian Church
 Construction Date: 1922
 Location: River Lot #120
 Present Owner: Presbyterian Church of Canada
 Present Use: Active Congregation
 Construction:
 walls - horizontal siding on milled wooden frame
 roof - asphalt shingles on milled wooden rafters
 Integrity: Largely unaltered
 Condition: Good

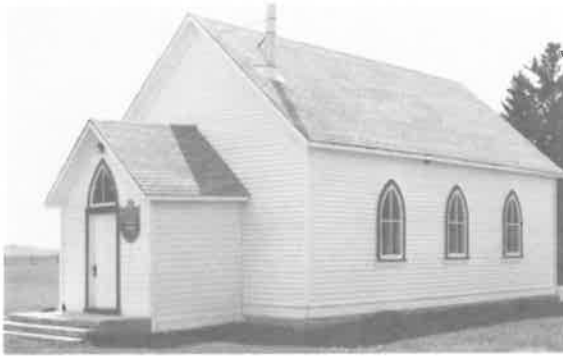
- 181) Dunara United Church
 Construction Date: 1893
 Location: SE 36-15-3E
 Present Owner: United Church of Canada
 Present Use: Active Congregation
 Construction:
 walls - horizontal siding on milled wooden frame
 roof - asphalt shingles on milled wooden rafters
 Integrity: Largely unaltered
 Condition: Good

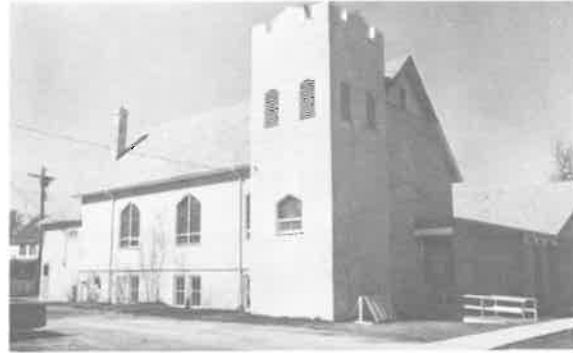
- 182) Selkirk United Church
 Construction Date: 1986
 Location: 202 McLean Avenue, Selkirk
 Present Owner: United Church of Canada
 Present Use: Active Congregation
 Construction:
 Walls - stucco on milled wooden frame
 roof - asphalt shingles on milled wooden rafters
 Integrity: The building originally stood on Dufferin Avenue.
 Condition: Good

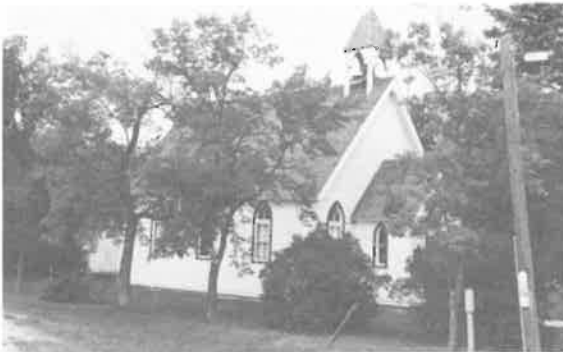
- 183) Clandeboye United Church
 Construction Date: 1901
 Location: Clandeboye
 Present Owner: United Church of Canada
 Present Use: Active Congregation
 Construction:
 walls - horizontal siding on milled wooden frame
 roof - wood shingles on milled wooden rafters
 Integrity: Largely unaltered
 Condition: Good
 Notes: This church was destroyed in 1984 to make way for a new church building.

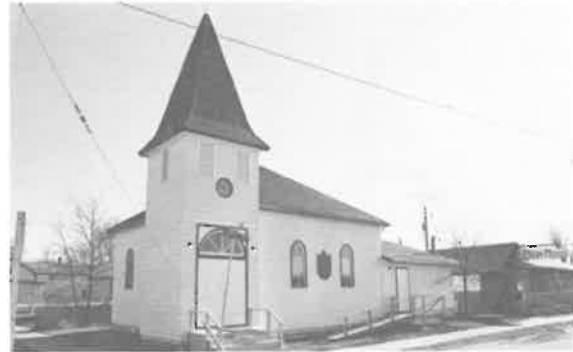
- 184) Winnipeg Beach United Church
 Construction Date: 1905
 Location: Winnipeg Beach
 Present Owner: United Church of Canada
 Present Use: Active Congregation
 Construction:
 walls - horizontal siding on milled wooden frame
 roof - wood shingles on milled wooden rafters
 Integrity: The building has recently been covered with aluminum siding.
 Condition: Good
 Notes: This building is also discussed on page 133.

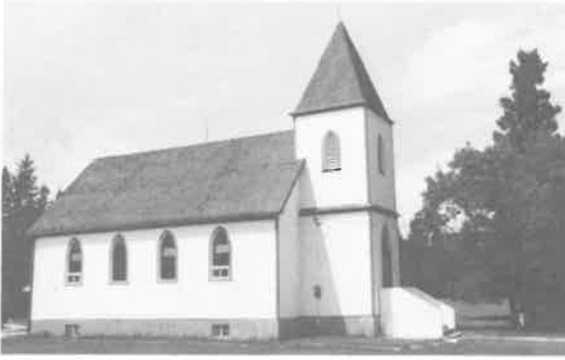
- 185) Cloverdale United Church
 Construction Date: 1921
 Location: SE 8-14-4E
 Present Owner: United Church of Canada
 Present Use: Active Congregation
 Construction:
 walls - horizontal siding on milled wooden frame
 roof - wood shingles on milled wooden rafters
 Integrity: Largely unaltered
 Condition: Good
 Notes: This building is also discussed on pages 94-95.

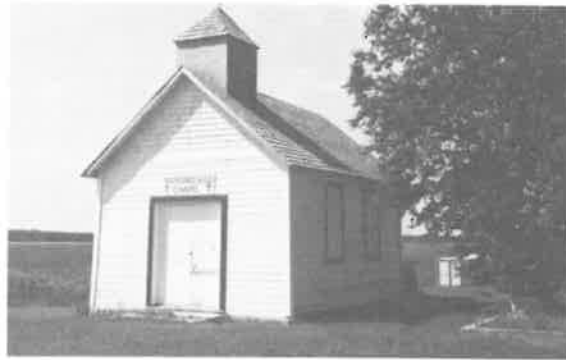
- 186) Mustard Seed Chapel
 Construction Date: 1901
 Location: SE 34-16-4E
 Present Owner: Anglican Church of Canada
 Present Use: Occasional Use
 Construction:
 walls - horizontal siding on milled wooden frame
 roof - wood shingles on milled wooden rafters
 Integrity: Largely unaltered
 Condition: Good

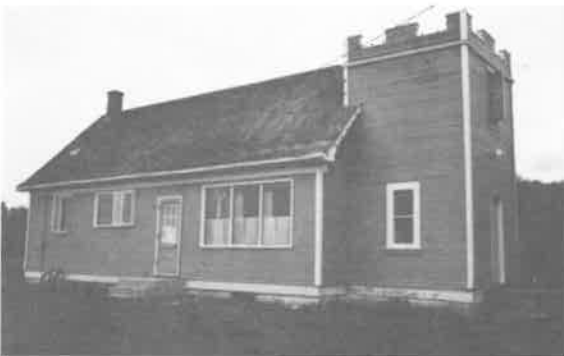
- 187) MacBeth Church
 Construction Date: 1932
 Location: SE 25-13-5E
 Present Owner:
 Present Use: Residence
 Construction:
 walls - horizontal siding on milled wooden frame
 roof - asphalt shingles on milled wooden rafters
 Integrity: The building has been moved and much altered to fulfill its present function.
 Condition: Good

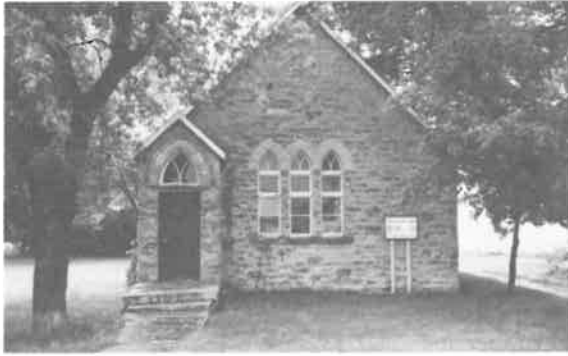
- 189) Gerson Mission Church
 Construction Date: 1919
 Location: Gerson
 Present Owner: Baptist Church of Canada
 Present Use: Active Congregation
 Construction:
 walls - solid fieldstone
 roof - asphalt shingles on milled wooden rafters
 Integrity: Largely unaltered
 Condition: Good
 Notes: This building is also discussed on page 125.

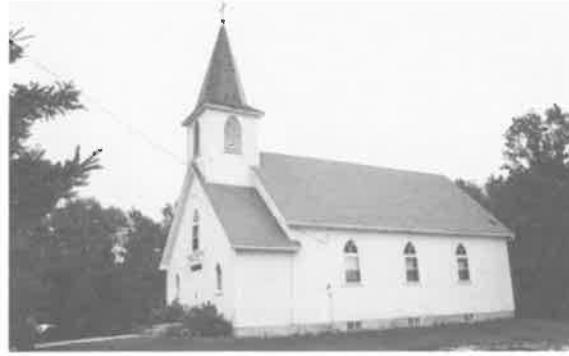
- 190) St. John's Evangelical Lutheran Church
 Construction Date: ca. 1920
 Location: SW 19-15-8E
 Present Owner: Lutheran Church of Canada
 Present Use: Active Congregation
 Construction:
 walls - horizontal siding on milled wooden frame
 roof - asphalt shingles on milled wooden rafters
 Integrity: Largely unaltered
 Condition: Good

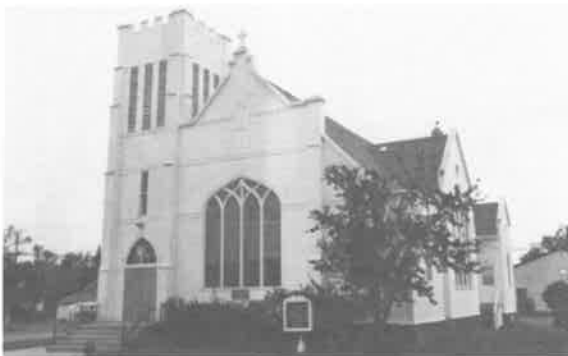
- 191) Icelandic Evangelical Lutheran Church
 Construction Date: 1924
 Location: Clandeboye Avenue, Selkirk
 Present Owner: Lutheran Church of Canada
 Present Use: Active Congregation
 Construction:
 walls - horizontal siding on milled wooden frame
 roof - asphalt shingles on milled wooden rafters
 Integrity: Largely unaltered
 Condition: Good
 Notes: This building is also discussed on page 117.

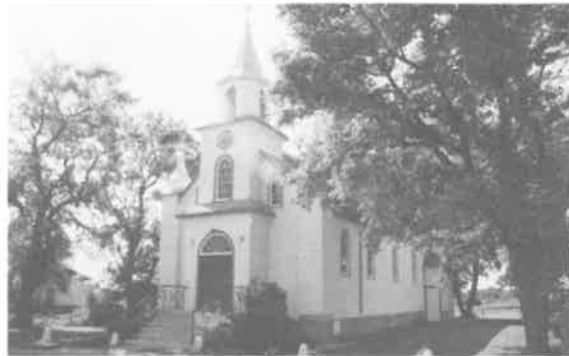
- 192) St. Stanislaus Roman Catholic Church
 Construction Date: ca. 1910
 Location: East Selkirk
 Present Owner: Roman Catholic Church of Canada
 Present Use: Active Congregation
 Construction:
 walls - stucco veneer on milled wooden frame
 roof - asphalt shingles on milled wooden rafters
 Integrity: Largely unaltered
 Condition: Good
 Notes: This building is also discussed on page 122.

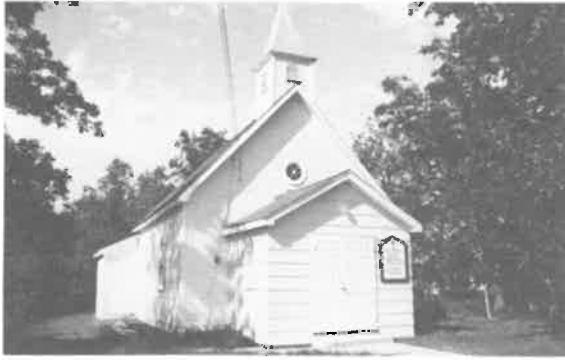
- 197) St. Joseph's Polish Catholic Church
 Construction Date: ca. 1920
 Location: Libau
 Present Owner: Polish Catholic Church of Canada
 Present Use: Active Congregation
 Construction:
 walls - aluminum siding on milled wooden frame
 roof - asphalt shingles on milled wooden rafters
 Integrity: Largely unaltered
 Condition: Good

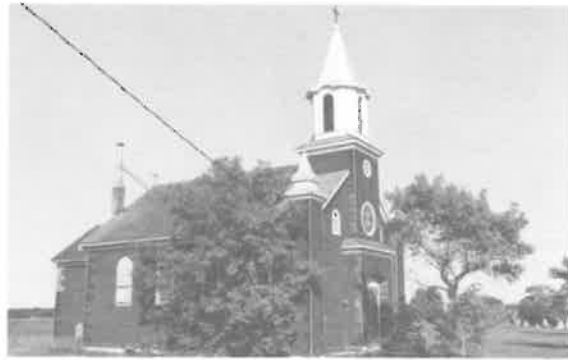
- 198) Sacred Heart Chapel, Victoria Park
 Construction Date: 1937
 Location: River Lot #70
 Present Owner:
 Present Use: Vacant
 Construction:
 walls - insulbrick siding on milled wooden frame
 roof - wood shingles on milled wooden rafters
 Integrity: Largely unaltered
 Condition: Poor
 Notes: This building has been dismantled and the hall section used as a private residence.

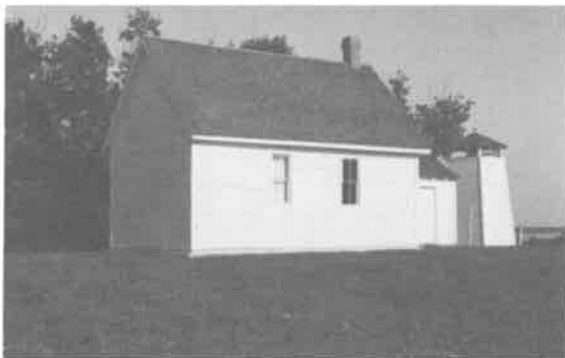
- 199) Holy Rosary Polish Catholic Church
 Construction Date: ca. 1910
 Location: SE 34-17-3E
 Present Owner: Polish Catholic Church of Canada
 Present Use: Occasional service
 Construction:
 walls - horizontal siding on milled wooden frame
 roof - asphalt shingles on milled wooden rafters
 Integrity: Unaltered
 Condition: Good

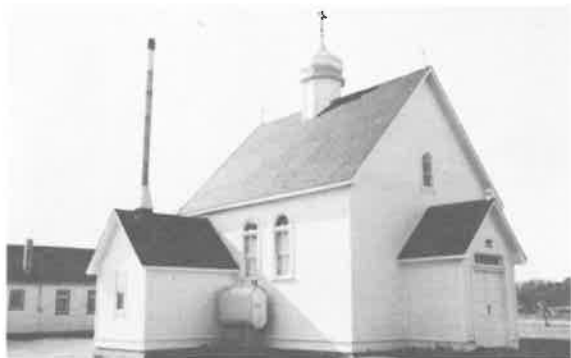
- 200) St. John the Baptist Ukrainian Catholic Church
 Construction Date: ca. 1920
 Location: NE 34-15-6E
 Present Owner: Ukrainian Catholic Church of Canada
 Present Use: Active Congregation
 Construction:
 walls - horizontal siding on milled wooden frame
 roof - asphalt shingles on milled wooden rafters
 Integrity: Largely unaltered
 Condition: Good

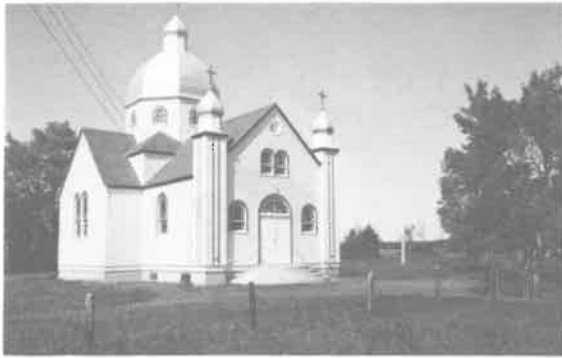
- 201) **St. Peter & St. Paul Ukrainian Catholic Church**
Construction Date: ca. 1930
Location: SE 19-16-8E
Present Owner: Ukrainian Catholic Church of Canada
Present Use: Active Congregation
Construction:
 walls - horizontal siding on milled wooden frame
 roof - asphalt shingles on milled wooden rafters
Integrity: Largely unaltered
Condition: Good

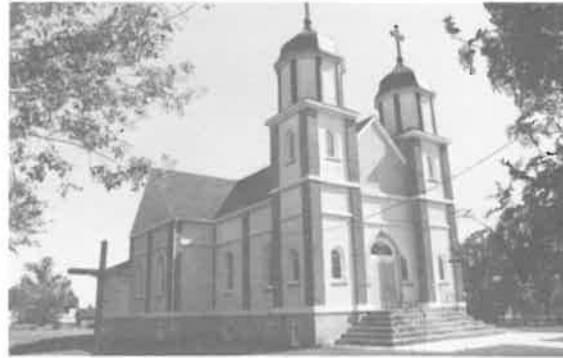
- 202) **Ukrainian Catholic Church**
Construction Date: 1951
Location: East Selkirk
Present Owner: Ukrainian Catholic Church of Canada
Present Use: Active Congregation
Construction:
 walls - stucco veneer on milled wooden frame
 roof - asphalt shingles on milled wooden rafters
Integrity: Largely unaltered
Condition: Good
Notes: This building is also discussed on page 122.

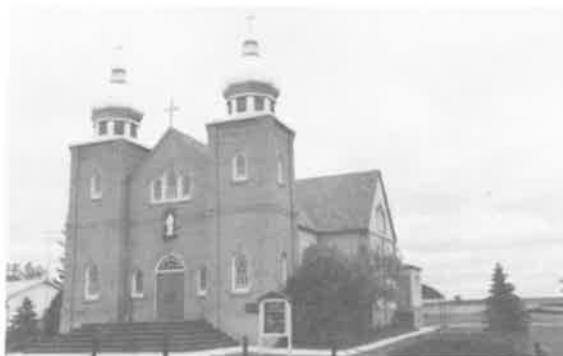
- 203) **Holy Trinity Ukrainian Catholic Church**
Construction Date: 1952
Location: River Lots #201-204
Present Owner: Ukrainian Catholic Church of Canada
Present Use: Active Congregation
Construction:
 walls - stucco veneer on milled wooden frame
 roof - asphalt shingles on milled wooden rafters
Integrity: Largely unaltered
Condition: Good
Notes: This building is also discussed on page 100.

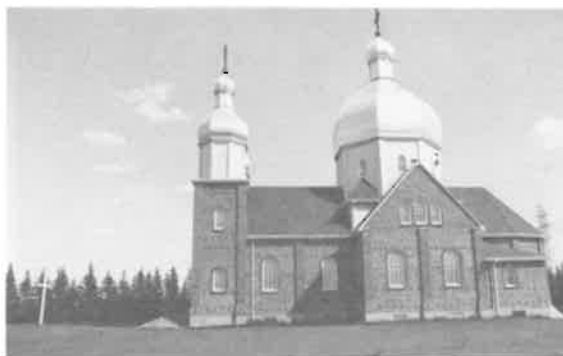
- 204) **Blessed Virgin Mary Ukrainian Catholic Church**
Construction Date: 1958-60
Location: River Lots 78 & 79
Present Owner: Ukrainian Catholic Church of Canada
Present Use: Active Congregation
Construction:
 walls - buff brick on wood frame
 roof - asphalt shingles on milled wooden rafters
Integrity: Unaltered floorplan
Condition: Good
Notes: This building is also discussed on page 100.

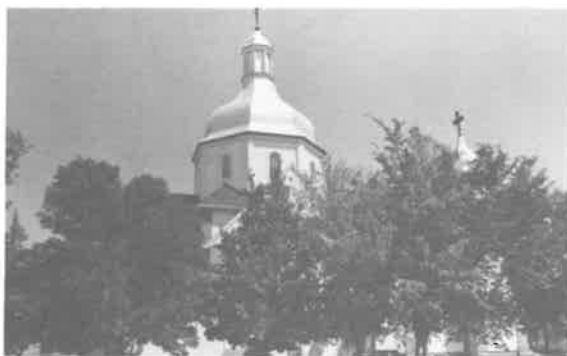
- 205) Ukrainian Greek Catholic Church of Holy Eucharist
 Construction Date: 1955
 Location: Sophia Street, Selkirk
 Present Owner: Ukrainian Catholic Church of Canada
 Present Use: Active Congregation
 Construction:
 walls - stucco veneer on milled wooden frame
 roof - asphalt shingles on milled wooden rafters
 Integrity: Largely unaltered
 Condition: Good
 Notes: This building is also discussed on page 117.

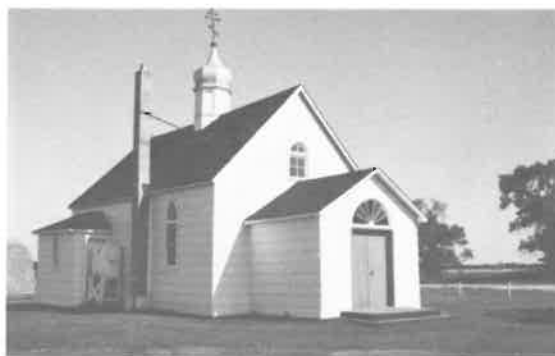
- 206) Ukrainian Orthodox Church of the Holy Trinity
 Construction Date: 1906
 Location: SW 27-15-6E
 Present Owner: Ukrainian Orthodox Church of Canada
 Present Use: Active Congregation
 Construction:
 walls - horizontal siding on milled wooden frame
 roof - asphalt shingles on milled wooden rafters
 Integrity: Largely unaltered
 Condition: Good
 Notes: This building is also discussed on page 98.

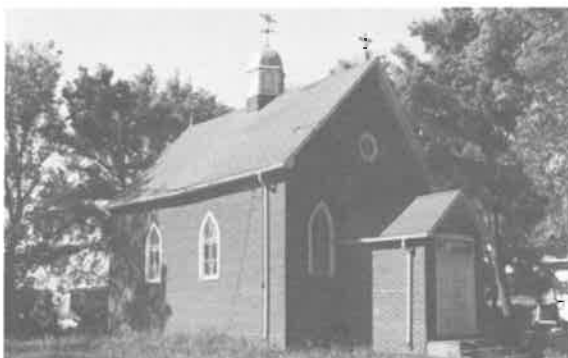
- 207) St. Michael's Ukrainian Greek Orthodox Church
 Construction Date: 1920
 Location: East Selkirk
 Present Owner: Ukrainian Greek Orthodox Church of Canada
 Present Use: Vacant
 Construction:
 walls - asphalt shingles on milled wooden frame
 roof - asphalt shingles on milled wooden rafters
 Integrity: Largely unaltered
 Condition: Fair
 Notes: This building has been demolished since the survey was undertaken.
