ARCHITECTURAL HERITAGE

The Selkirk and District

Planning Area

David
Butterfield

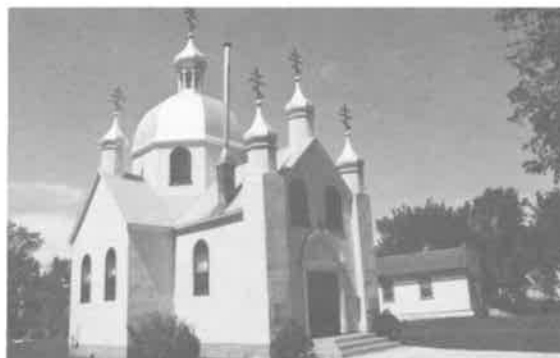
- 208) St. Nicholas Ukrainian Greek Orthodox Church
 Construction Date: 1945
 Location: River Lots #183-185
 Present Owner: Ukrainian Greek Orthodox Church of Canada
 Present Use: Active Congregation
 Construction:
 walls - stucco veneer on milled wooden frame
 roof - asphalt shingles on milled wooden rafters
 Integrity: Largely unaltered
 Condition: Good
 Notes: This building is also discussed on pages 98-99.

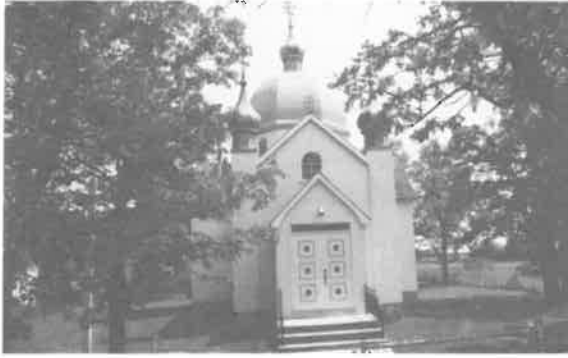
- 209) **St. Nicholas Orthodox Church of Narol**
Construction Date: 1948 or 1952
Location: River Lot #228
Present Owner: Ukrainian Orthodox Church of Canada
Present Use: Active Congregation
Construction:
 wall - stucco veneer on milled wooden frame
 roof - wood shingles on milled wooden rafters
Integrity: Largely unaltered
Condition: Good
Notes: This building is also discussed on pages 98-99.

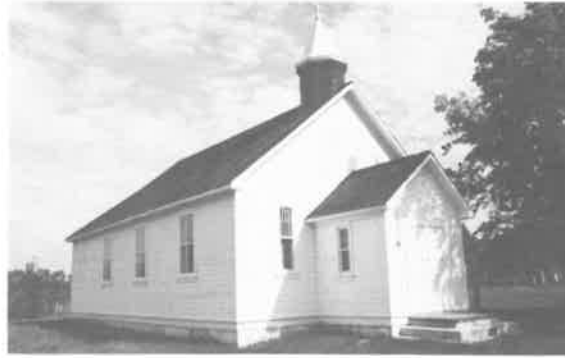
- 210) **Libau Lutheran Church**
Construction Date: ca. 1920
Location: Libau
Present Owner: Lutheran Church of Canada
Present Use: Active Congregation
Construction:
 walls - horizontal siding on milled wooden frame
 roof - wood shingles on milled wooden rafters
Integrity: Largely unaltered
Condition: Good
Notes: This building is also discussed on page 128.

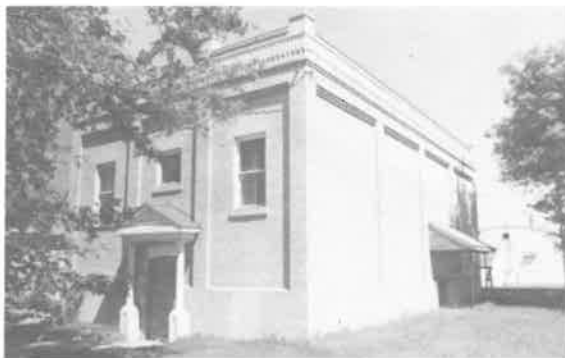
- 213) **Masonic Temple**
Construction Date: 1871
Location: Eaton Avenue, Selkirk
Present Owner: Lisgar Lodge No. 2 AF & AM
Present Use: Active lodge
Construction:
 walls - buff brick veneer on milled wooden frame
 roof - built-up roofing
Integrity: The interior has been altered
Condition: Good
Notes: This building is also discussed on page 117.

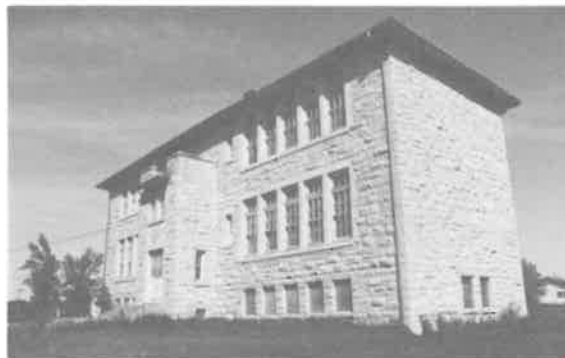
- 214) **Happy Thought School**
Construction Date: 1916
Location: Garson
Present Owner: R.M. of St. Clements
Present Use: Vacant
Construction:
 walls - fieldstone
 roof - wood shingles on milled wooden rafters
Integrity: Unaltered
Condition: Good
Notes: This building is also discussed on page 122.

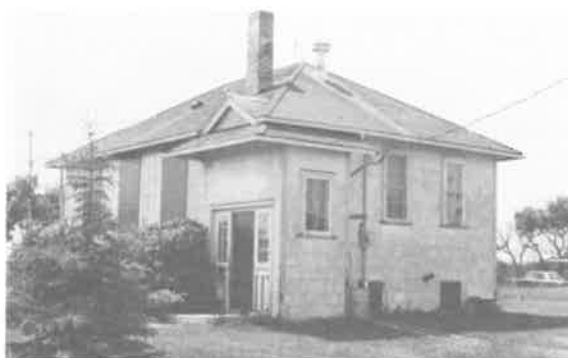
- 215) **Norwood School**
Construction Date:
Location: NE 14-15-3E
Present Owner: Mr. Waite
Present Use: Residence
Construction:
 walls - asphalt shingles on milled wooden frame
 roof - wood shingles on milled wooden rafters
Integrity: The interior has been much altered for its present function
Condition: Good
Notes: This building is also discussed on page 103.

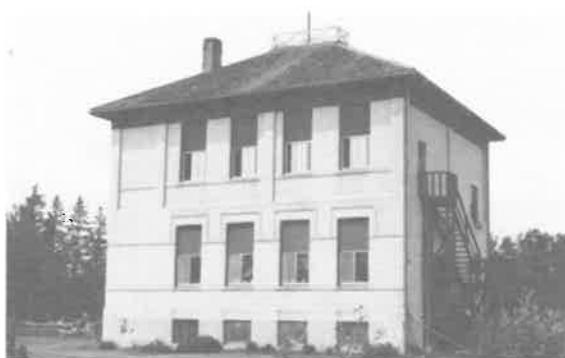
- 216) **Petersfield School**
Construction Date: ca. 1915
Location: Petersfield
Present Owner: Larry Jackson
Present Use: Residence
Construction:
 walls - buff brick on milled wooden frame
 roof - wood shingles on milled wooden rafters
Integrity: Interior has been altered for its present function
Condition: Good
Notes: This building is also discussed on page 127.

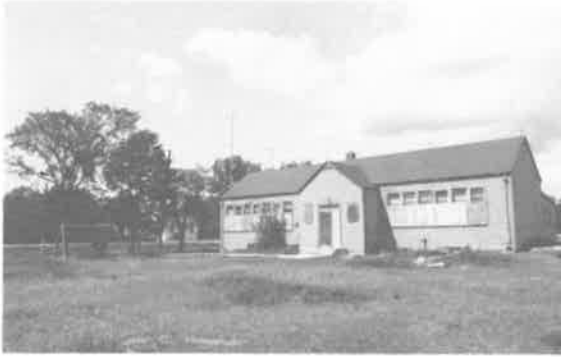
- 217) **Cloverdale School**
Construction Date:
Location: NW 4-14-4E
Present Owner: Jack Harriott
Present Use: Vacant
Construction:
 walls - wood shingles on milled wooden frame
 roof - asphalt shingles on milled wooden rafters
Integrity: Unaltered
Condition: Fair

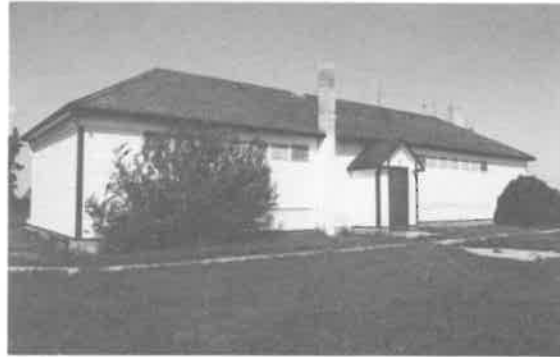
- 218) **Rosedale School**
Construction Date: ca. 1920
Location: River Lot #83
Present Owner: United Croats Association
Present Use: Vacant
Construction:
 walls - horizontal siding on milled wooden frame
 roof - wood shingles on milled wooden rafters
Integrity: Unaltered
Condition: Good
Notes: This building is also discussed on page 104.

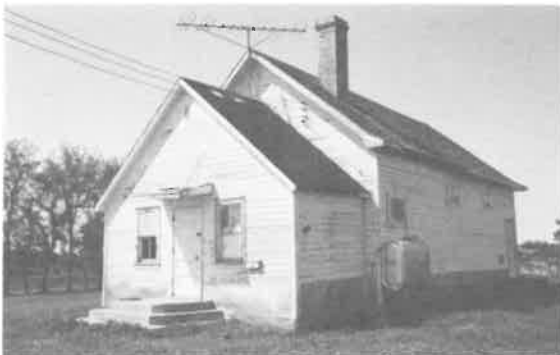
- 219) **Sheffield School**
Construction Date: ca. 1925
Location: SW 3-16-6E
Present Owner: R. Gutterson
Present Use: Vacant
Construction:
 walls - horizontal siding on milled wooden frame
 roof - wood shingles on milled wooden rafters
Integrity: Unaltered
Condition: Fair
Notes: This building is also discussed on page 104.

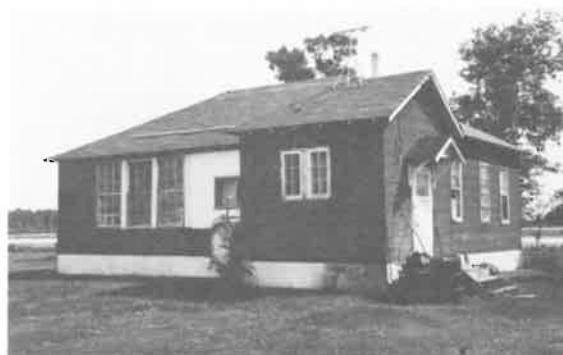
- 220) **Lilleydale School**
Construction Date: ca. 1925
Location: SE 11-14-5
Present Owner: W. Jacyk
Present Use: Storage
Construction:
 walls - insulbrick veneer on milled wooden frame
 roof - asphalt shingles on milled wooden rafters
Integrity: Unaltered
Condition: Good

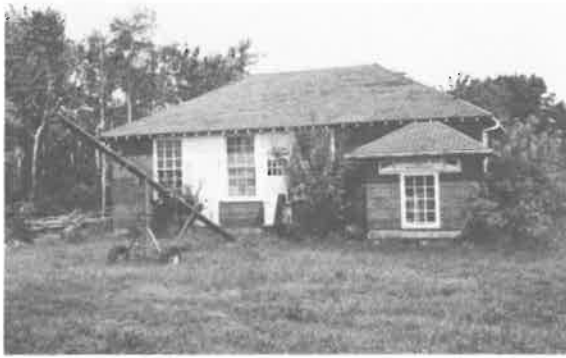
- 221) Brookside School
 Construction Date: ca. 1925
 Location: SE 11-14-5E
 Present Owner: W. Jacyk
 Present Use: Storage
 Construction:
 walls - insulbrick veneer on milled wooden frame
 roof - asphalt shingles on milled wooden rafters
 Integrity: Unaltered
 Condition: Good

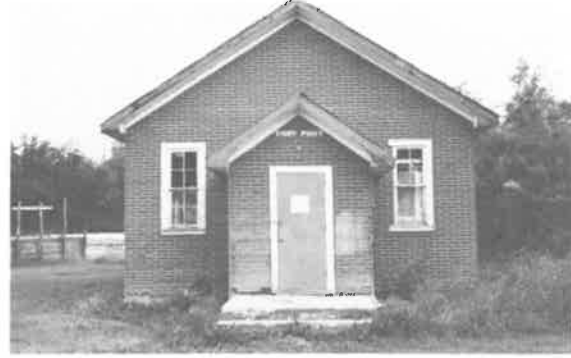
- 222) Stony Point School
 Construction Date: ca. 1925
 Location: SE 6-17-7E
 Present Owner: R.M. of St. Clements
 Present Use: Vacant
 Construction:
 walls - insulbrick veneer on milled wooden frame
 roof - asphalt shingles on milled wooden rafters
 Integrity: Unaltered
 Condition: Poor

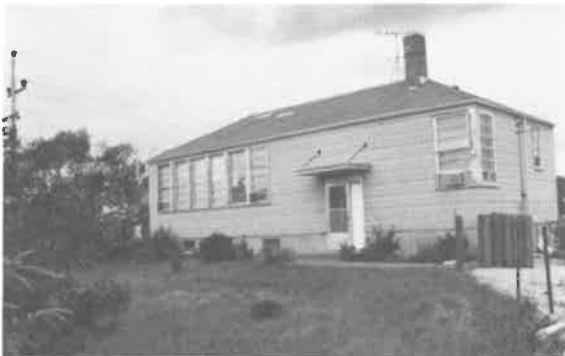
- 223) Earl Grey School
 Construction Date: ca. 1925
 Location: SW 36-13-3E
 Present Owner: L. LeBlanc
 Present Use: Residence
 Construction:
 walls - wood shingles on milled wooden frame
 roof - asphalt shingles on milled wooden rafters
 Integrity: The interior has undergone renovations for its present function
 Condition: Good
 Notes: This building is also discussed on page 104.

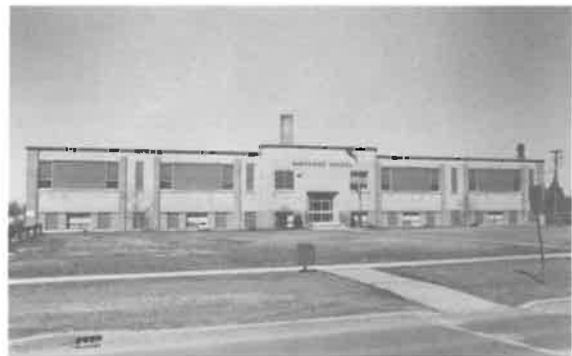
- 224) Deerwood School
 Construction Date: 1949
 Location: Main Street, Selkirk
 Present Owner: Town of Selkirk
 Present Use: Active School
 Construction:
 walls - buff brick on milled wooden frame
 roof - built-up roofing
 Integrity: Largely unaltered
 Condition: Good

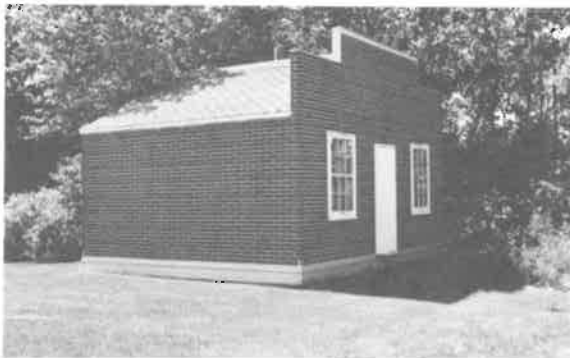
- 226) Netley Airport Store
 Construction Date: ca. 1915
 Location: NW 15-16-4E
 Present Owner: Block Brothers Realty
 Present Use: Vacant
 Construction:
 walls - insulbrick siding on milled wooden frame
 roof - asphalt shingles on milled wooden rafters
 Integrity: The interior has been altered several times
 Condition: Fair
 Notes: This building is also discussed on page 105.

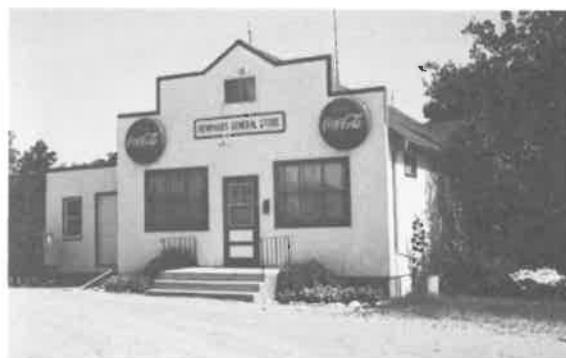
- 227) General Store
 Construction Date: ca. 1915
 Location: NE 15-14-6E
 Present Owner:
 Present Use: Storage
 Construction:
 walls - insulbrick siding on milled wooden frame
 roof - asphalt shingles on milled wooden rafters
 Integrity: The interior has been altered
 Condition: Good

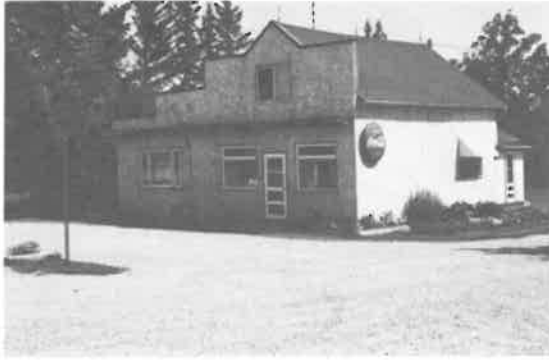
- 228) Newman's General Store
 Construction Date: ca. 1920
 Location: SW 19-16-8E
 Present Owner: Mr. Newman
 Present Use: Vacant
 Construction:
 walls - stucco veneer on milled wooden frame
 roof - asphalt shingles on milled wooden rafters
 Integrity: Unaltered
 Condition: Good
 Notes: This building is also discussed on page 105.

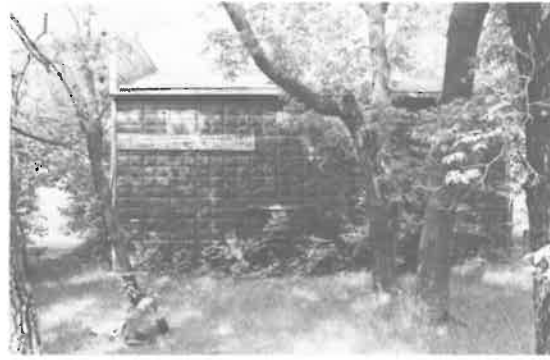
- 229) General Store
 Construction Date: ca. 1920
 Location: NW 18-16-8E
 Present Owner:
 Present Use: Vacant
 Construction:
 walls - stucco veneer on milled wooden frame
 roof - asphalt shingles on milled wooden rafters
 Integrity: Unaltered
 Condition: Good

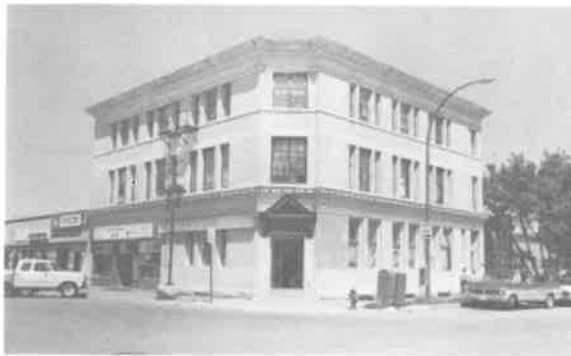
- 232) Merchant's Hotel
 Construction Date: 1903
 Location: Manitoba & Eveline, Selkirk
 Present Owner: Verna Konowalchuk
 Present Use: Functioning Hotel
 Construction:
 walls - buff brick on milled wooden frame
 roof - built-up tar and gravel
 Integrity: Both interior and exterior have been altered.
 Condition: Good
 Notes: This building is also discussed on page 114.

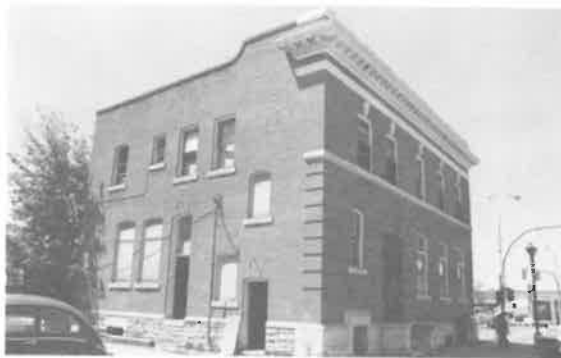
- 233) **Former Dominion Bank**
Construction Date: ca. 1900
Location: Manitoba & Eveline, Selkirk
Present Owner:
Present Use: Various businesses and offices
Construction:
 walls - buff brick on milled wooden frame
 roof - built-up tar and gravel
Integrity: Both interior and exterior have been altered
Condition: Good
Notes: This building is also discussed on page 114.

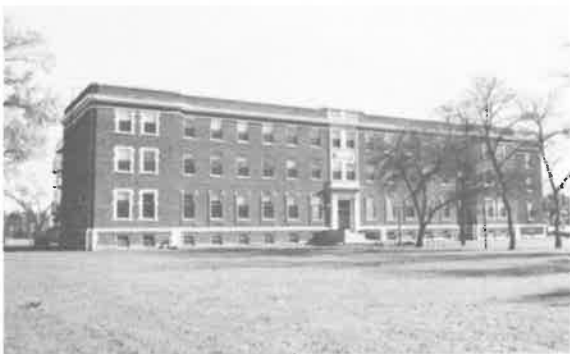
- 238) Reception Hospital
 Construction Date: 1922
 Location: Selkirk Mental Health Centre
 Present Owner: Selkirk Mental Health Centre
 Present Use: Functioning Hospital
 Construction:
 walls - red brick veneer on milled wooden frame
 roof - asphalt shingles on sloped surfaces; built-up roofing on flat surfaces
 Integrity: Largely unaltered
 Condition: Good
 Notes: This building is also discussed on page 113.

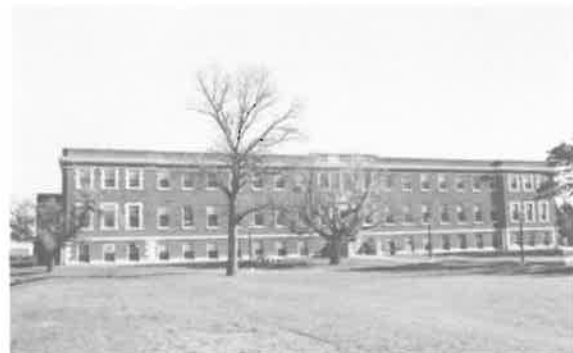
- 239) Nurses Home
 Construction Date: 1926
 Location: Selkirk Mental Health Centre
 Present Owner: Selkirk Mental Health Centre
 Present Use: Residential Facility
 Construction:
 walls - red brick veneer and limestone details on milled wooden frame
 roof - built-up roofing
 Integrity: Largely unaltered
 Condition: Good

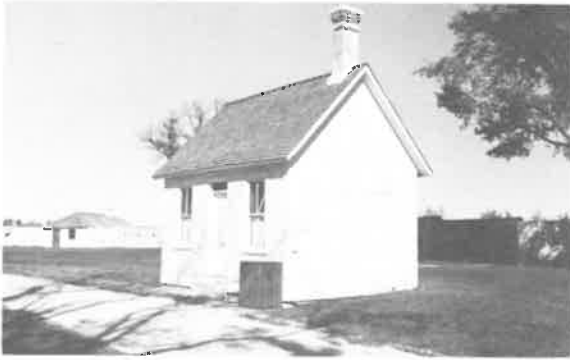
248) Men's House
 Construction Date: 1850s
 Location: Lower Fort Garry National Historic Park
 Present Owner: Parks Canada
 Present Use: Display
 Construction:
 walls - dressed limestone
 roof - wooden shingles on hewn timber rafters
 Integrity: The building has been carefully restored
 Condition: Good
